Council Assessment Panel Agenda & Reports

19 May 2025

DEVELOPMENT NO.:	25003913
APPLICANT:	John Miller and Haley Miller
ADDRESS:	69 HIGH ST KENSINGTON SA 5068
NATURE OF DEVELOPMENT:	Demolition of a dwelling (Local Heritage Place)
ZONING INFORMATION:	<p>Zones:</p> <ul style="list-style-type: none"> • Established Neighbourhood <p>Overlays:</p> <ul style="list-style-type: none"> • Airport Building Heights (Regulated) • Historic Area • Heritage Adjacency • Hazards (Flooding - General) • Local Heritage Place • Prescribed Wells Area • Regulated and Significant Tree • Stormwater Management • Urban Tree Canopy <p>Technical Numeric Variations (TNVs):</p> <ul style="list-style-type: none"> • Minimum Site Area (Minimum site area is 400 sqm) • Maximum Building Height (Levels) (Maximum building height is 2 levels)
LODGEMENT DATE:	17 Feb 2025
RELEVANT AUTHORITY:	Assessment panel/Assessment manager at City of Norwood, Payneham and St. Peters
PLANNING & DESIGN CODE VERSION:	P&D Code (in effect) Version 2025.3 13/2/2025

RE: CRACKING IN EXISTING DWELLING - 69 High St, Kensington SA 5068

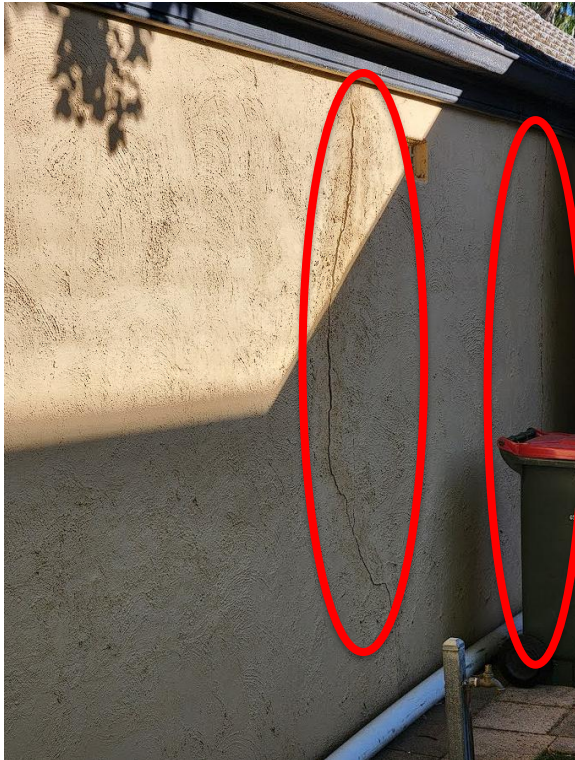
6-7mm diagonal cracking and 3-4mm vertical cracking on eastern boundary wall (from childcare side).

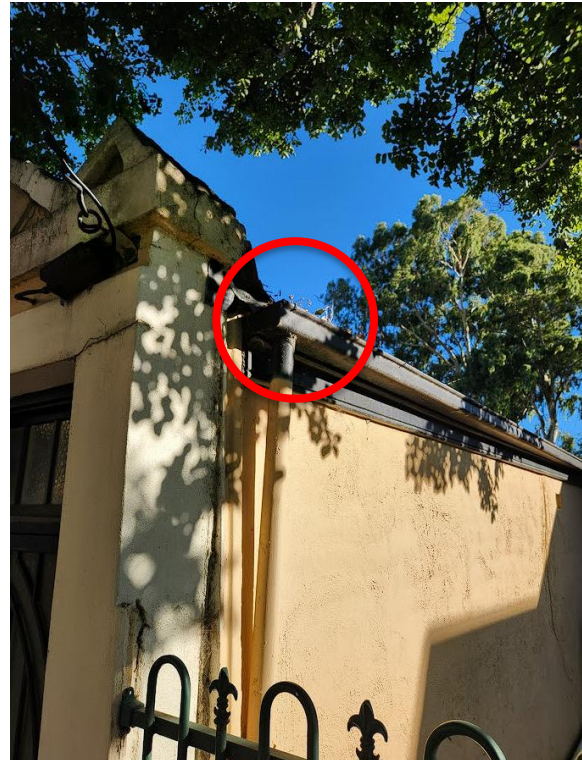
Debris in gutter.

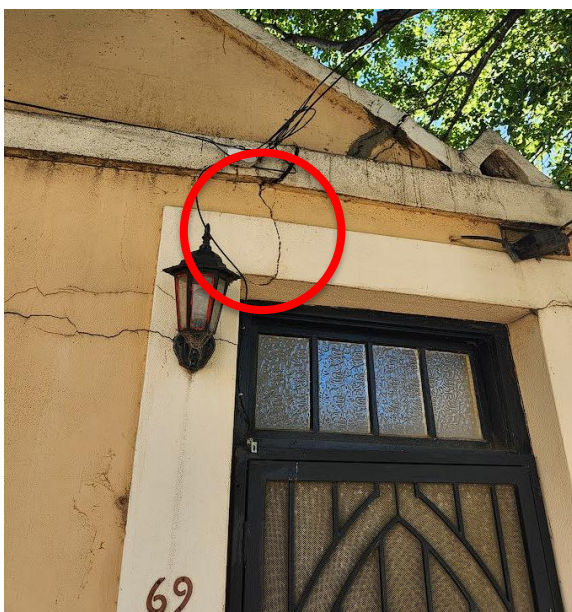
Vertical cracking above entry door.

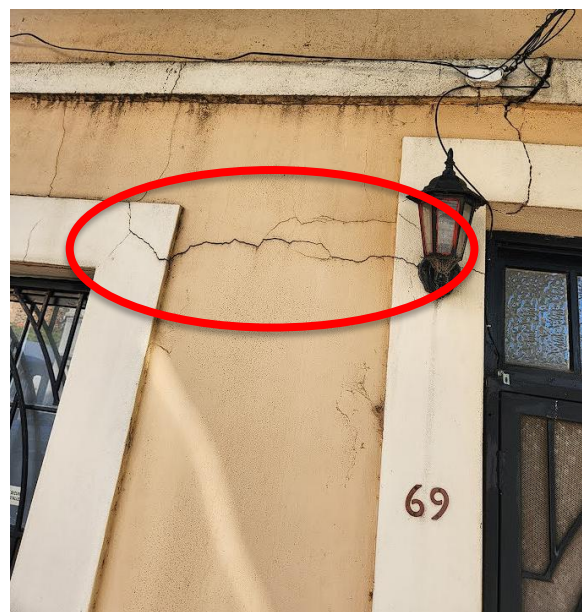
Horizontal cracking west of entry door.

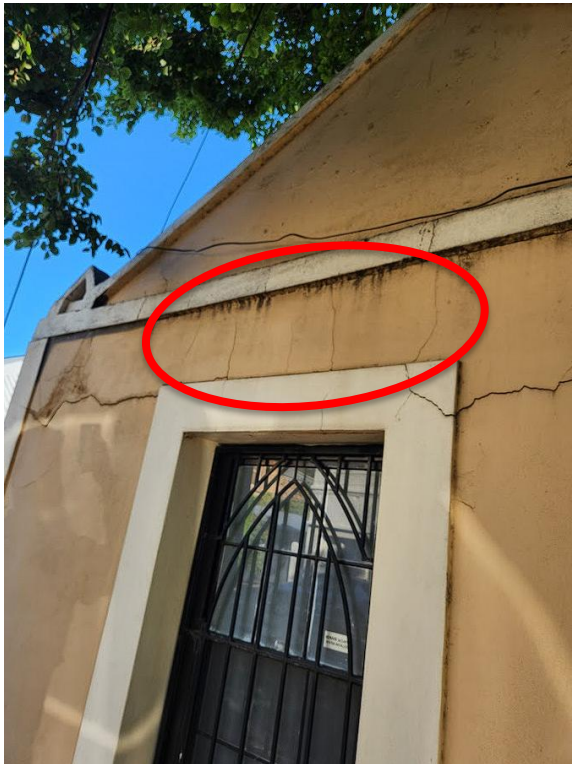
Horizontal and vertical cracking above southern living room window.

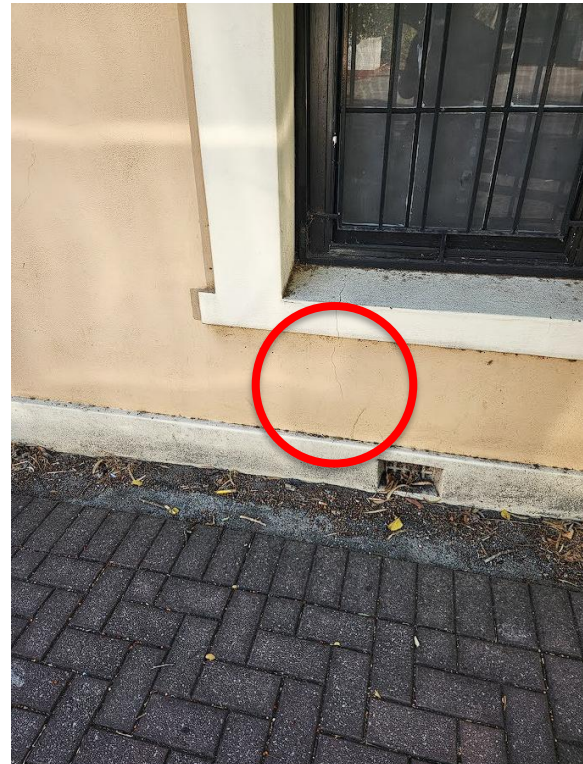
Vertical cracking below southern living room window.

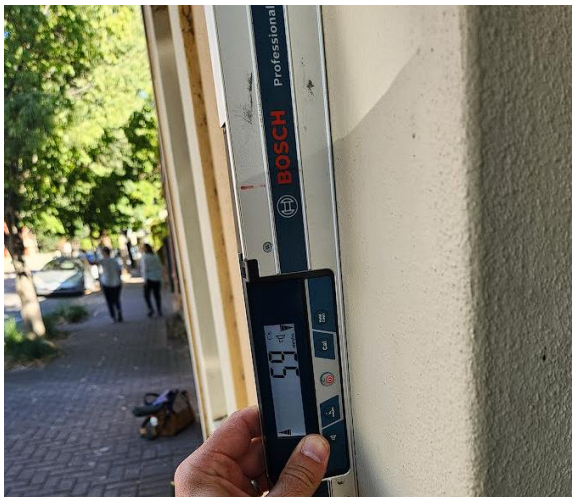
Rotation of southern wall on eastern end.

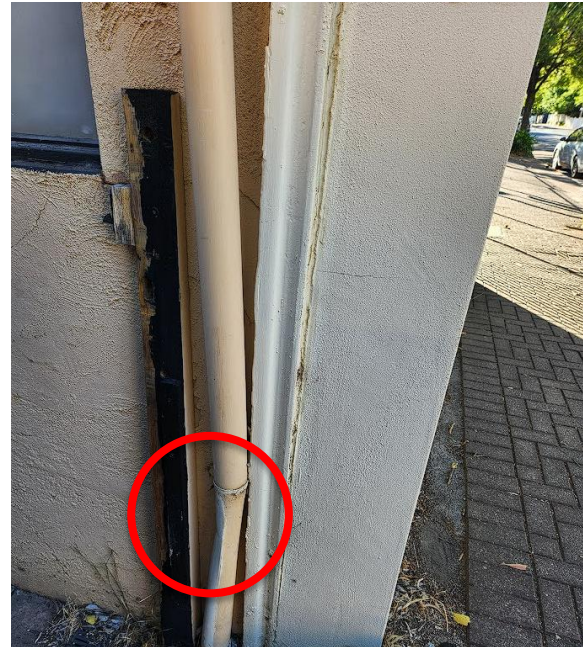
Damaged downpipe and clogged trench drain near side entry door.

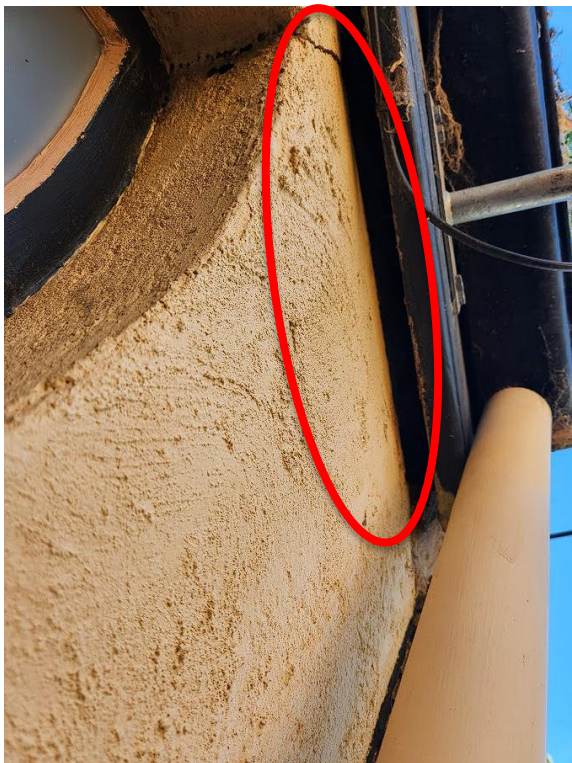
Separation of fascia from wall near southwestern corner of building.

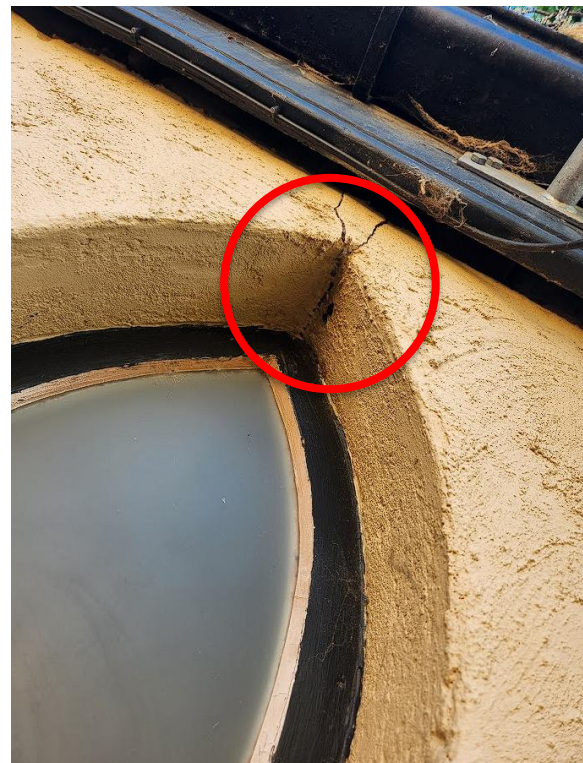
Cracking above western lounge room window.

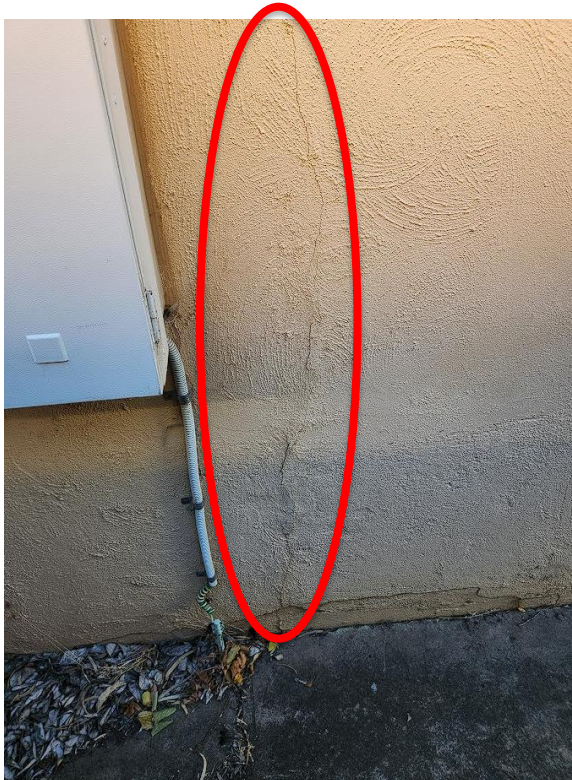
Hairline vertical cracking near meter box.

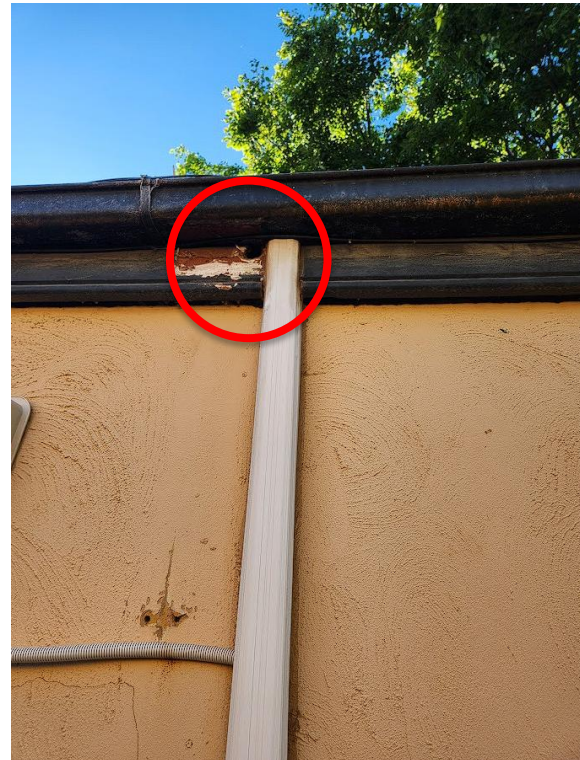
Holes in fascia board.

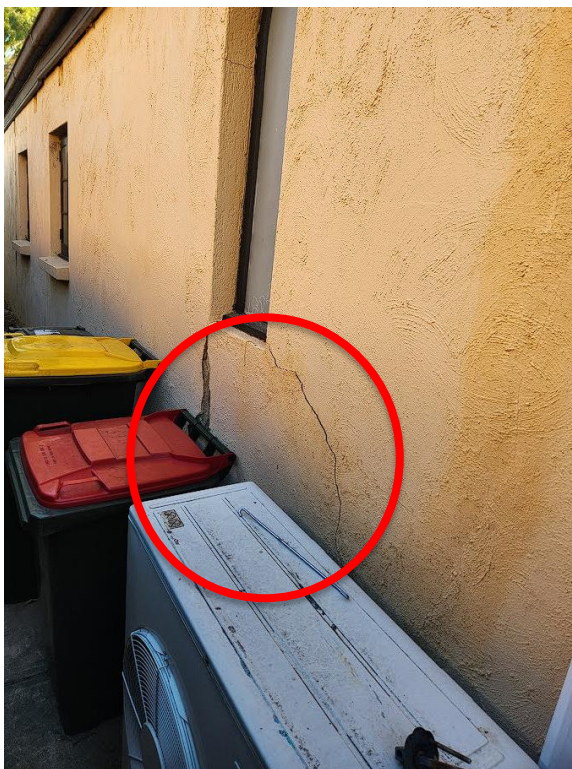
Diagonal cracking and debonded render near air conditioning unit.

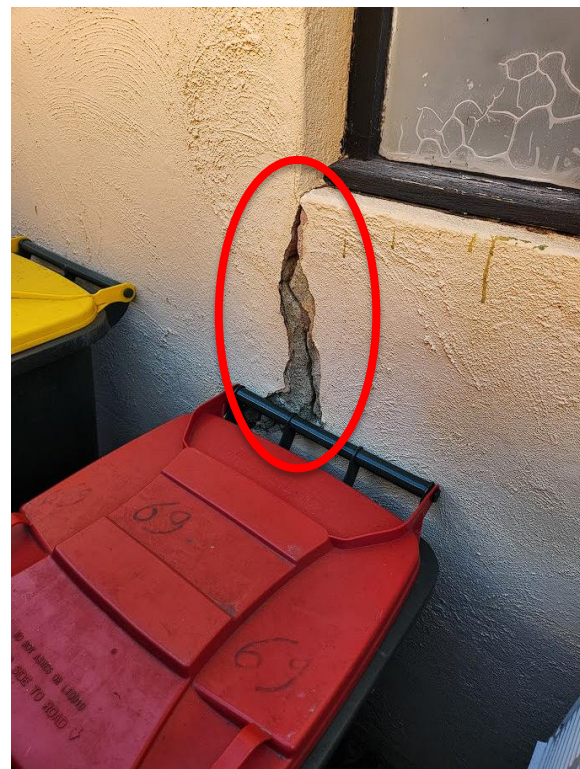
Vertical cracking below northern lounge room window on western wall.

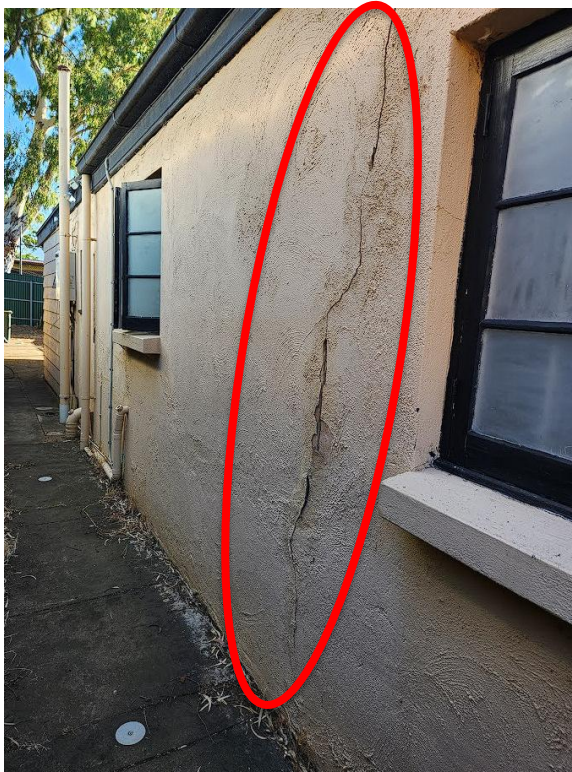
Vertical cracking to the north of bed 2 window.

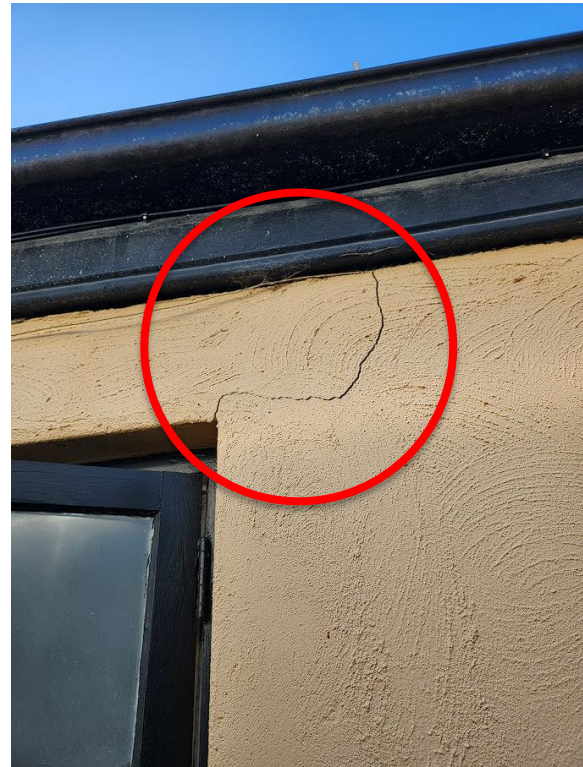
Diagonal cracking above kitchen window.

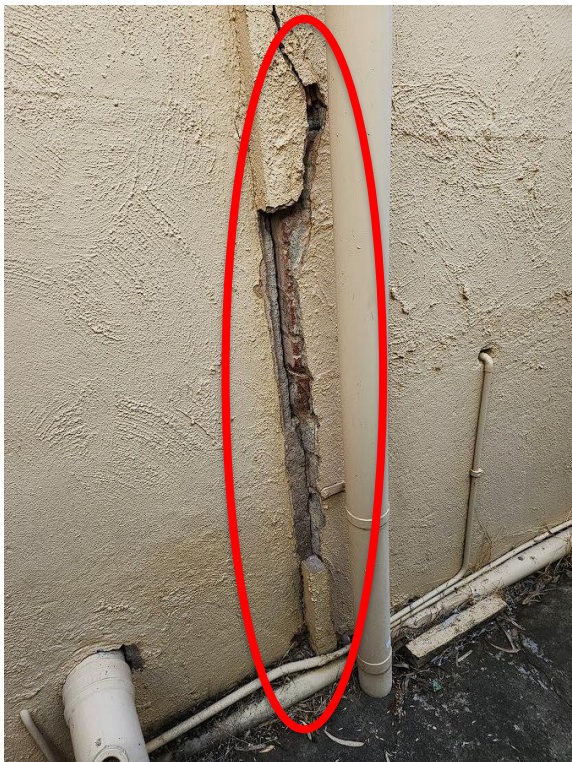
Vertical cracking to external wall near bathroom.

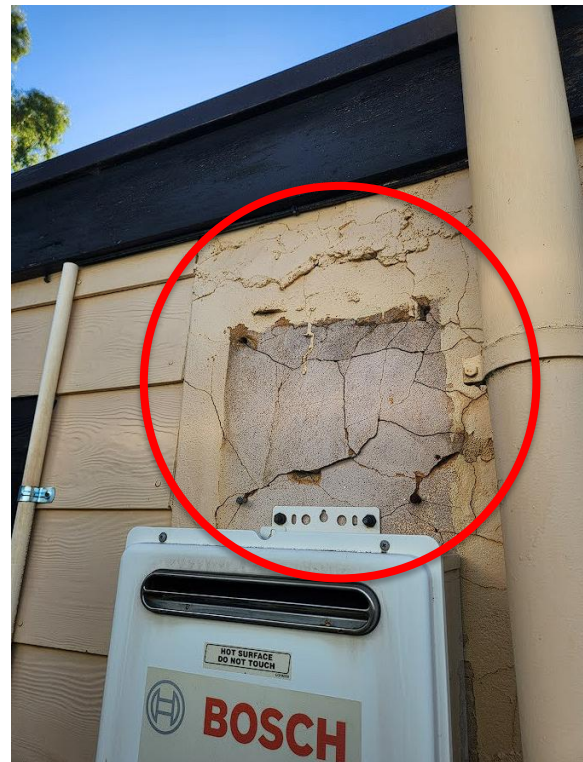
Cracking to render above water heater.

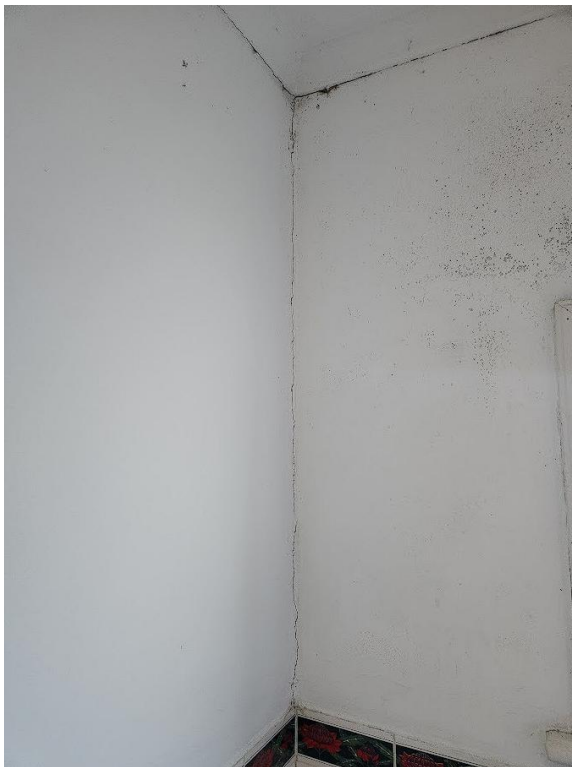
Vertical cracking in southwestern corner of room.

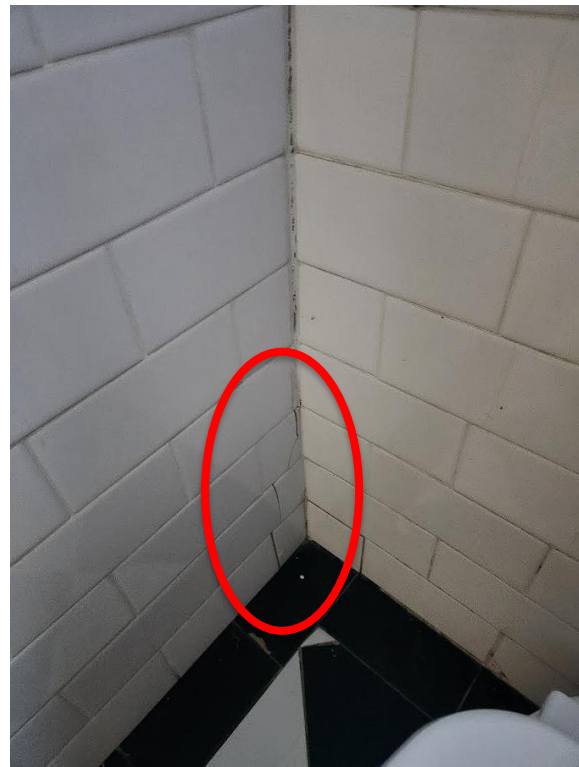
Broken tiles in southwestern corner of room.

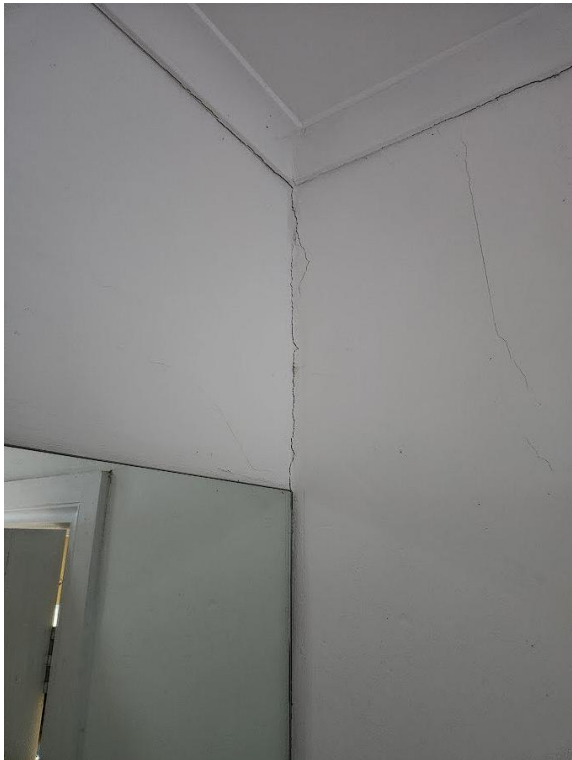
Vertical cracking in northeastern corner of room.

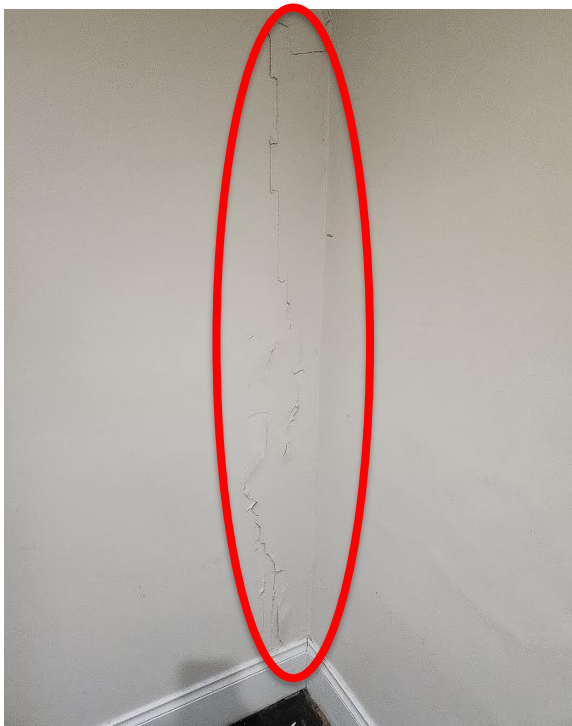
Vertical cracking in northeastern corner of room.

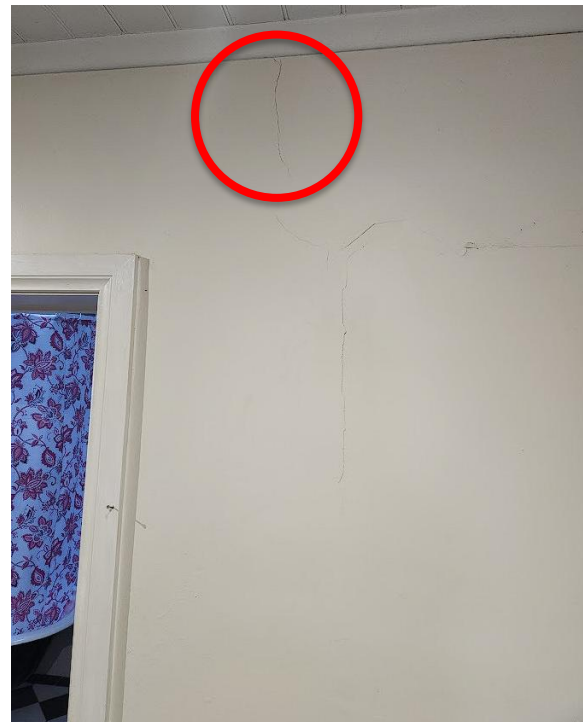
Vertical cracking to northern wall of room.

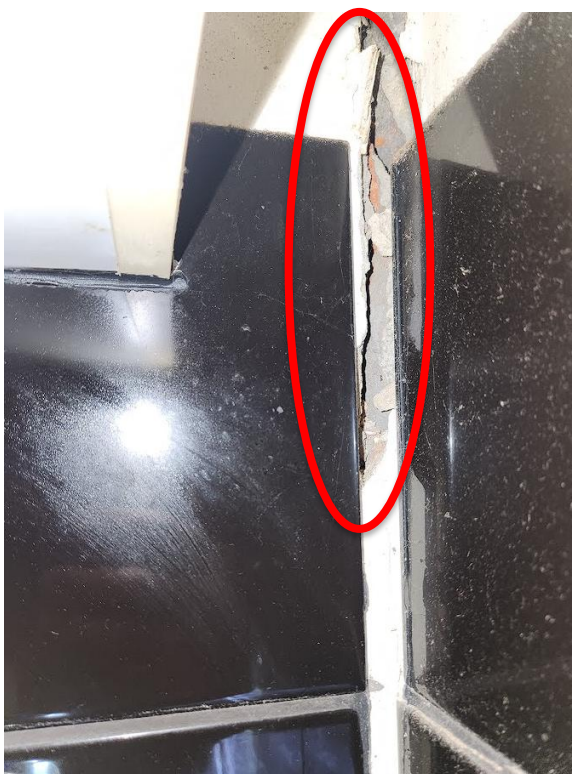
Vertical cracking in southwestern corner of room.

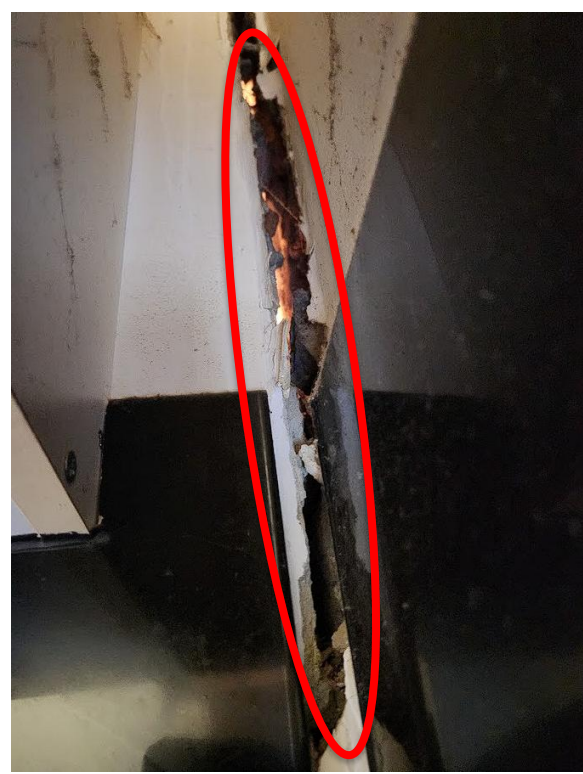
Vertical separation in southwestern corner of room.

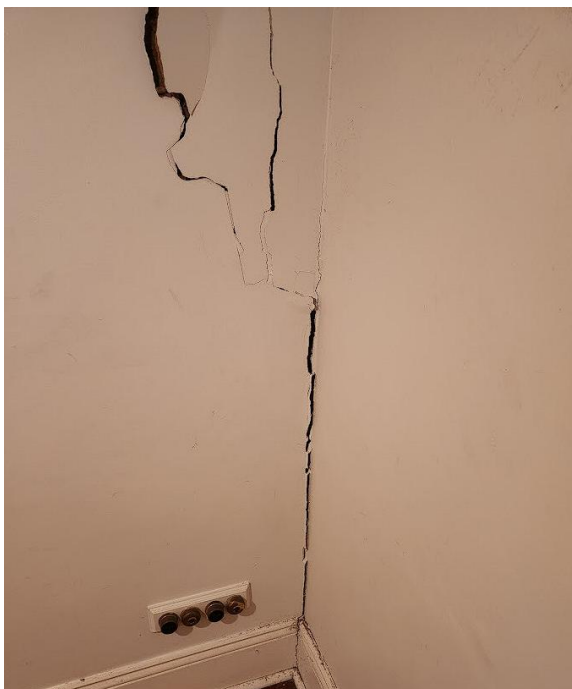
Vertical and diagonal cracking in southwestern corner of room.

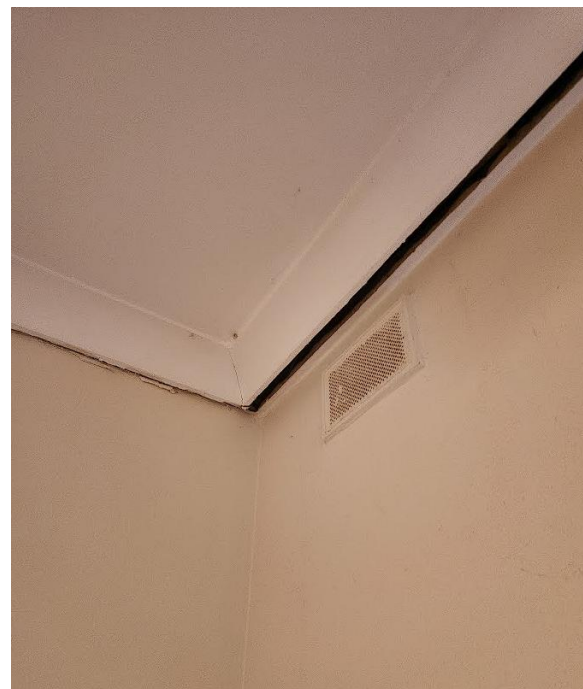
Separation of cornice from western wall on southern end.

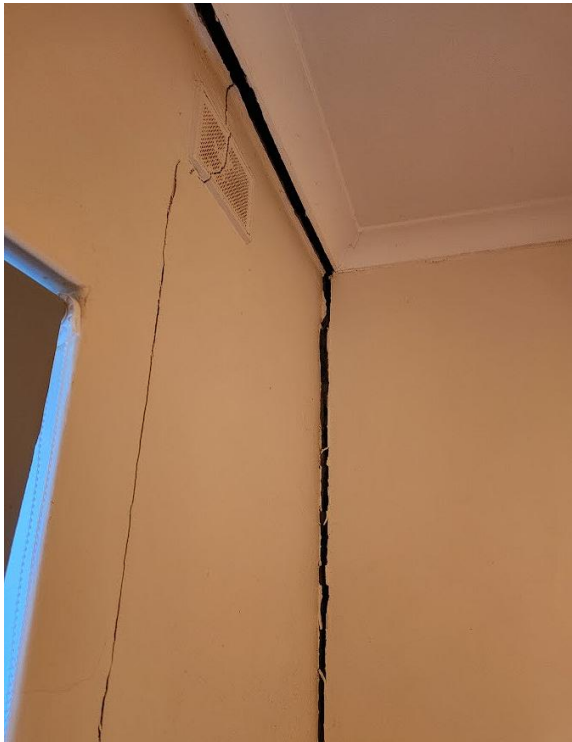
Vertical cracking in northwestern corner of room, indicating rotation of western external wall.

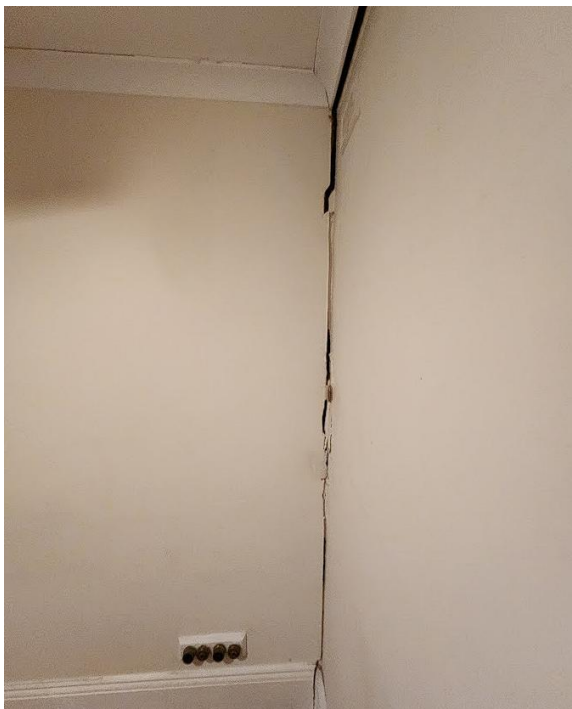
Vertical cracking in southwestern corner of room and separation of cornice from wall.

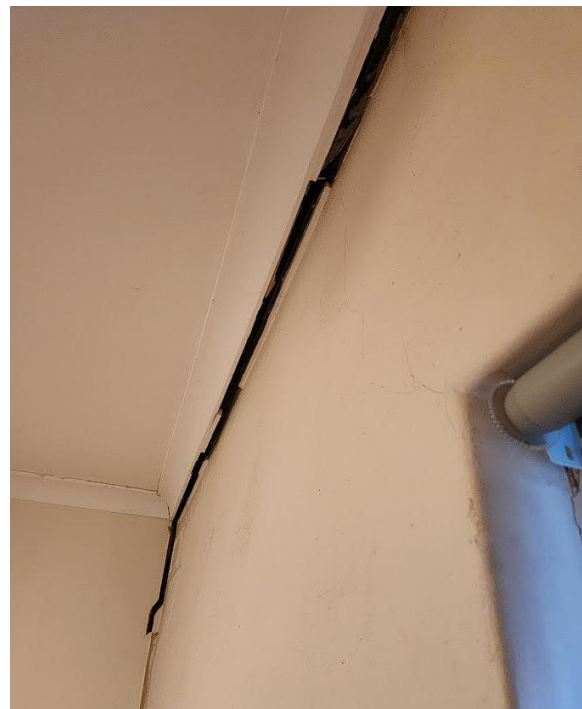
Separation of cornice from wall.

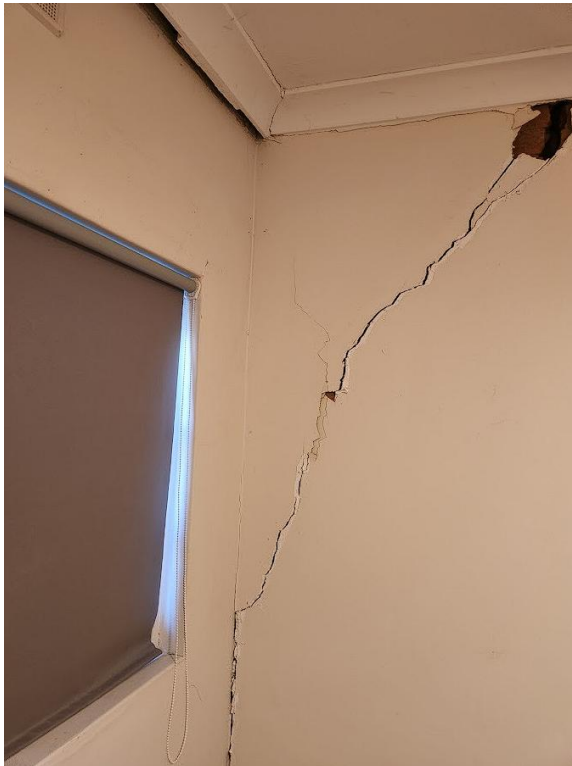
Diagonal cracking to northwestern corner of room.

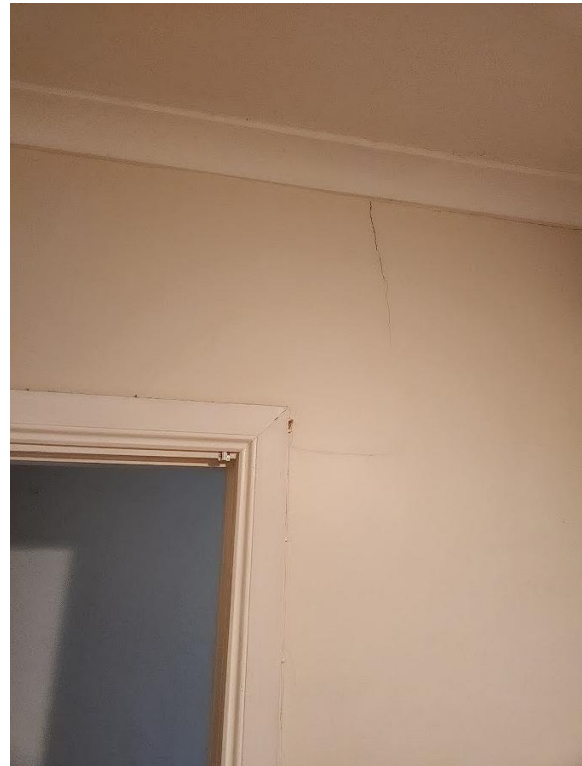
Vertical cracking above door.

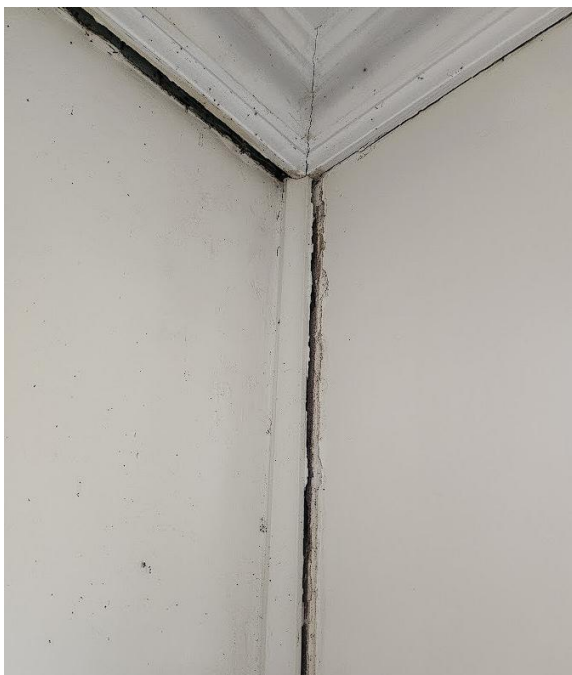
Vertical cracking and separation of cornice in southwestern corner of room.

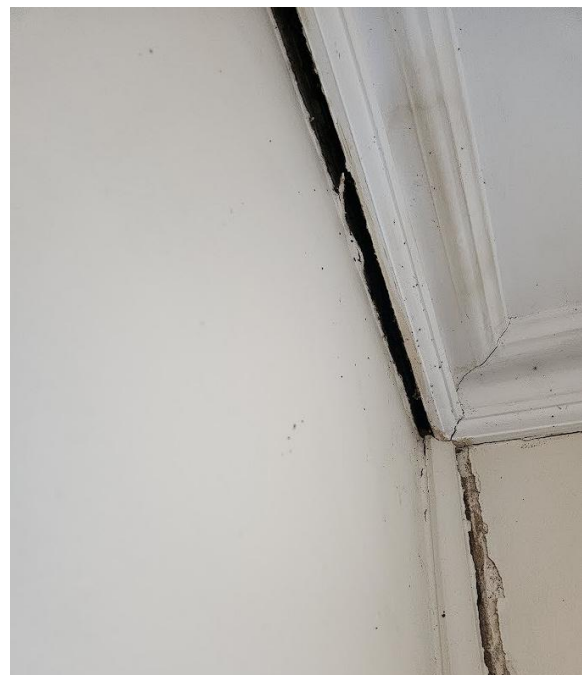
Separation of cornice from southern wall.

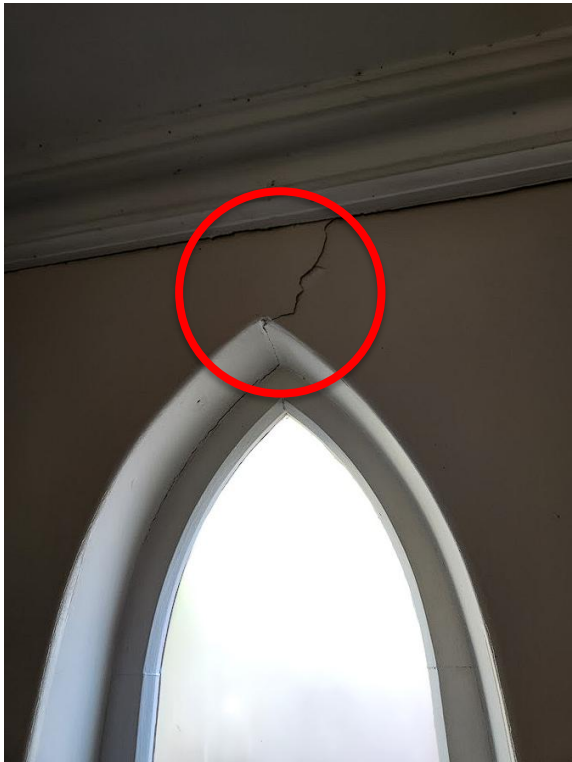
Diagonal cracking above southern window on western wall.

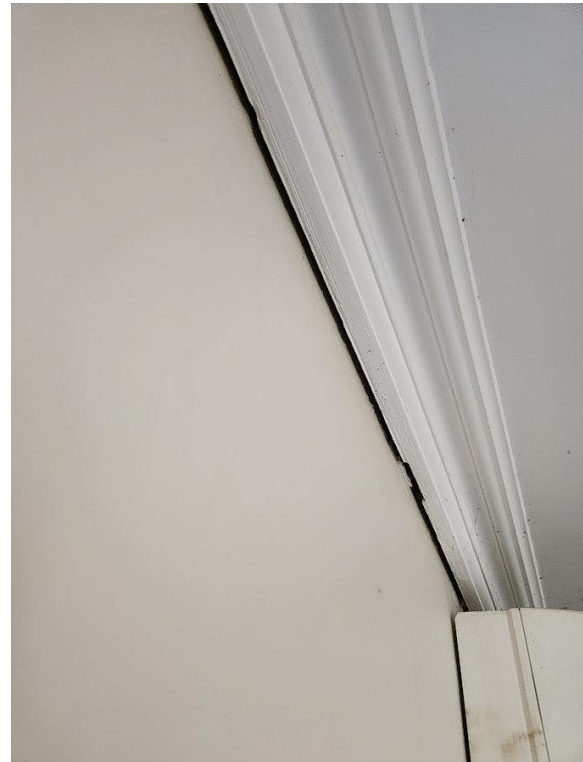
Separation of cornice from western wall.

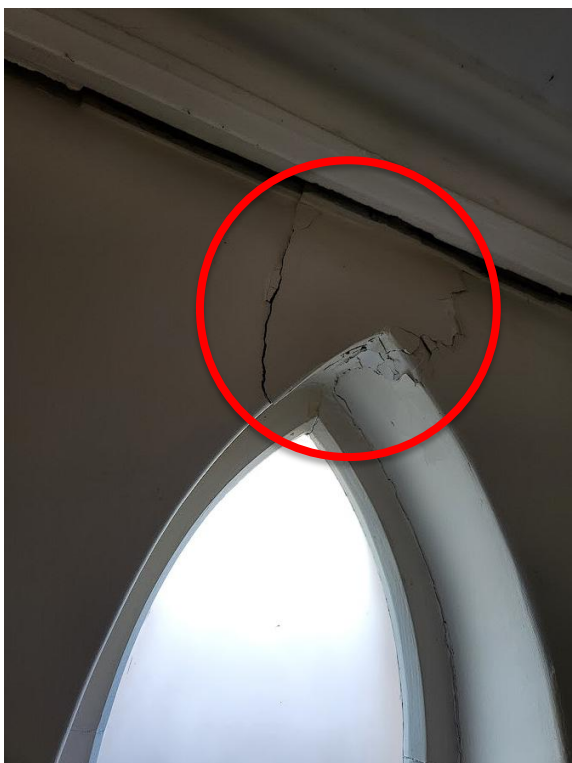
Vertical cracking and debonded render above northern window on western wall.

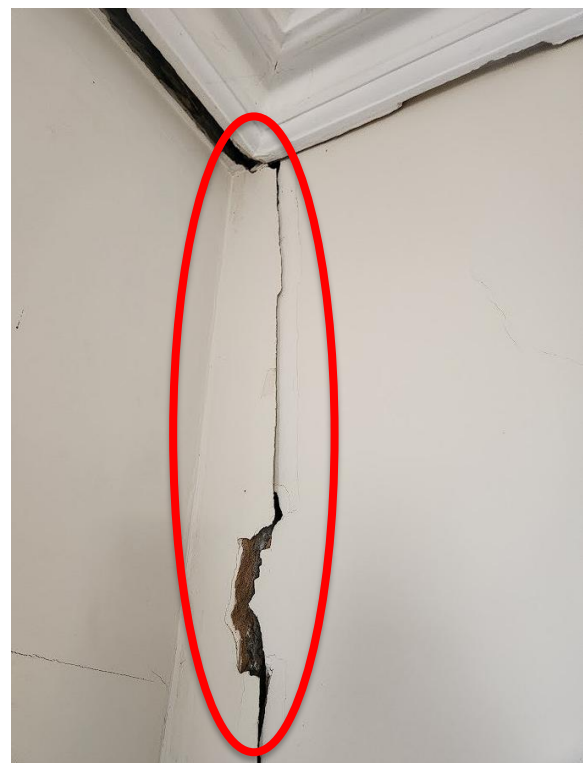
Severe cracking in northeastern corner of room and separation of cornice from wall.

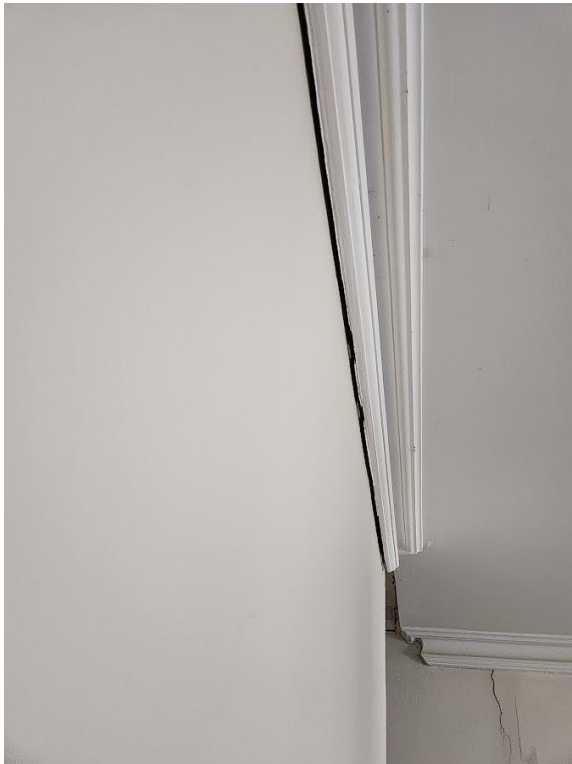
Separation of cornice from northern wall.

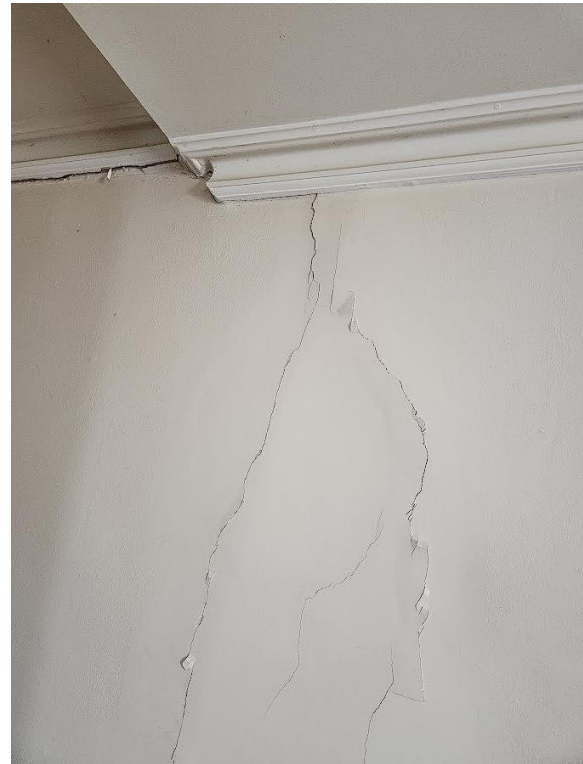
Vertical and diagonal cracking on eastern wall of lounge room.

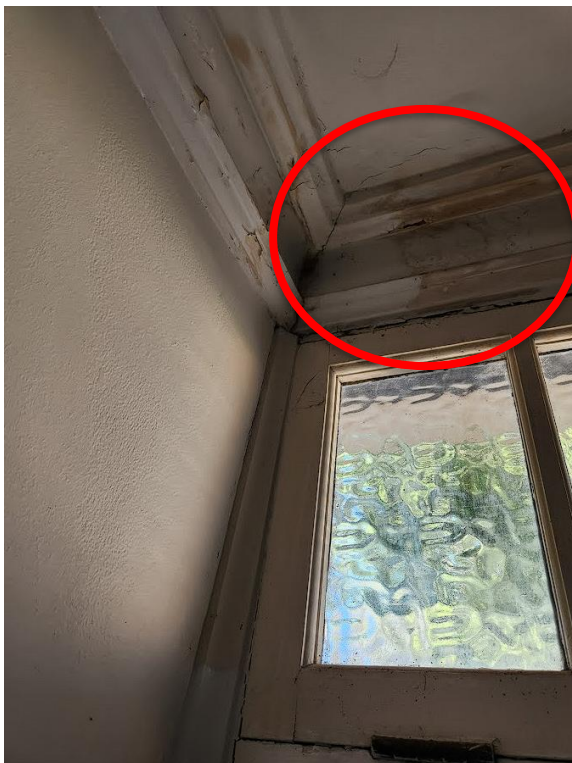
Water damaged in southeastern corner of room, above entry door.

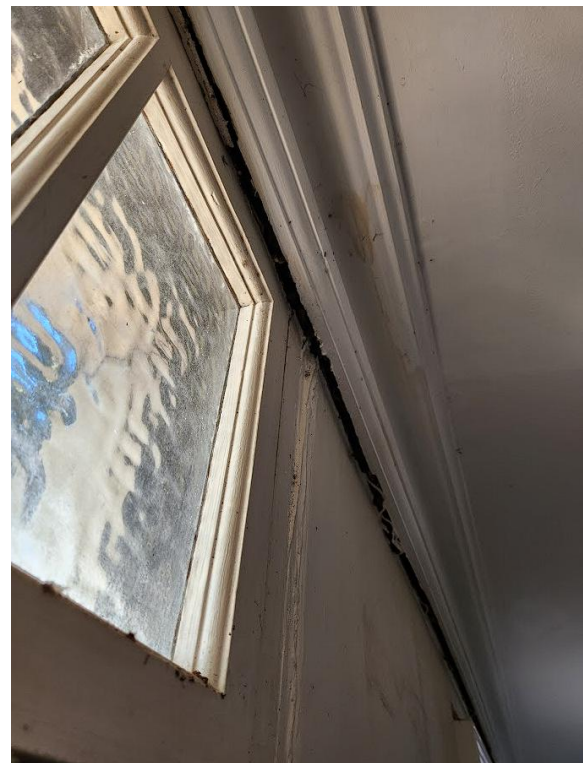
Separation of cornice from southern wall.

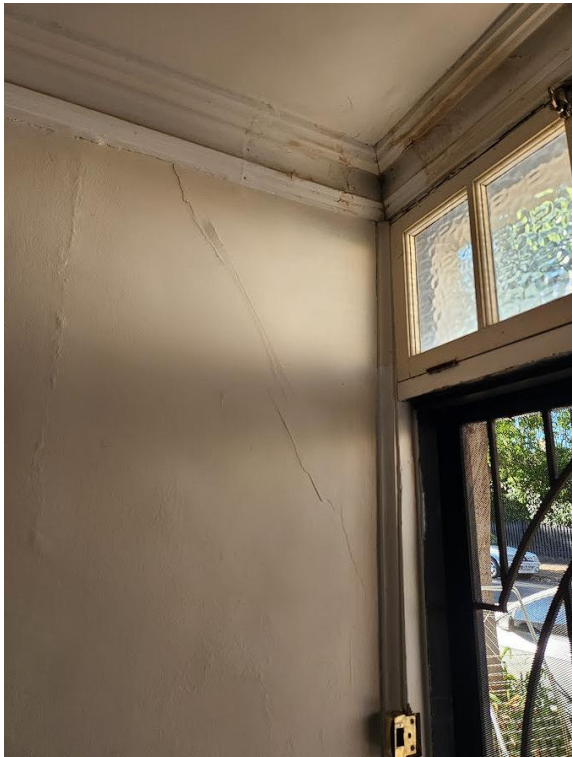
Diagonal cracking on eastern wall, near entry door.

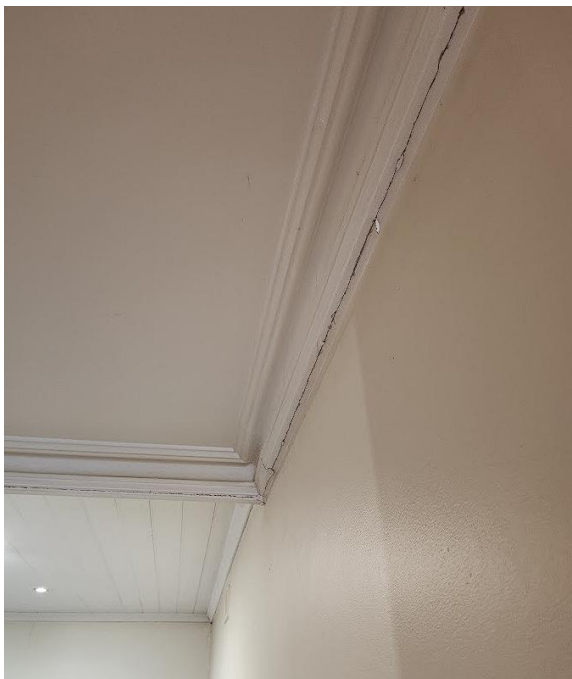
Horizontal cracking at bottom of cornice in northeastern corner of room.

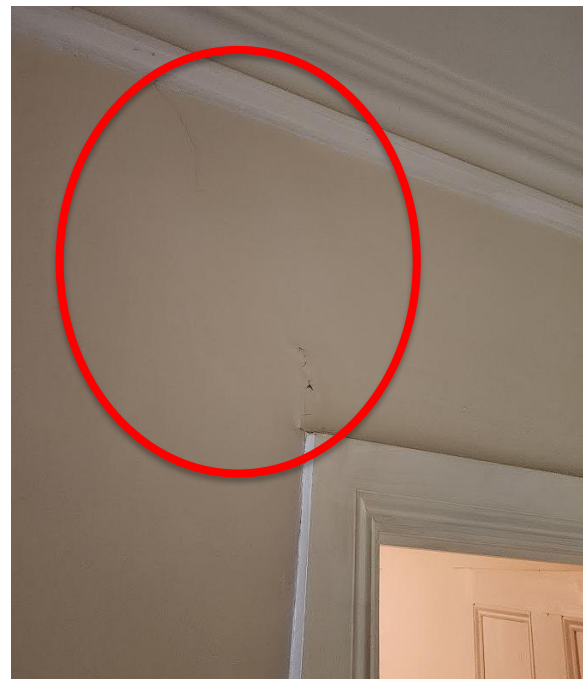
Diagonal cracking above bed 2 door.

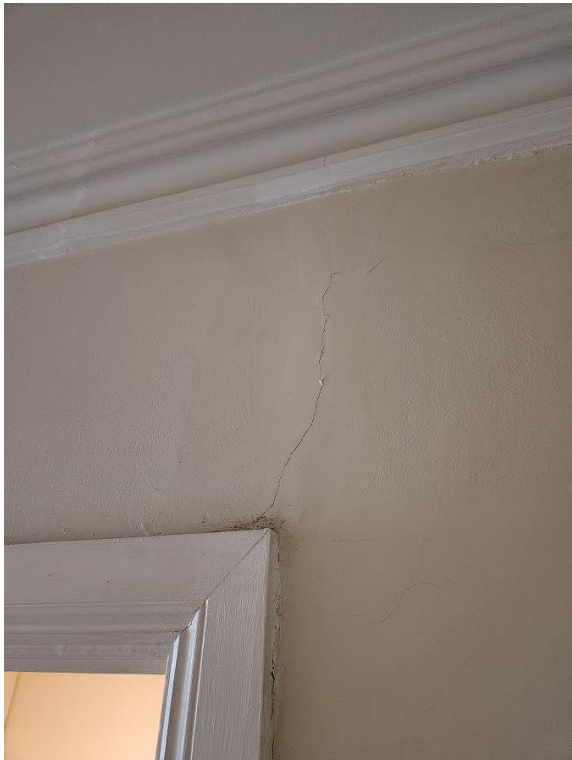
Diagonal cracking above bed 1 door.

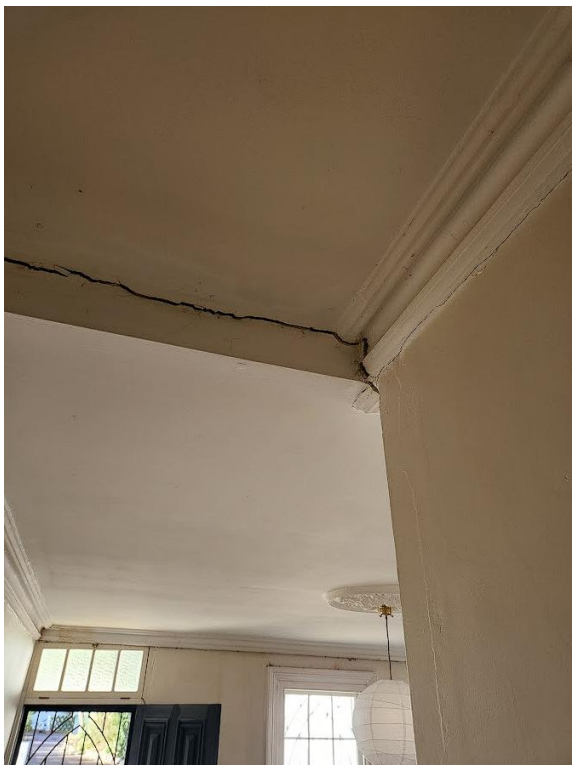
Horizontal cracking to ceiling between lounge room and corridor.

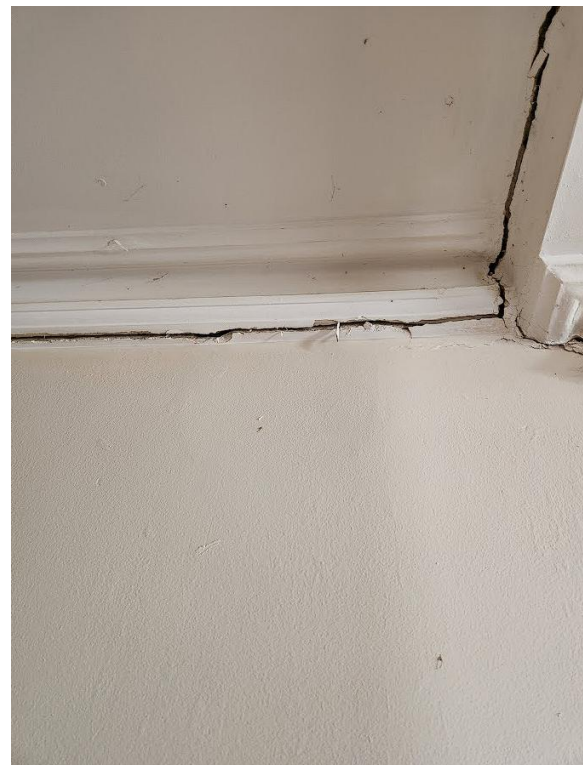
Horizontal cracking to cornice in southeastern corner of corridor.

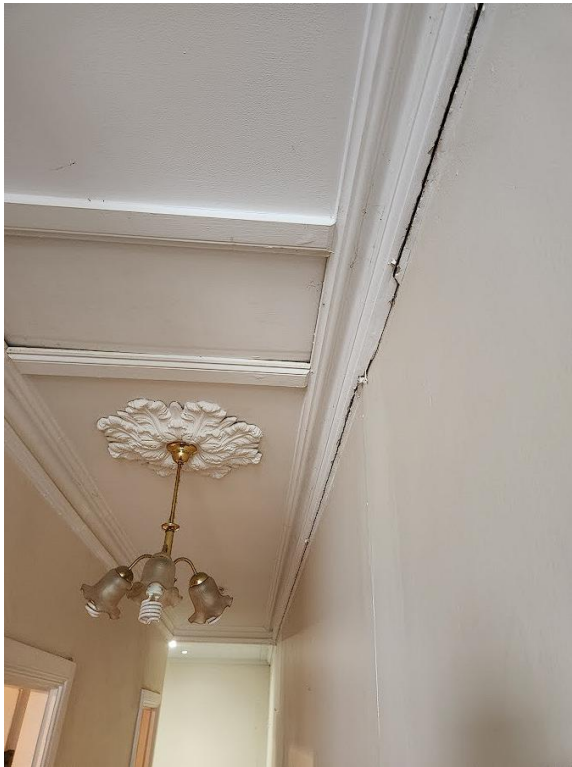
**Horizontal cracking to cornice on eastern wall.**

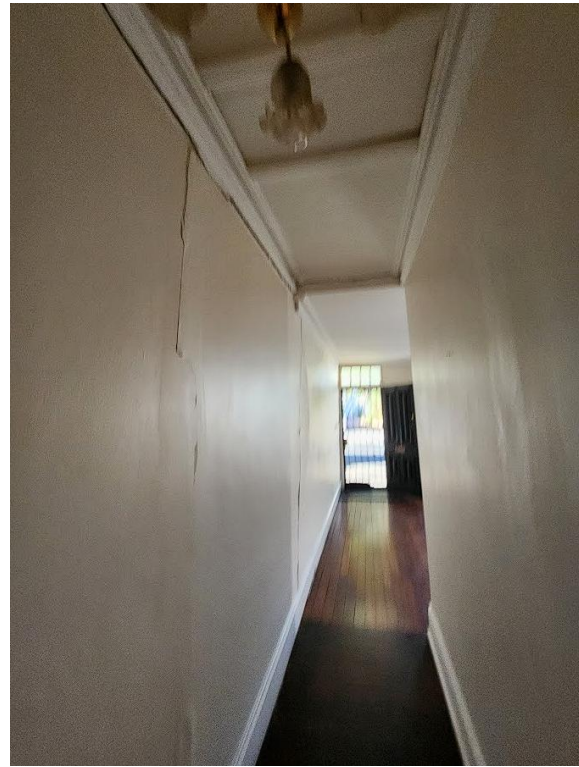
**Vertical cracking to eastern corridor wall.**

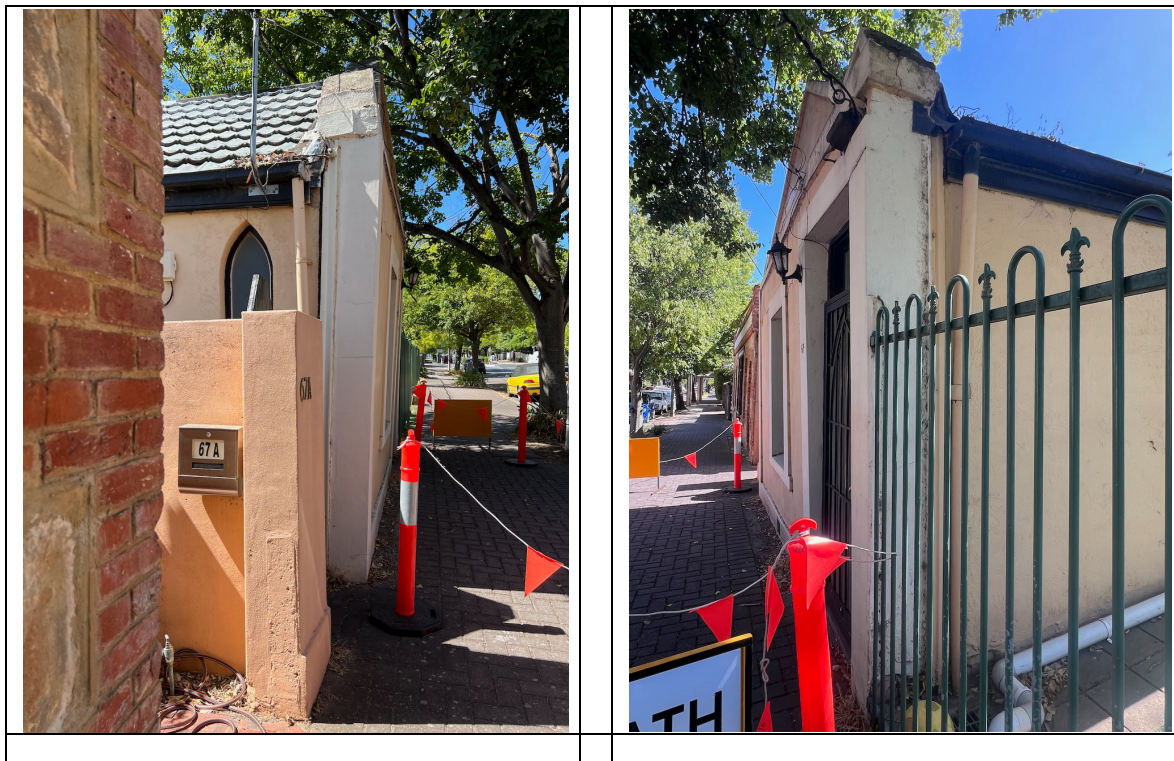
It would appear that since 2005 the front façade has rotated outwards. The lean is significant, but not irredeemably beyond repair.

I sought opinion from a company that I know that undertakes chemical underpinning, and wall straightening, **urathane solutions**.
