Council Assessment Panel Agenda & Reports

19 May 2025

DEVELOPMENT NO.:	25003913
APPLICANT:	John Miller and Haley Miller
ADDRESS:	69 HIGH ST KENSINGTON SA 5068
NATURE OF DEVELOPMENT:	Demolition of a dwelling (Local Heritage Place)
ZONING INFORMATION:	<p>Zones:</p> <ul style="list-style-type: none"> • Established Neighbourhood <p>Overlays:</p> <ul style="list-style-type: none"> • Airport Building Heights (Regulated) • Historic Area • Heritage Adjacency • Hazards (Flooding - General) • Local Heritage Place • Prescribed Wells Area • Regulated and Significant Tree • Stormwater Management • Urban Tree Canopy <p>Technical Numeric Variations (TNVs):</p> <ul style="list-style-type: none"> • Minimum Site Area (Minimum site area is 400 sqm) • Maximum Building Height (Levels) (Maximum building height is 2 levels)
LODGEMENT DATE:	17 Feb 2025
RELEVANT AUTHORITY:	Assessment panel/Assessment manager at City of Norwood, Payneham and St. Peters
PLANNING & DESIGN CODE VERSION:	P&D Code (in effect) Version 2025.3 13/2/2025

RE: CRACKING IN EXISTING DWELLING - 69 High St, Kensington SA 5068

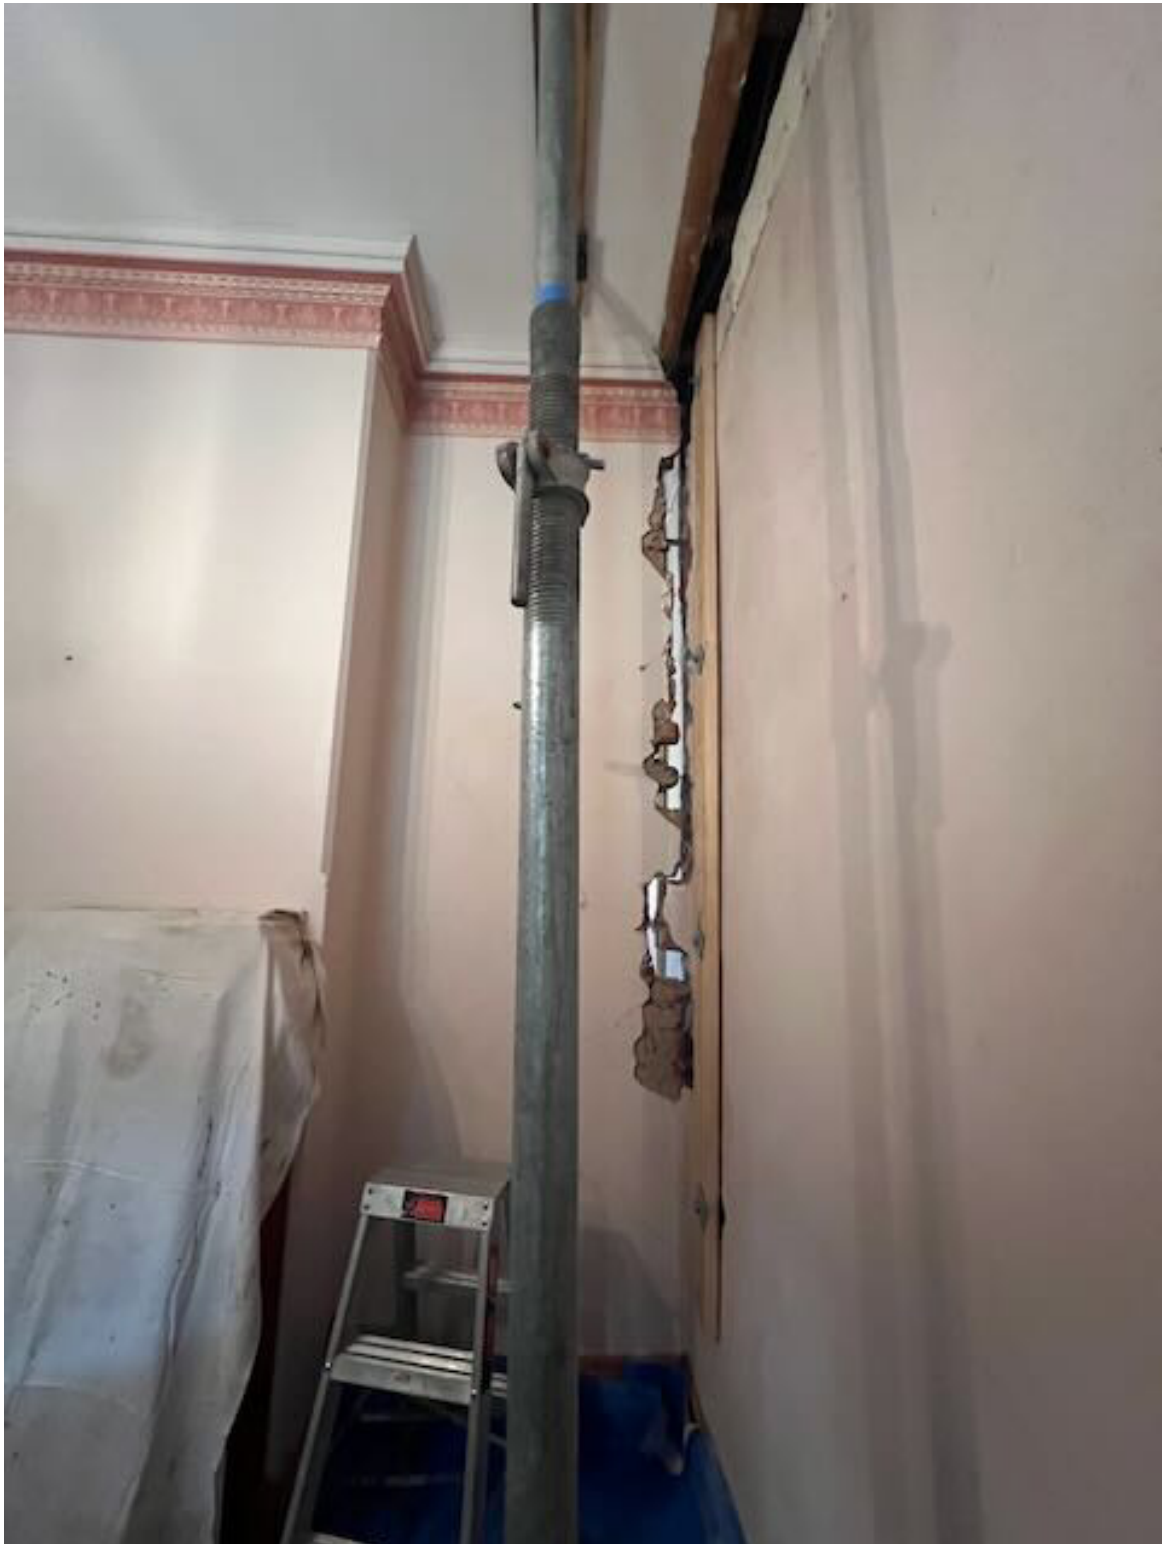
Crack raked out in front room in preparation for side wall being pushed back to plumb.

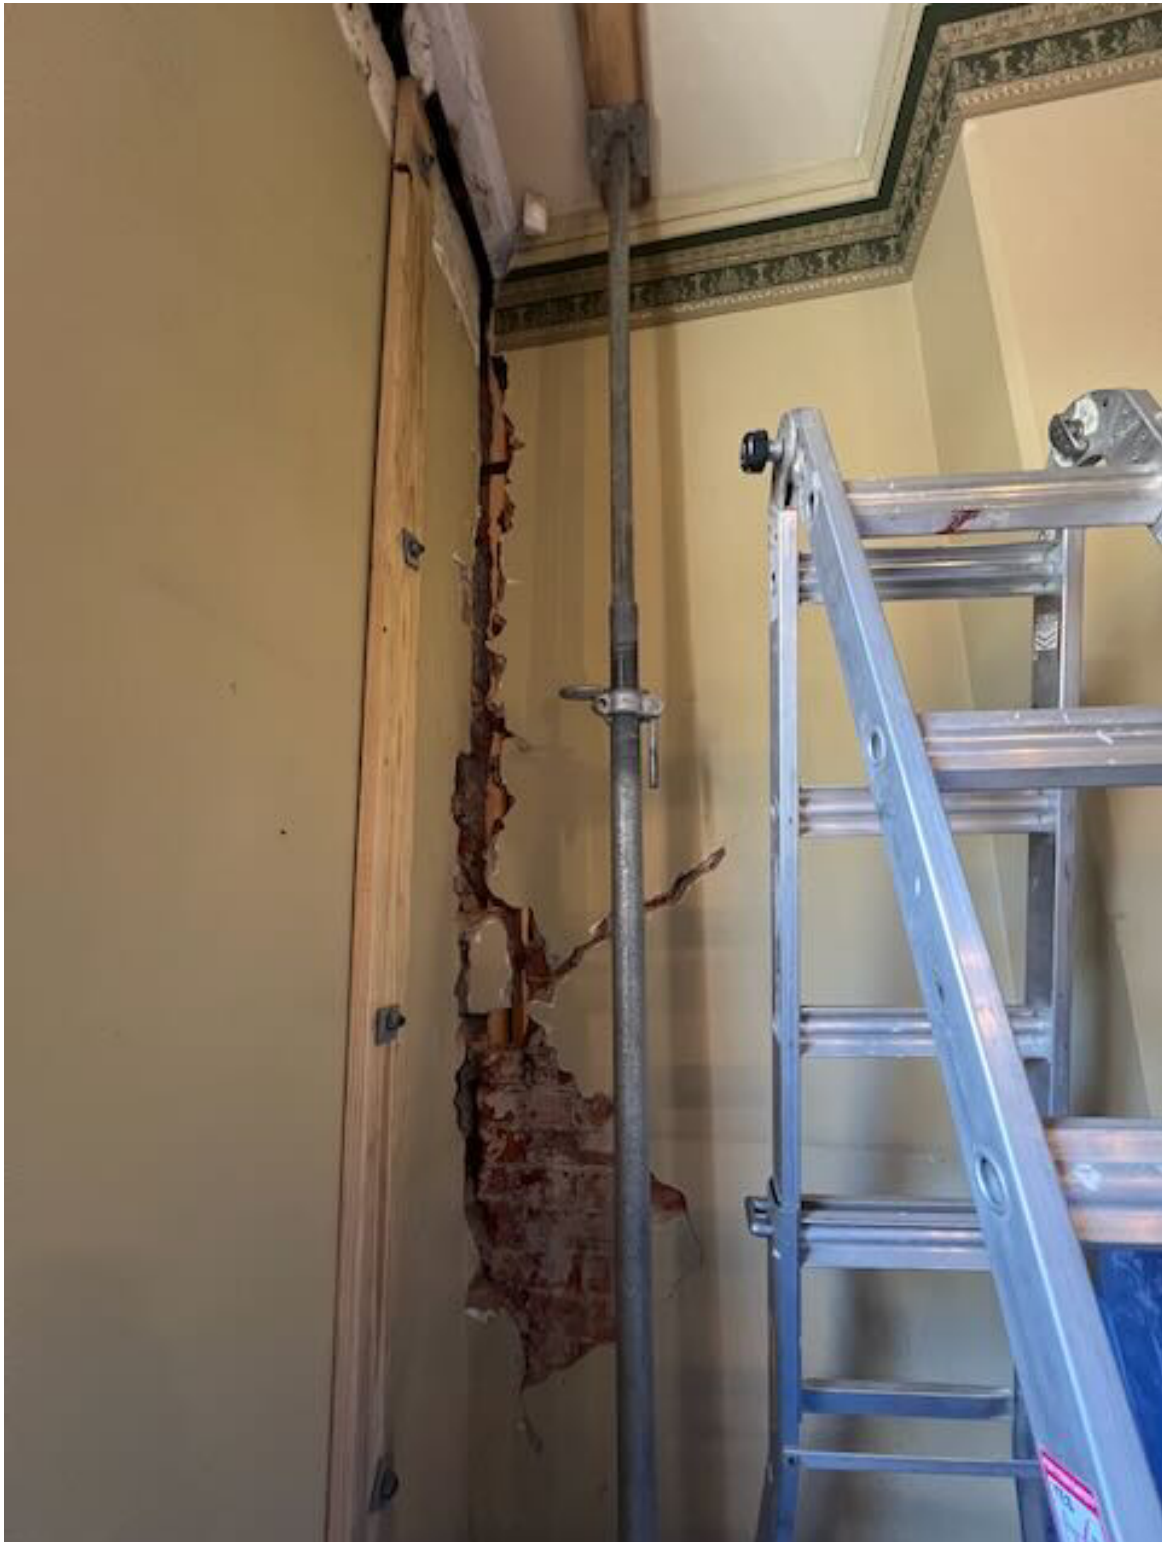
Crack raked out in second room in preparation for side wall being pushed back to plumb.

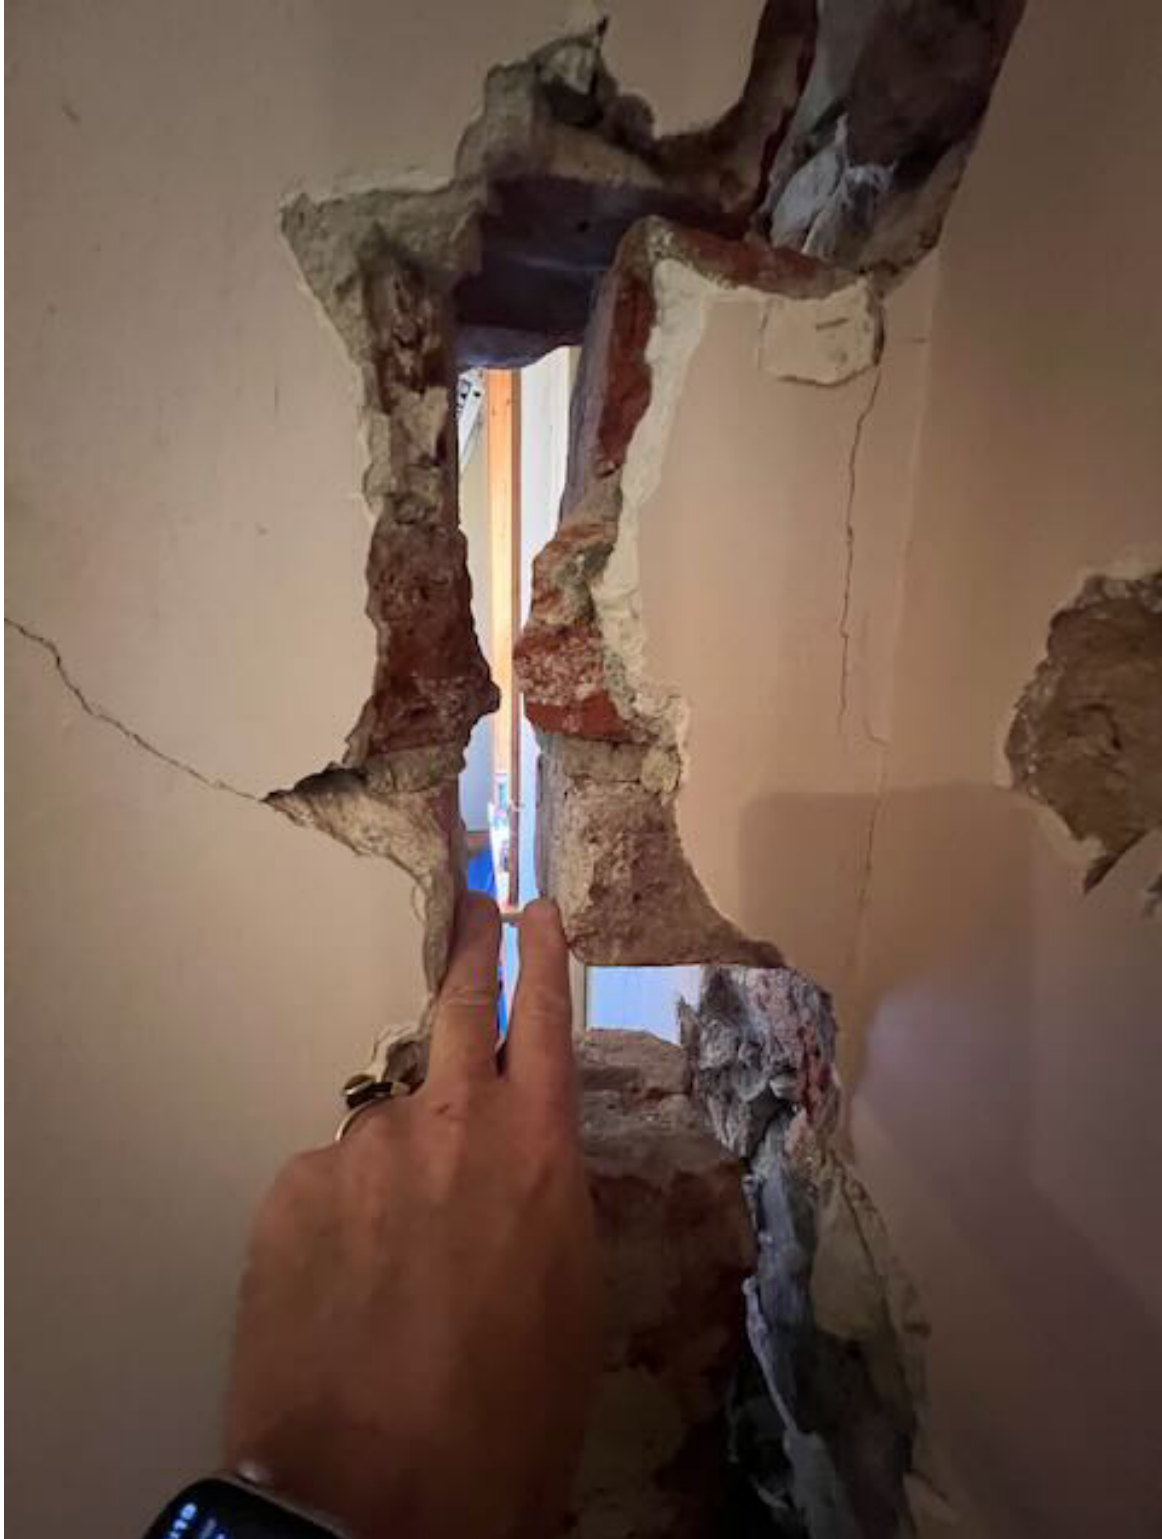
Crack raked out in preparation for side wall being pushed back to plumb.

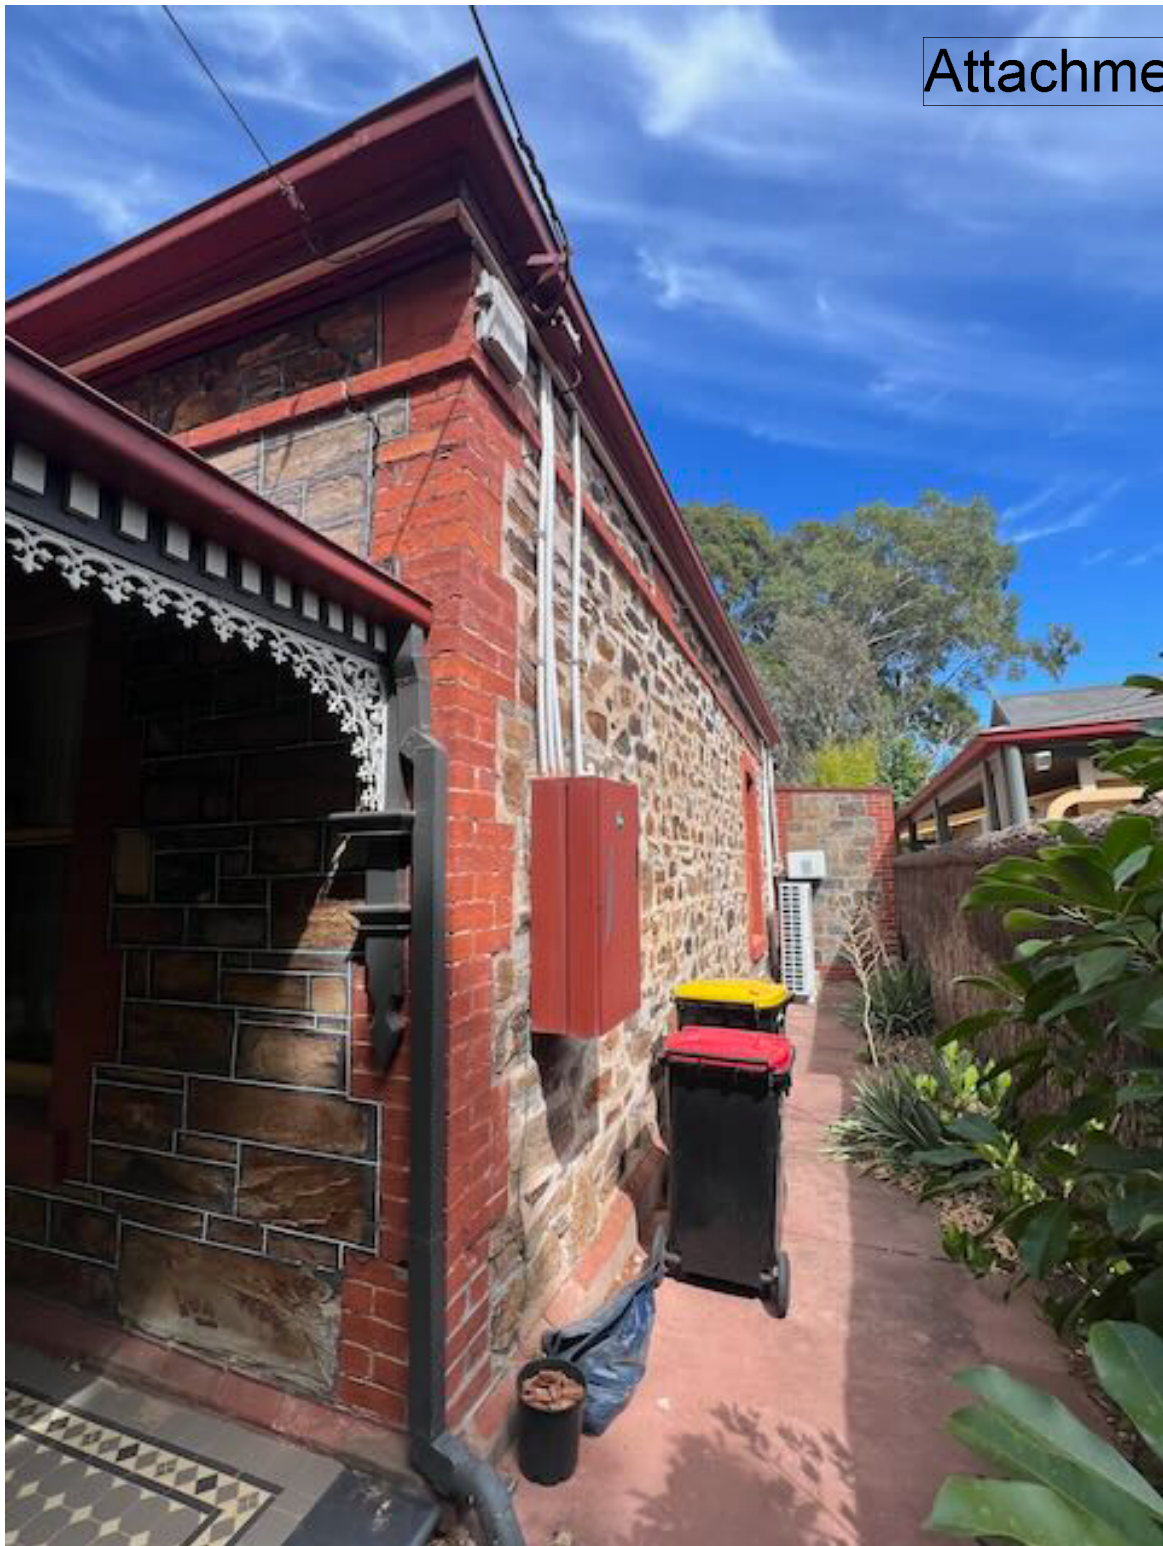
Side wall underpinned, straightened and plumbed for about \$20K by 'urathane solutions'

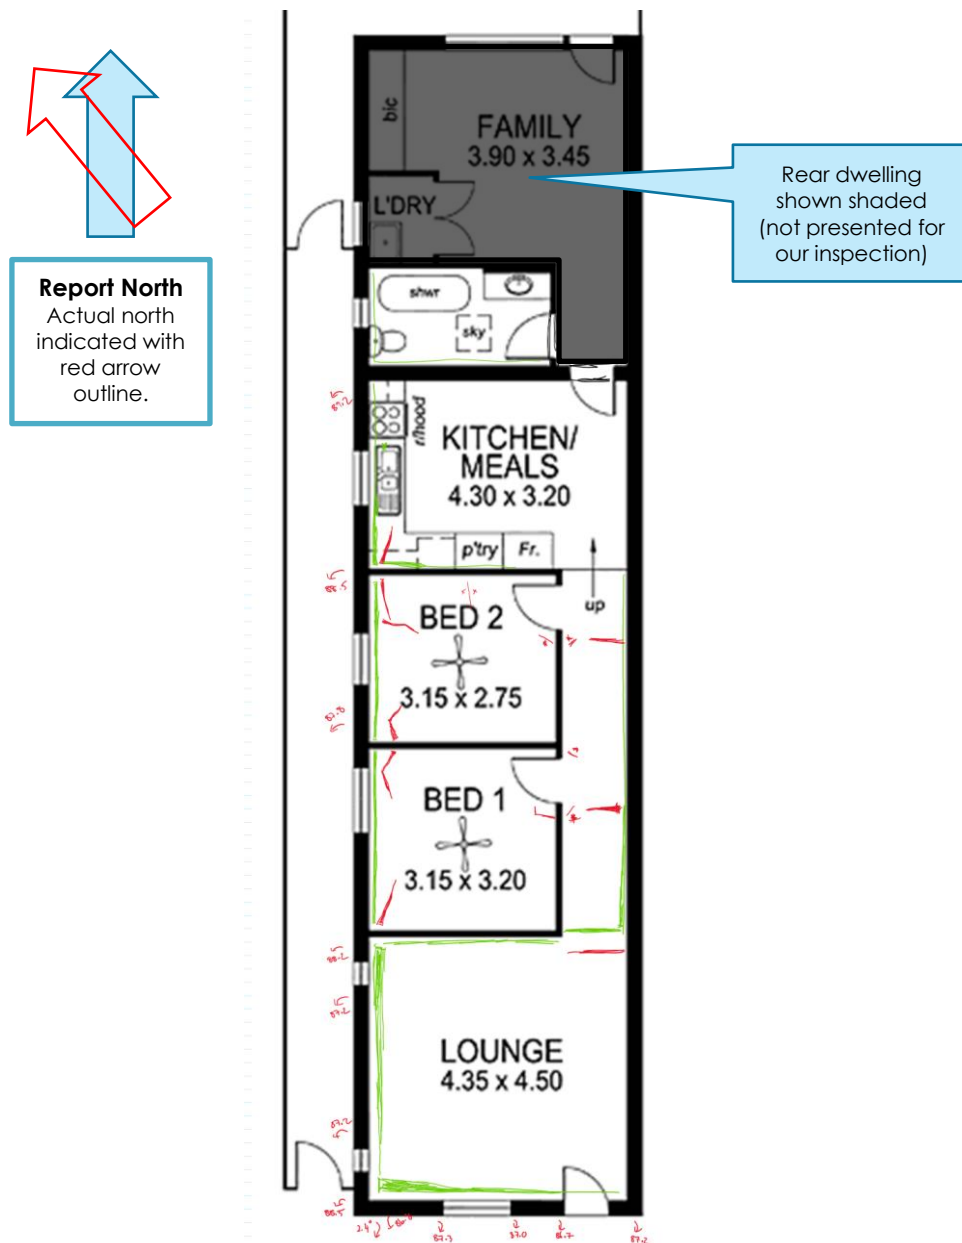
The most severe cracking, and that which we understand causes the applicant concern, was observed to the front lounge and along the western elevation (including the wall/ceiling junctions and the intersections between the western wall and internal return walls).

The southern (front) and western elevations' verticality was measured at various locations using a digital spirit level. The southern elevation was measured to be between 2.7° and 3.3° out of vertical alignment relatively consistently across its width. The western elevation was measured to be between 0.8° and 2.8° out of vertical alignment, with the severity of misalignment increasing from the rear to the front.

Figure 2 – Red is damage to walls, green is damage to ceilings & cornices, numbers and arrows externally indicate measured rotations

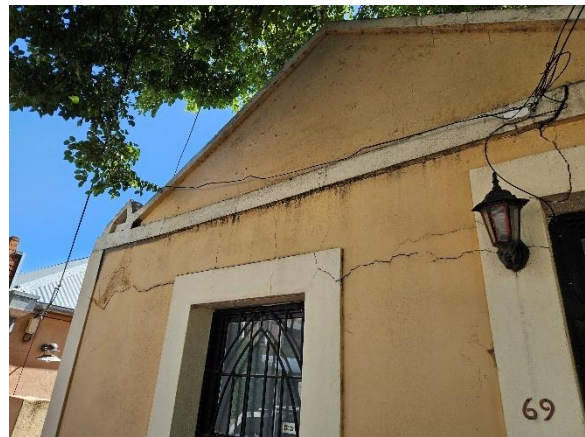
Photo 2 – Cracking in front gable, top of gable leans back towards the applicant's property (opposite to base of wall) creating a "bow" in the wall

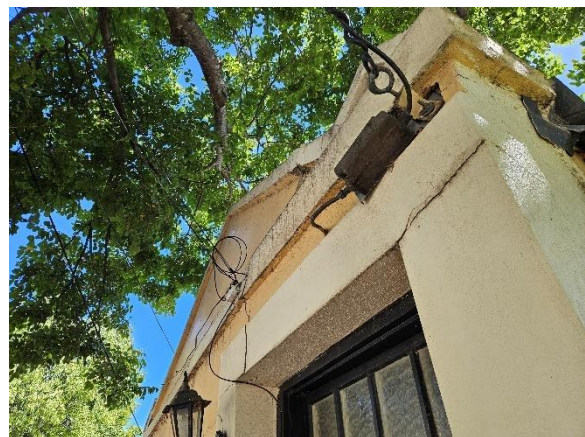
Photo 4 – Cracking at eastern end of front elevation

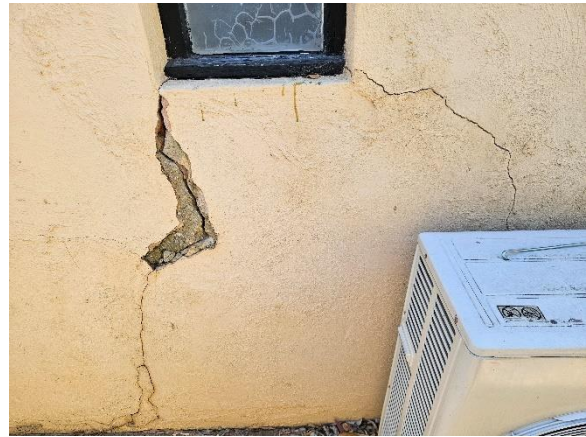
Photo 12 – Example of cracking and previous repair to cracking to western elevation (dislodged render on LHS makes cracking appear more severe)

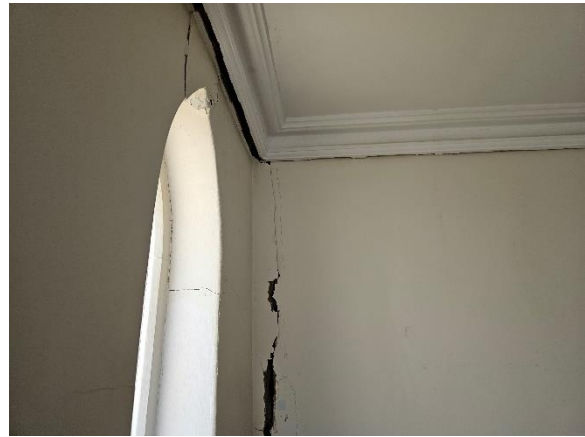
Photo 18 – Western elevation / cornice separation, cracking between western elevation and intersecting internal wall of front lounge room

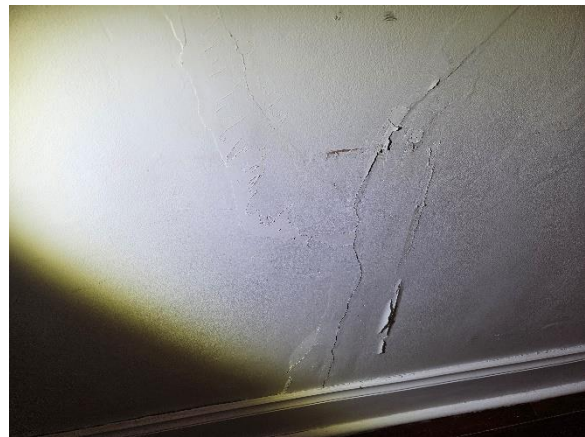
Photo 20 – Example of previous repairs to cracking typically seen to internal walls

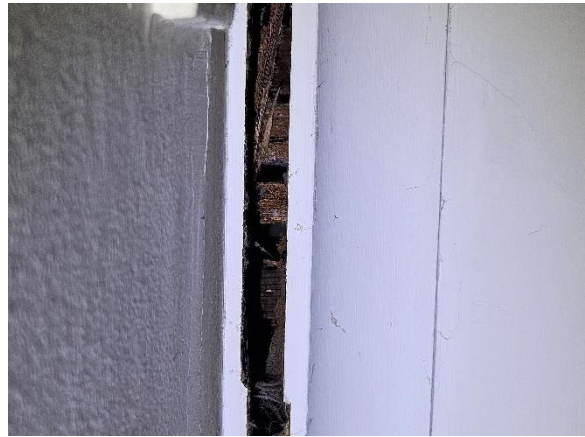
Photo 24 – Close up of separation between bed 1's wall and cornice, showing possible evidence of timber deterioration

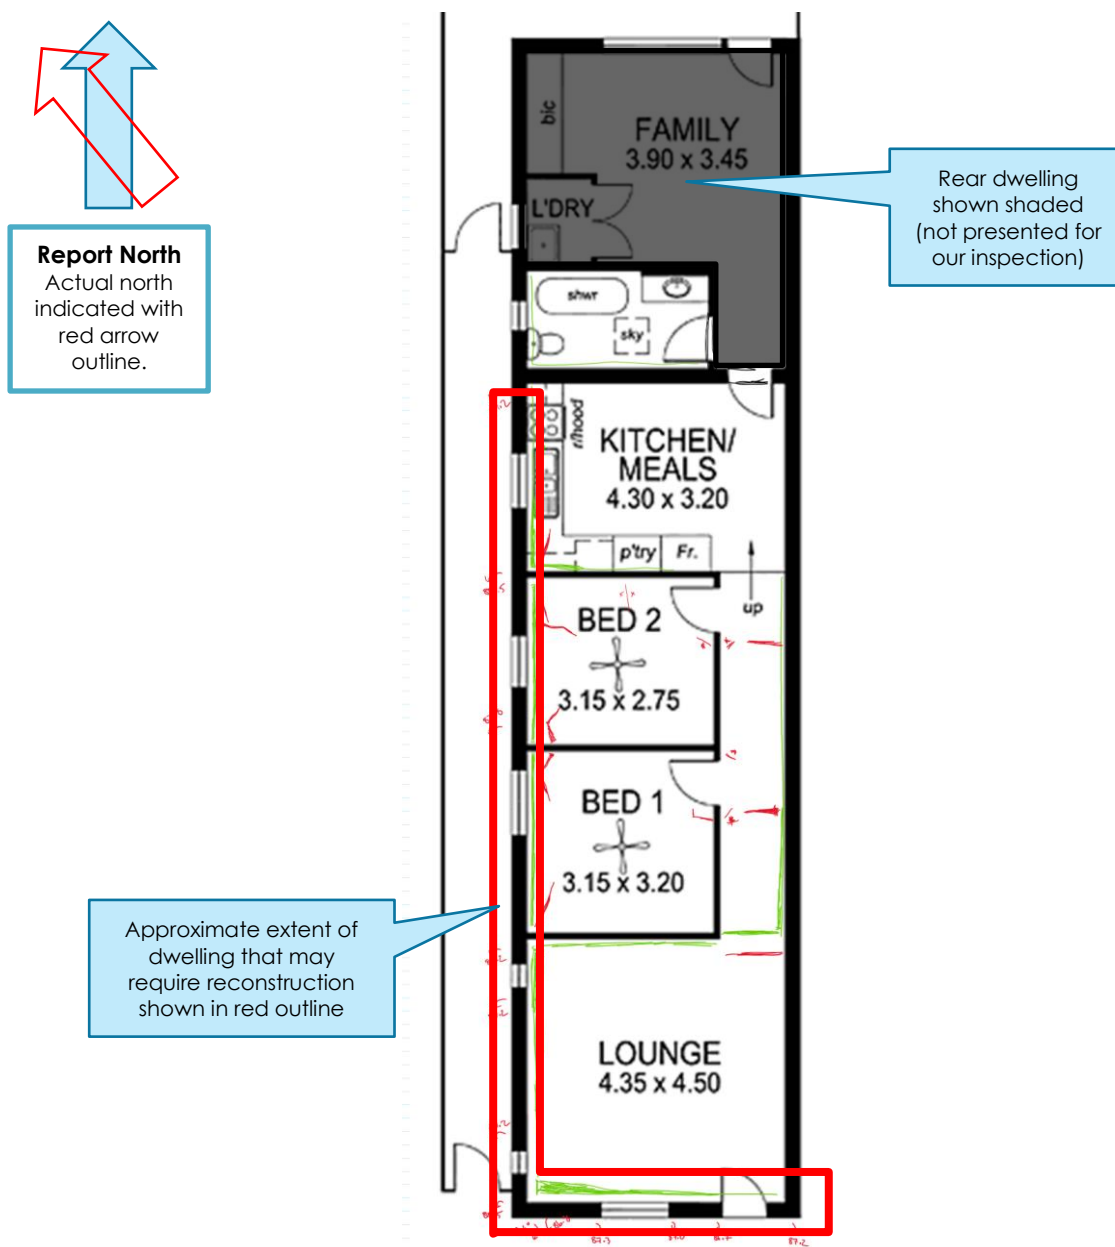
Figure 3 – Approximate extent of structure that may require reconstruction

If a reconstruction method is being contemplated, the southern and western elevations could be reconstructed upon the existing footings, on the existing footings that have been underpinned, or on entirely new footings. The method of reconstruction must consider the longevity of repairs – refer to further discussion regarding this in the following sub-section of this report.
