Council Assessment Panel Agenda & Reports

20 October 2025

1.1. This is an expert report prepared at the request of Mr Nic Wong of Nic Design Studio relating to the condition of the existing house at 7 Stephen Terrace, St Peters, South Australia.

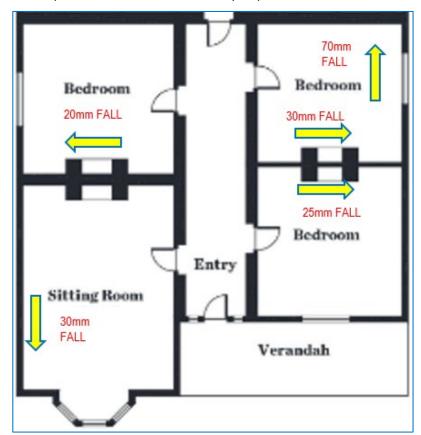
- 10.1. While the floors are not damaged, or beyond reasonable repair, the slope of the floors was noticeable and quite significant in that they demonstrate the degree of differential movement between the interior of the house and the external walls.
- 10.2. The slope of the floors as indicated by a spirit level is shown below.

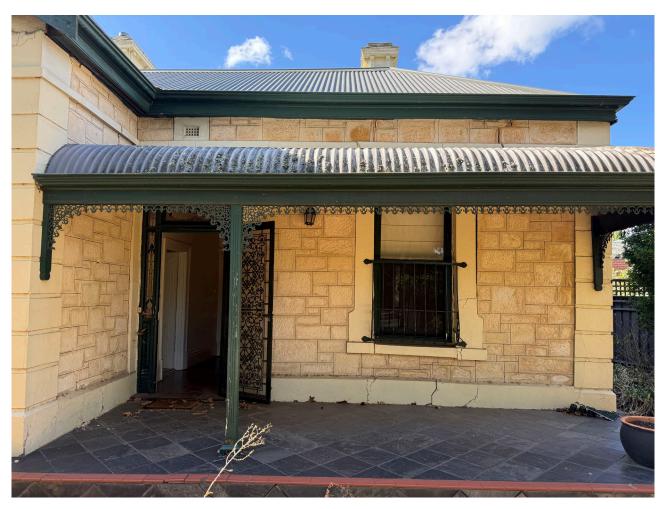
Front wall 01 (Damage category 3)
Significant settlement of right hand end of the wall
Window sill cracked and sloped due to movement
Cracked plastered plinth, wall, and window sill

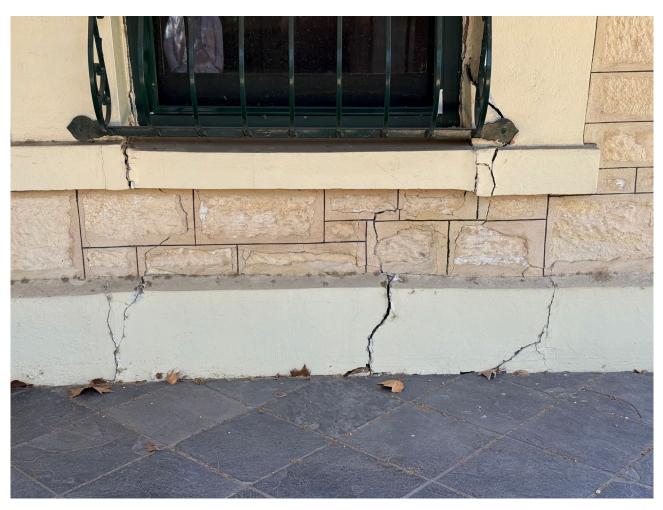
Front wall 02 (Damage category 3)
Significant settlement of right hand end of the wall
Window sill cracked and sloped due to movement
Cracked plastered plinth, wall, and window sill

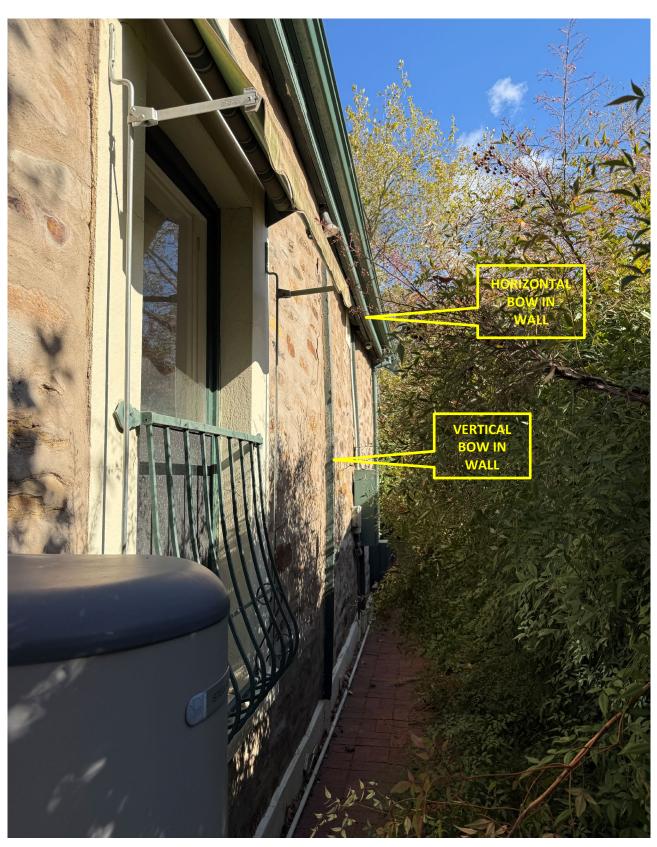
North western wall 01 (Damage category 4)

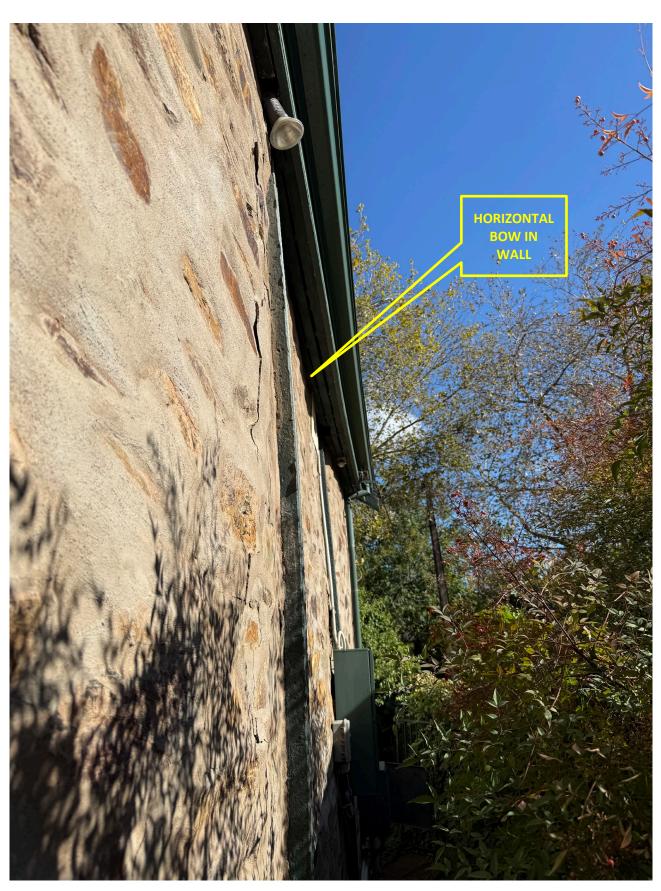
North western wall 02 (Damage category 4)

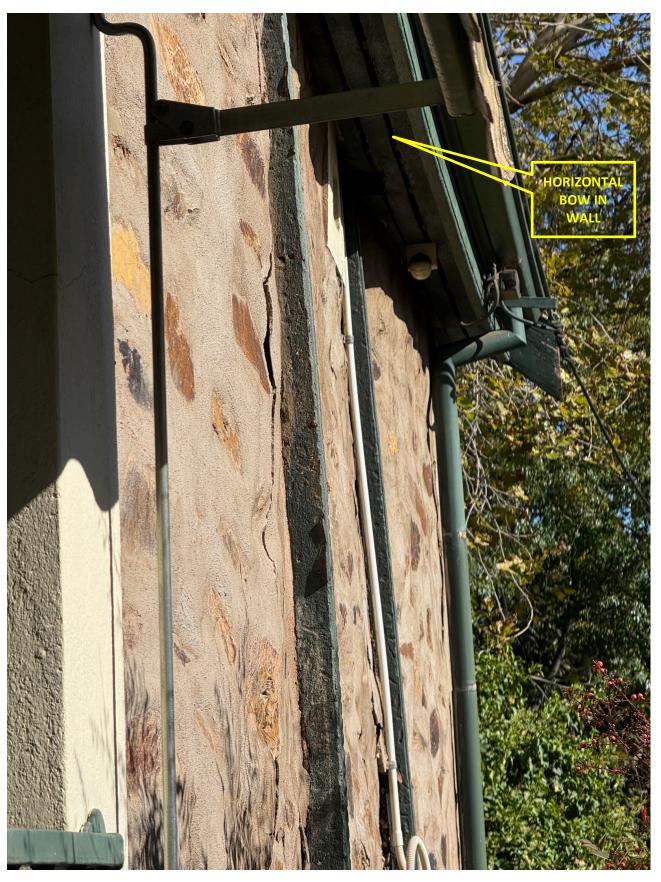
North western wall 03 (Damage category 4)

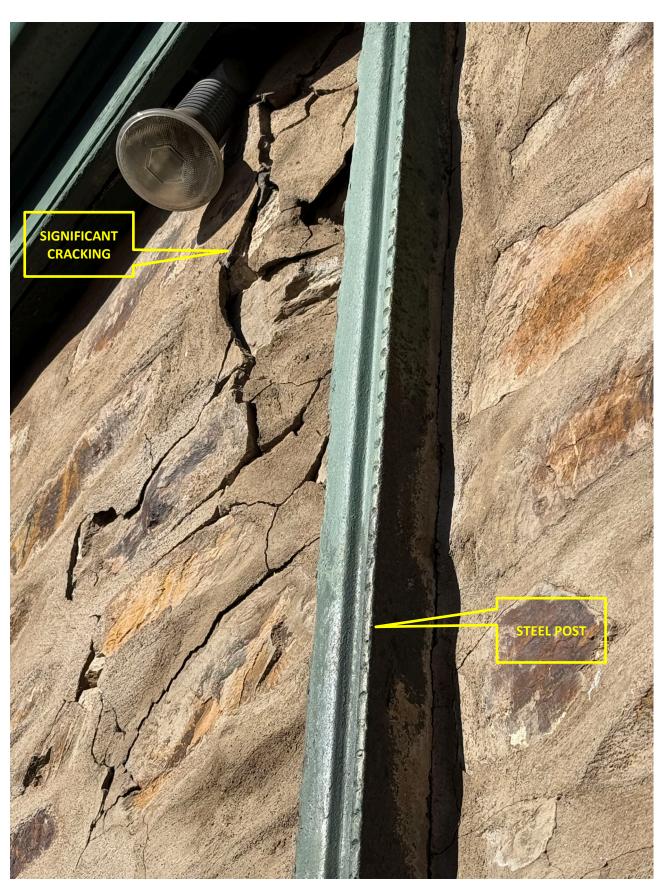
North western wall 04 (Damage category 4)

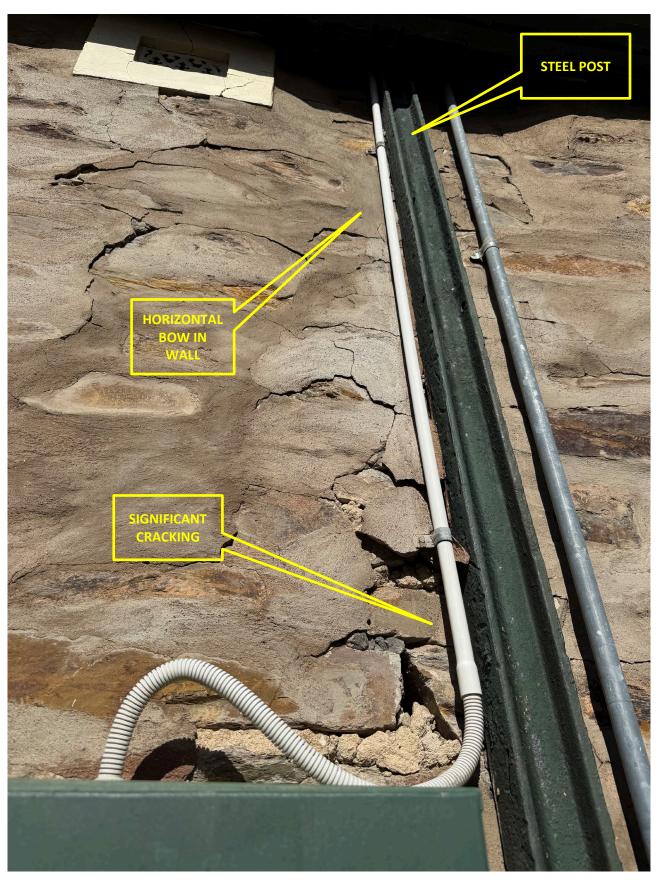
North western wall 05 (Damage category 4)

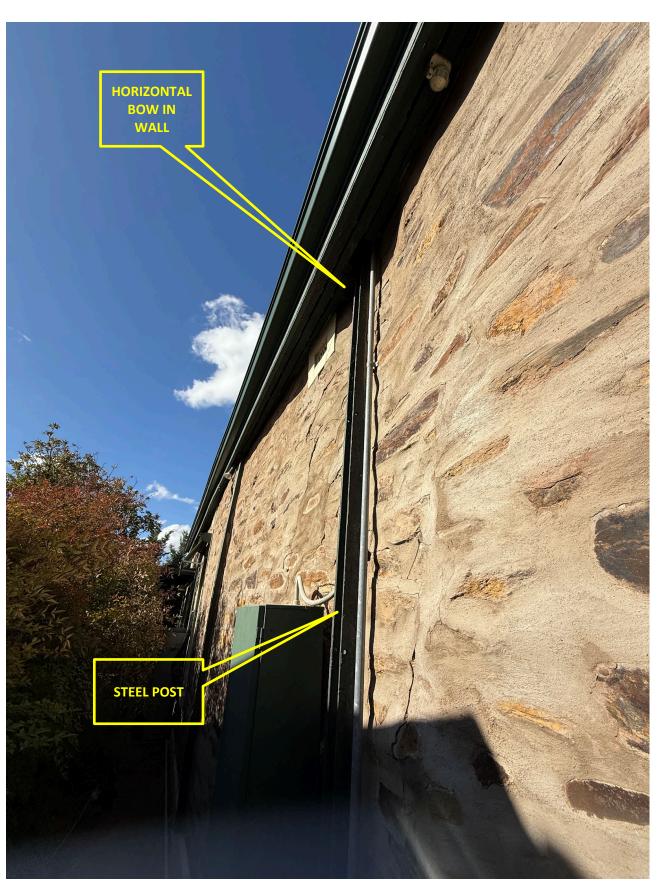
North western wall 06 (Damage category 4)

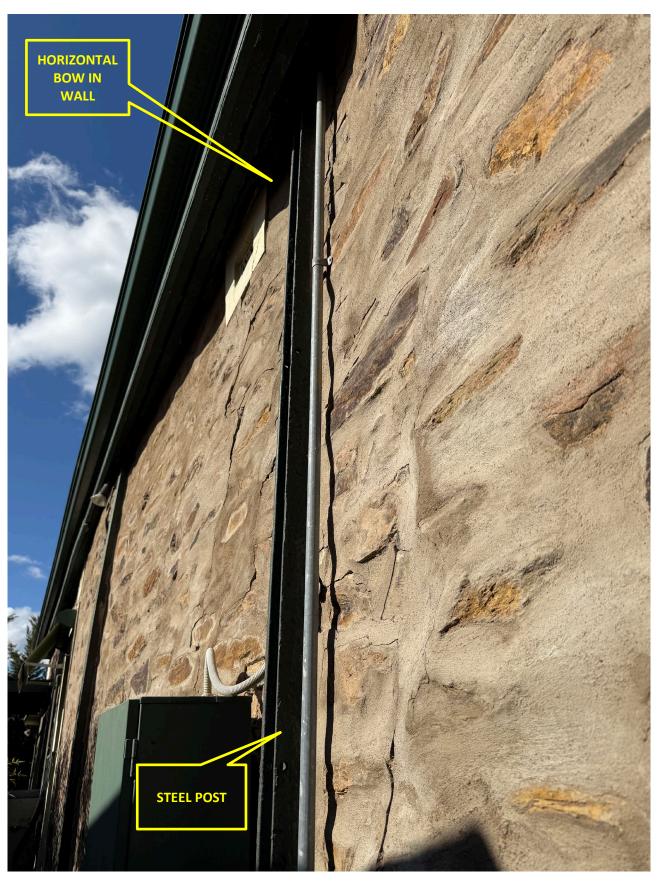
North western wall 07 (Damage category 4)

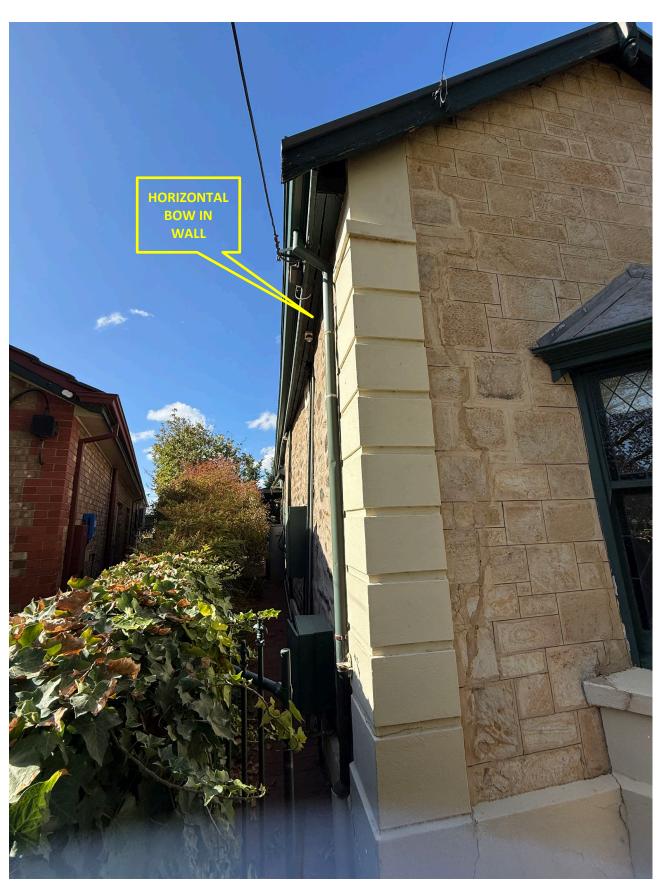
North western wall 08 (Damage category 4)

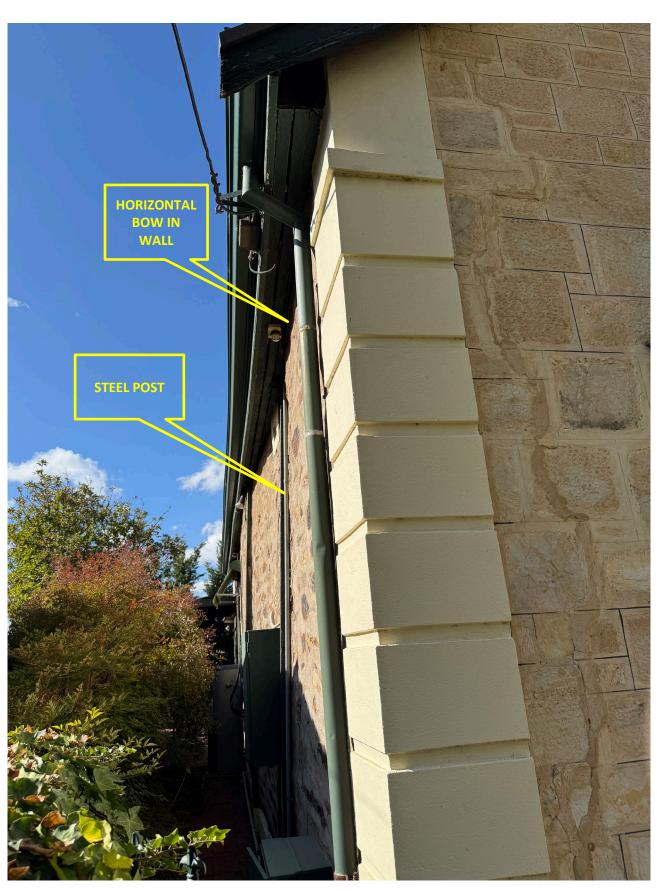
North western wall 09 (Damage category 4)

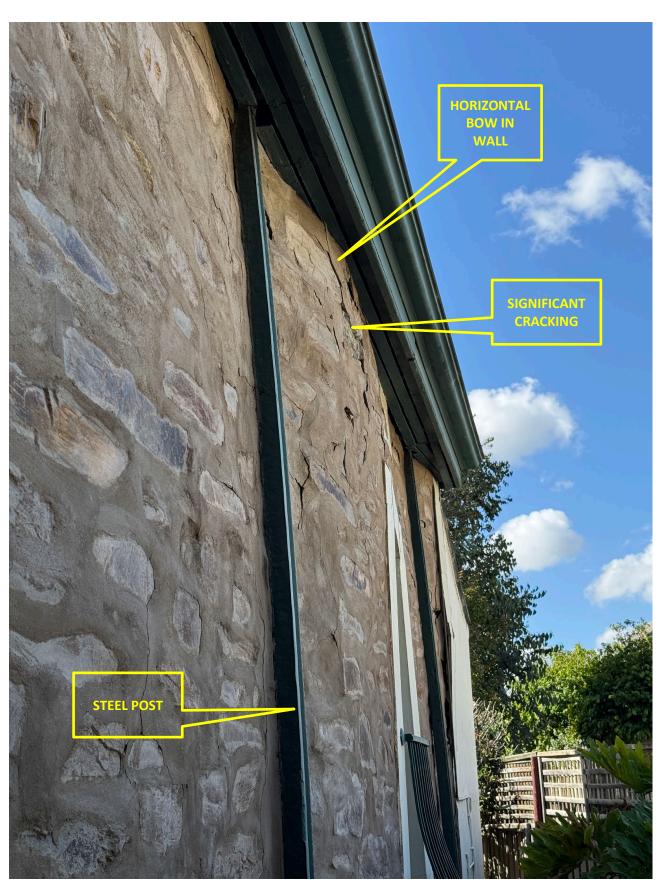
South eastern wall 01 (Damage category 4)

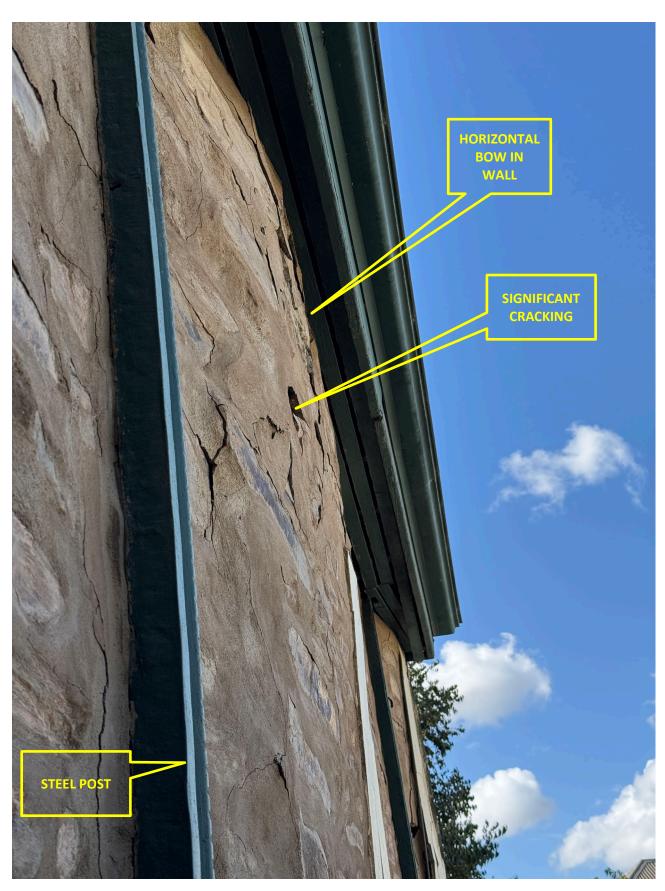
South eastern wall 01 (Damage category 4)

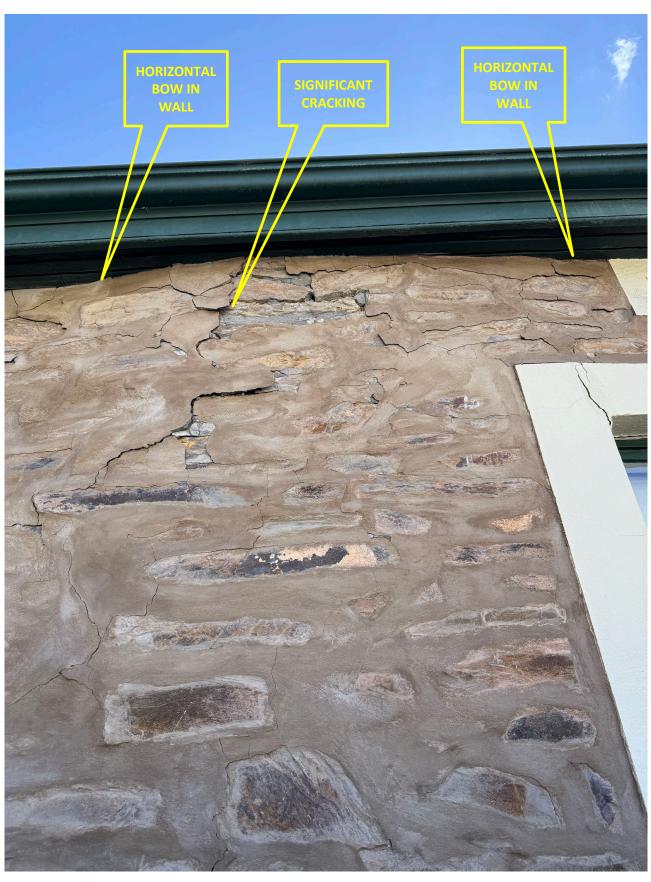
South eastern wall 01 (Damage category 4)

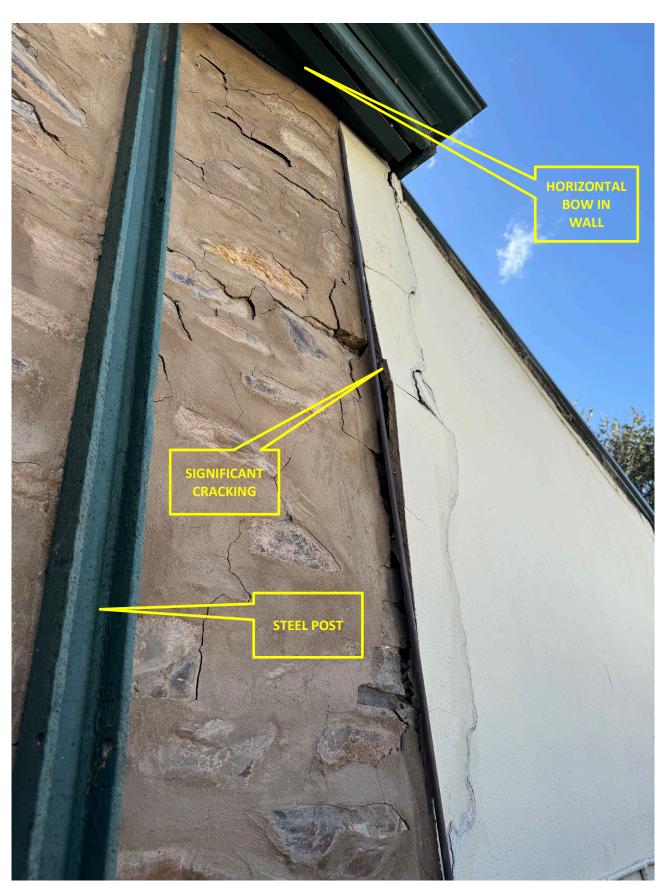
South eastern wall 01 (Damage category 4)

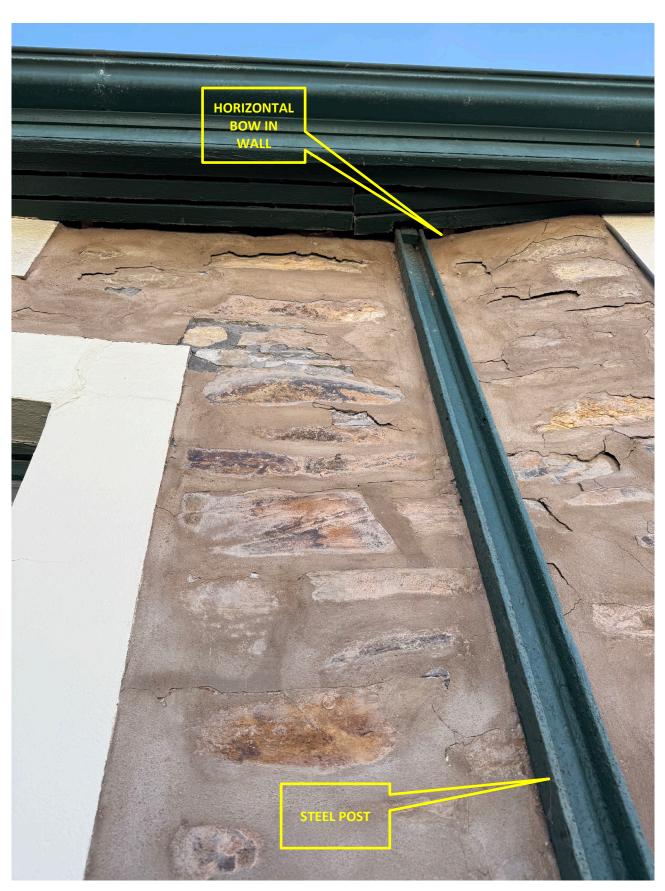
South eastern wall 01 (Damage category 4)

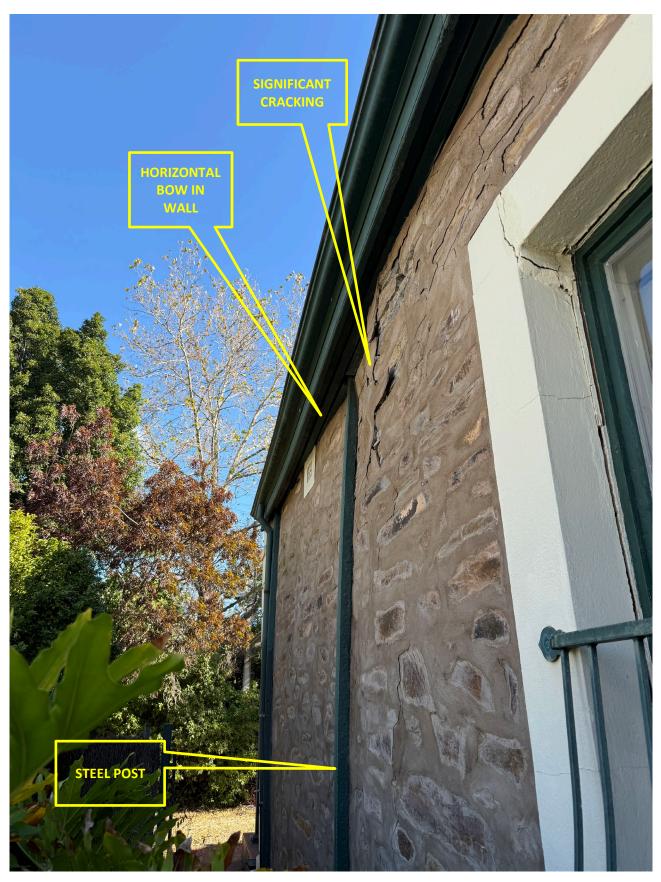
South eastern wall 01 (Damage category 4)

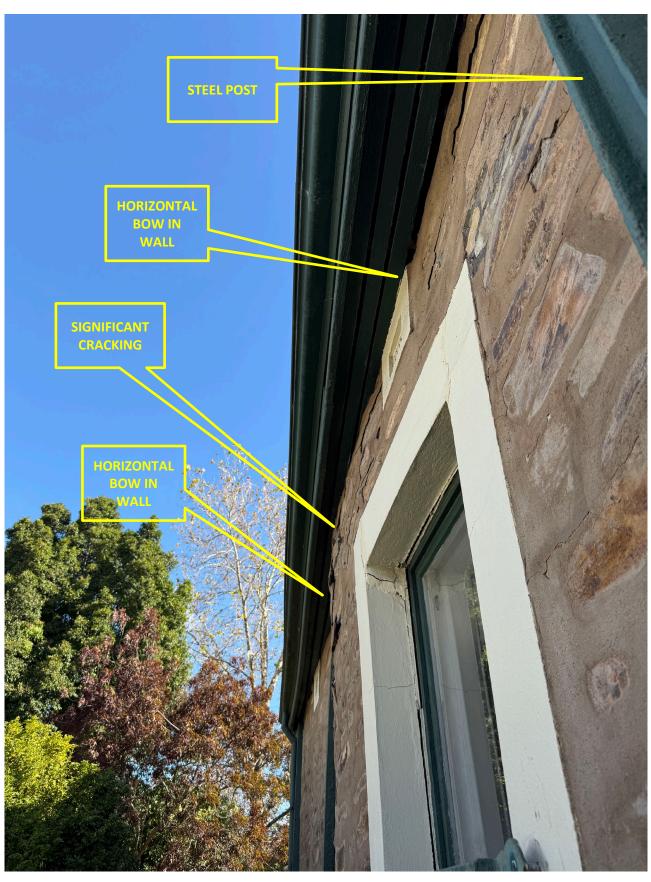
South eastern wall 01 (Damage category 4)

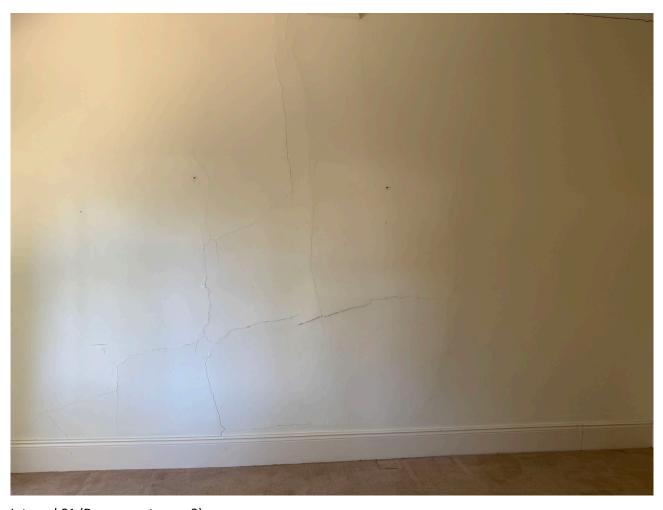
Internal 01 (Damage category 2)

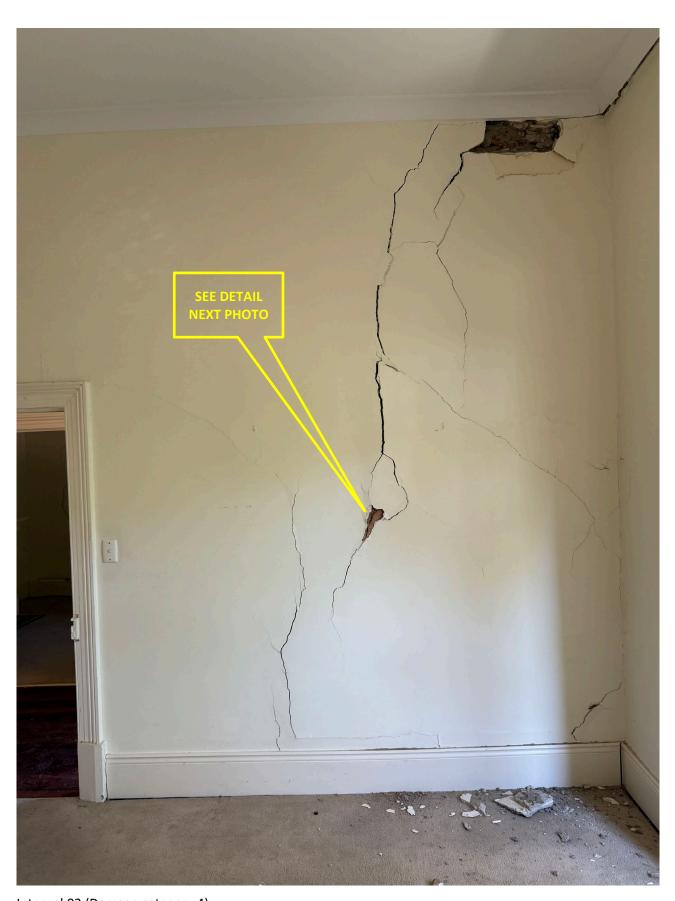
Internal 02 (Damage category 4)

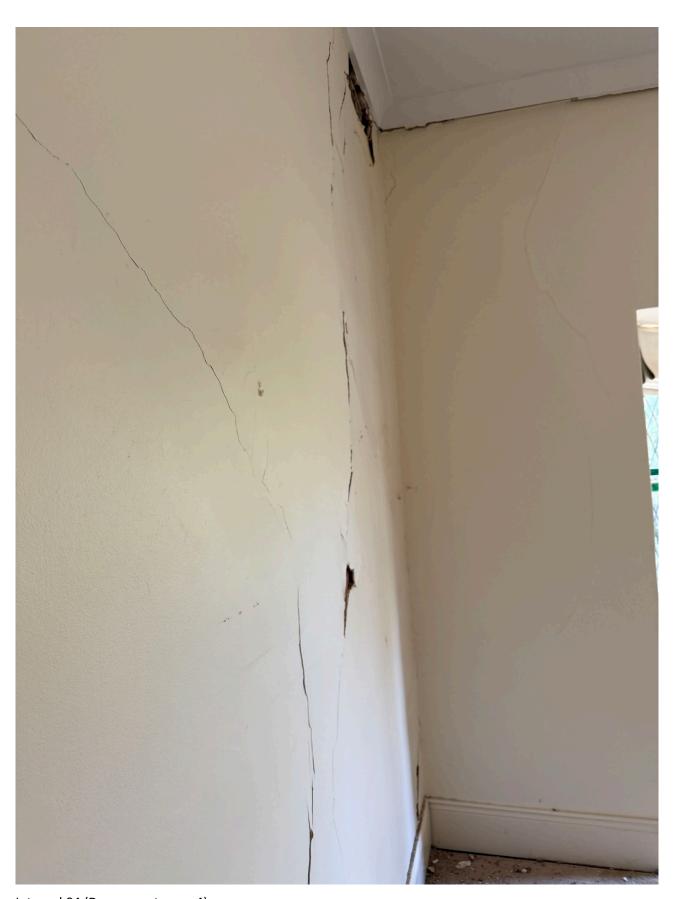
Internal 04 (Damage category 4)

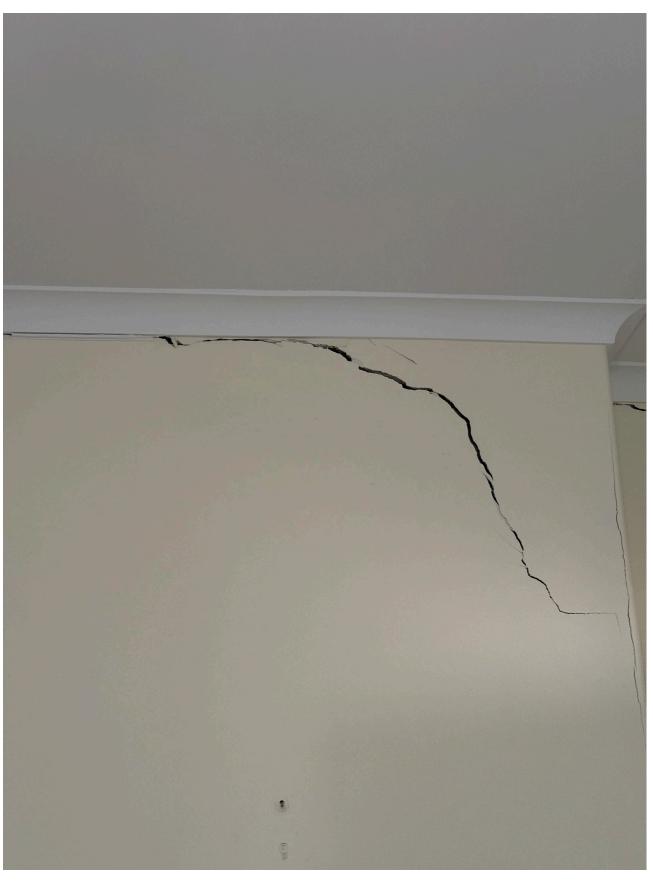
Internal 05 (Damage category 3)

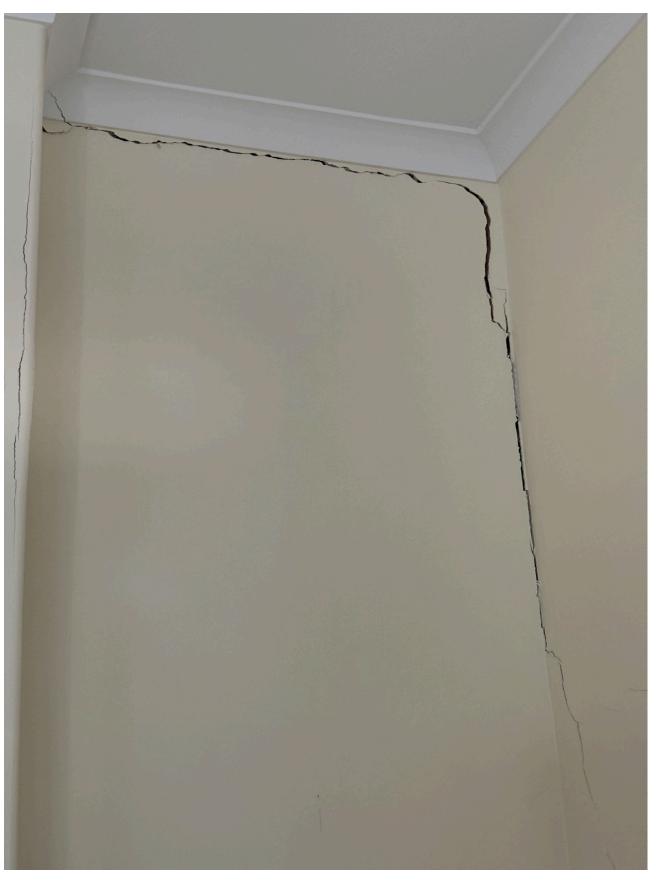
Internal 06 (Damage category 3)

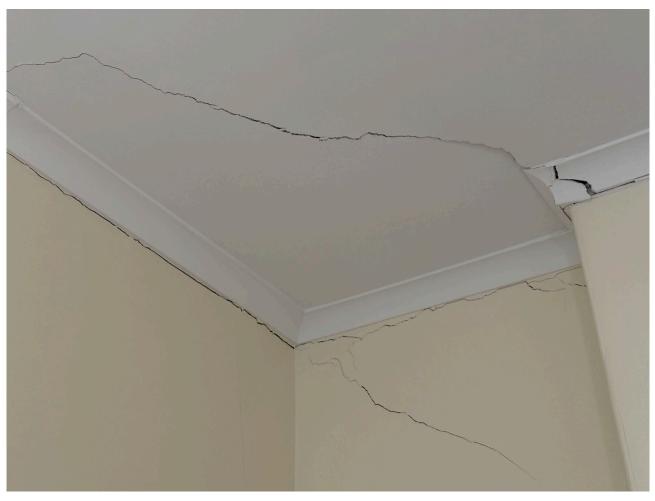
Internal 07 (Damage category 2)

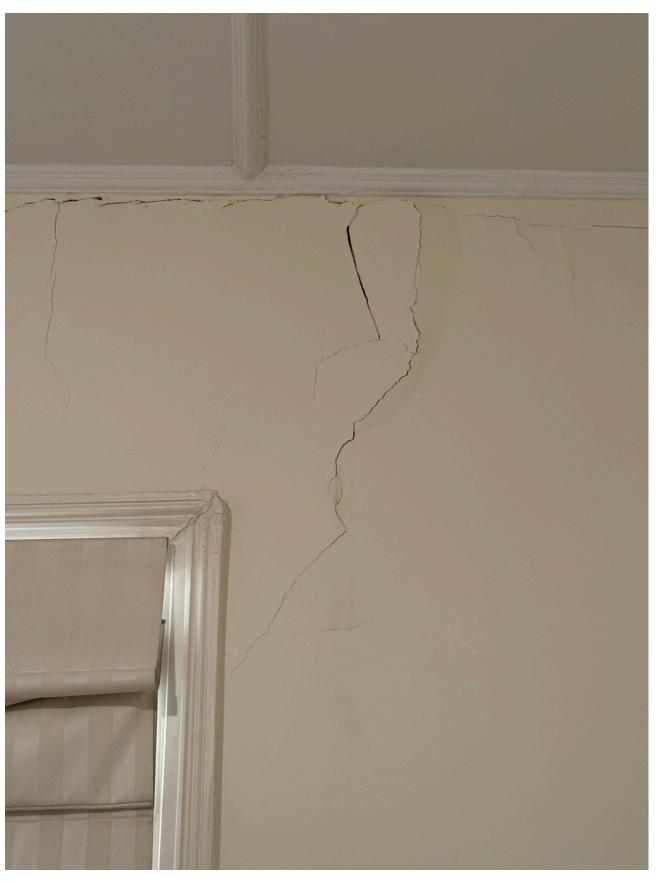
Internal 08 (Damage category 3)

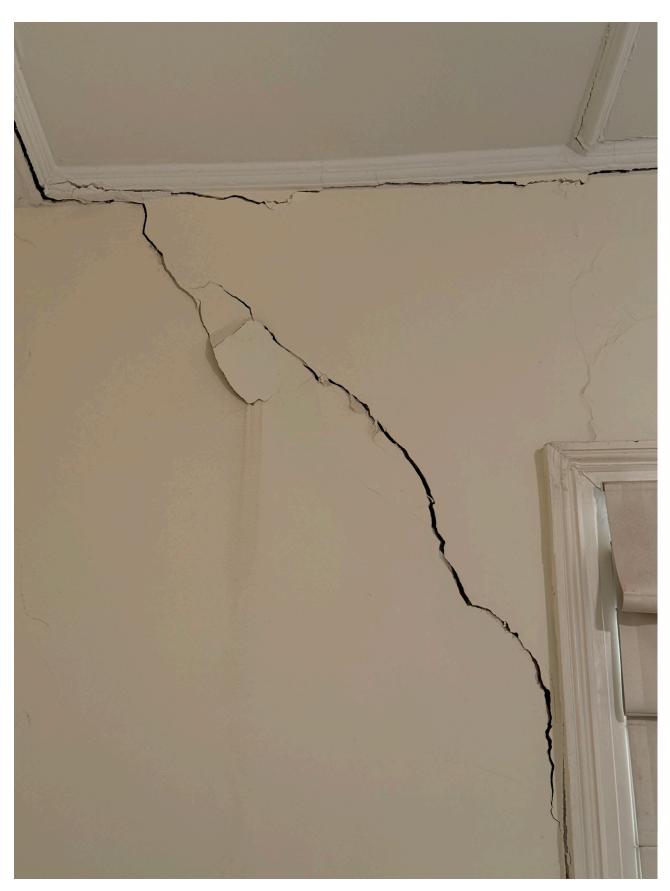
Internal 09 (Damage category 4)

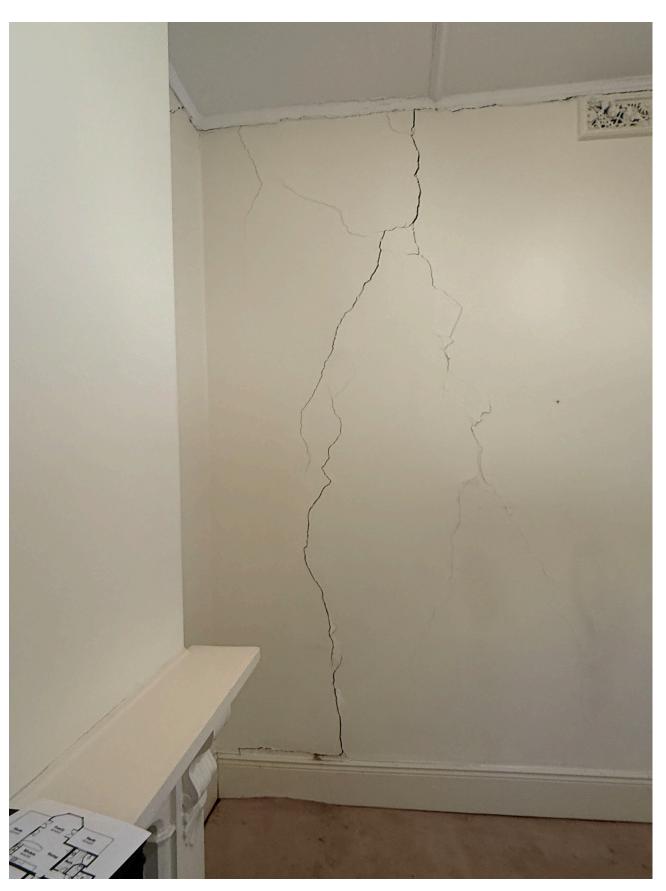
Internal 10 (Damage category 4)

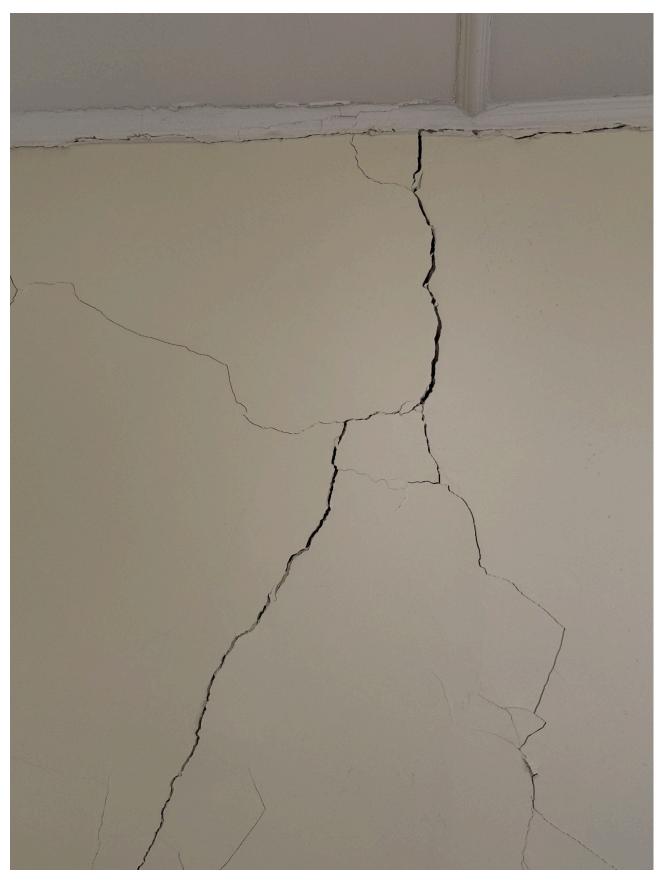
Internal 11 (Damage category 4)

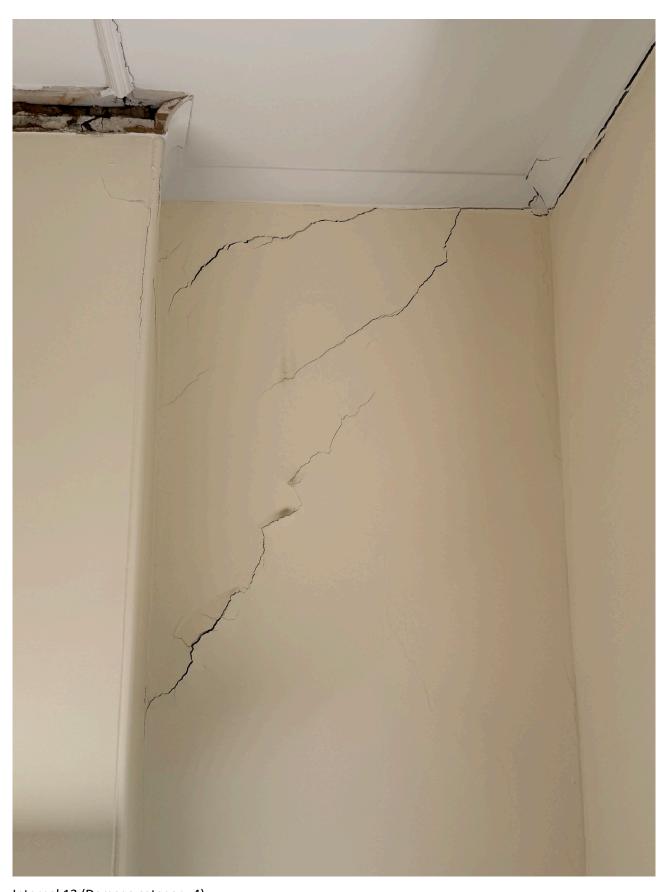
Internal 12 (Damage category 4)

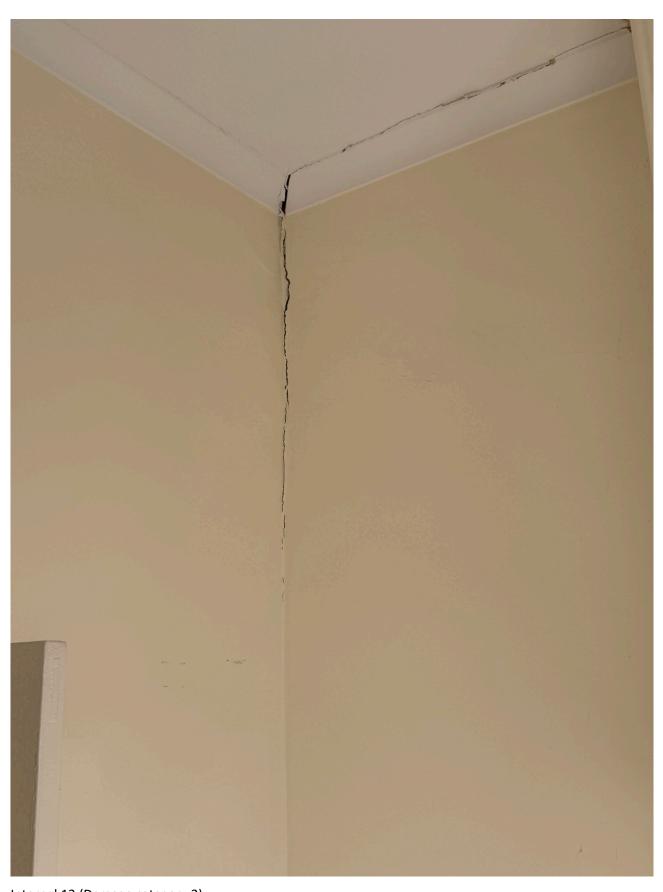
Internal 13 (Damage category 2)

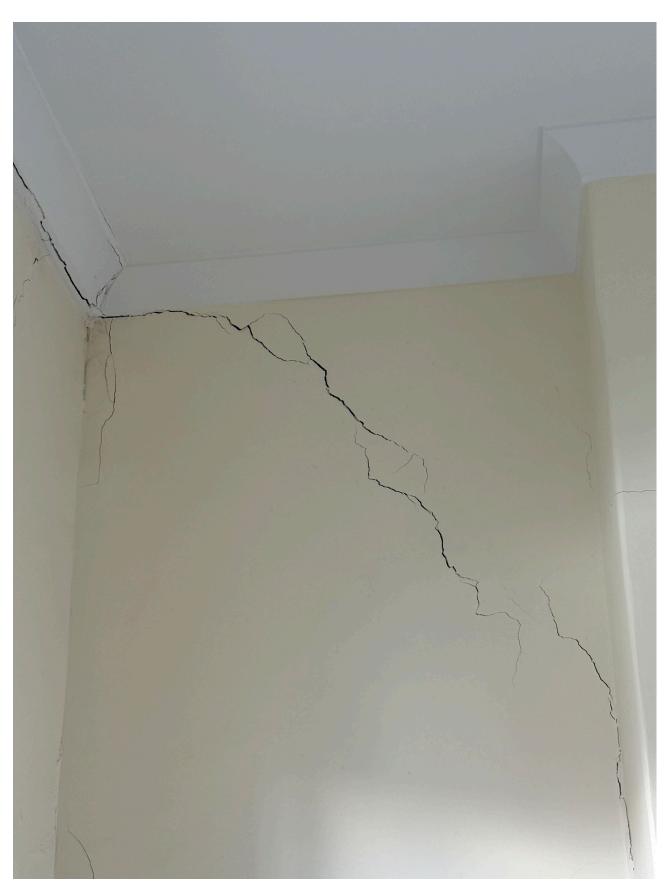
Internal 14 (Damage category 4)

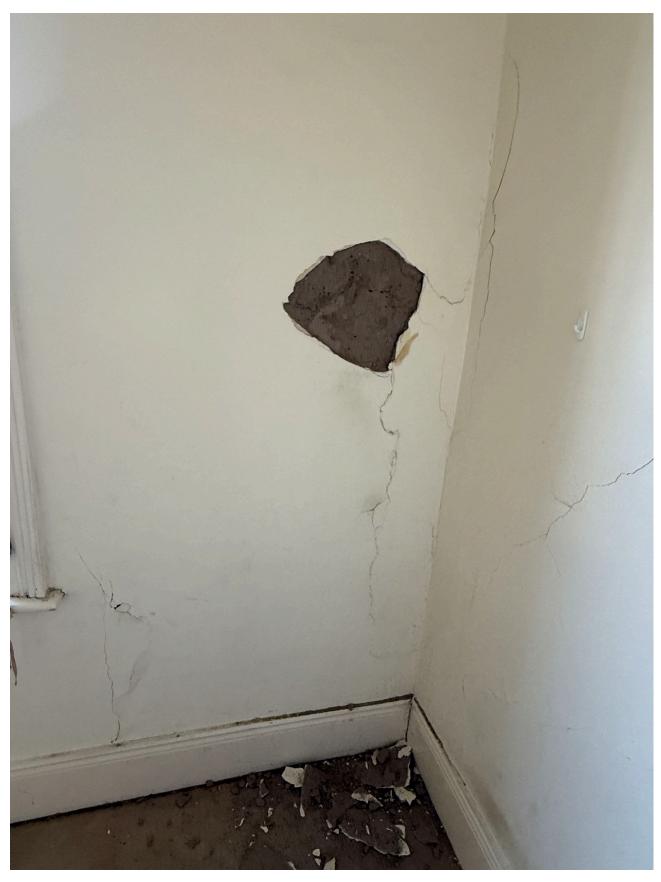
Internal 15 (Damage category 3)

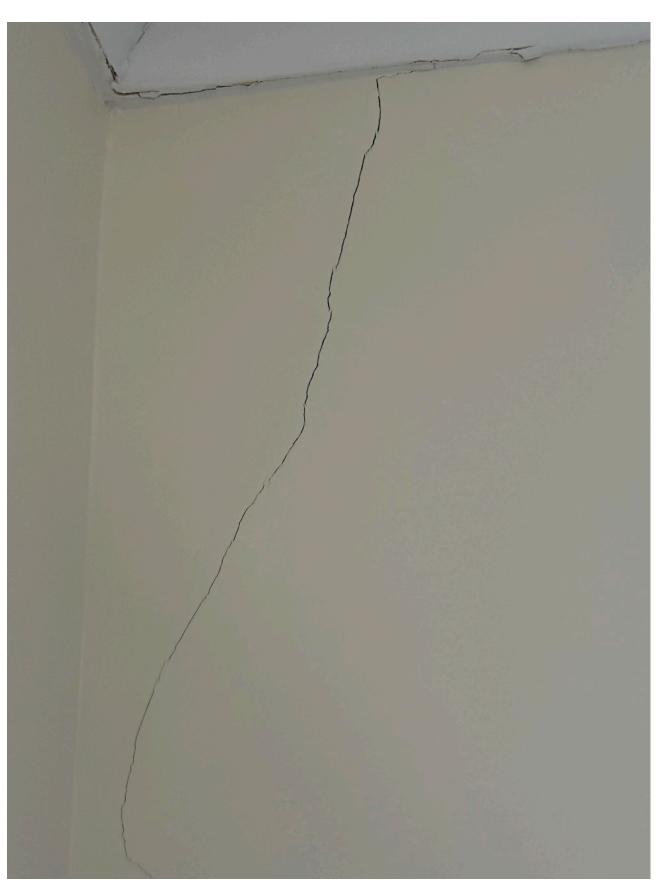
Internal 16 (Damage category 3)

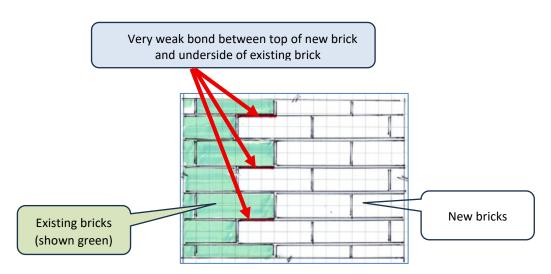
- Due to the inability of the existing footings to resist foundation movement of the highly expansive clays, I consider that breaking out sections of a brick wall on a vertical alignment and toothing in new bricks will not restore the full strength of the wall due to a lack of a full bond between the upper face of a new brick and the lower face of a retained brick, and will lead to cracking at the junction due to the inevitable foundation movement.

"TOOTHED" WALL JOINT - NOT STRUCTURALLY ADEQUATE

• The bricks will need to be removed to provide horizontal surfaces on top of which new bricks can be placed to ensure full bedding.

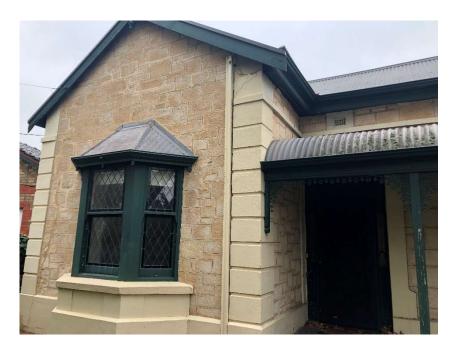
1. Front elevation, facing main road. Cracking adjacent to steel restraining post

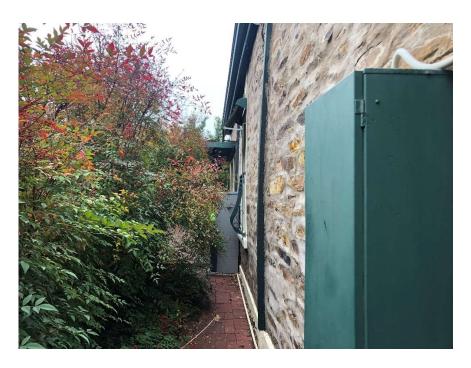
5. North west wall. Steel posts. Horizontal and vertical bowing in masonry

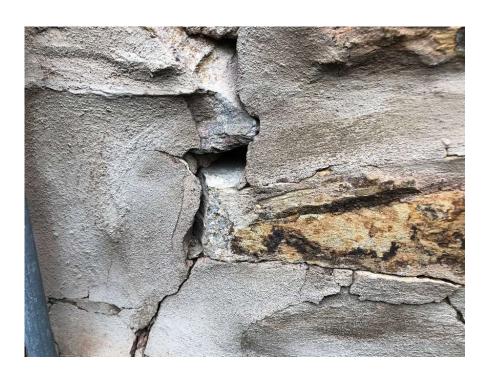
6. North west wall. Severe cracking in masonry wall

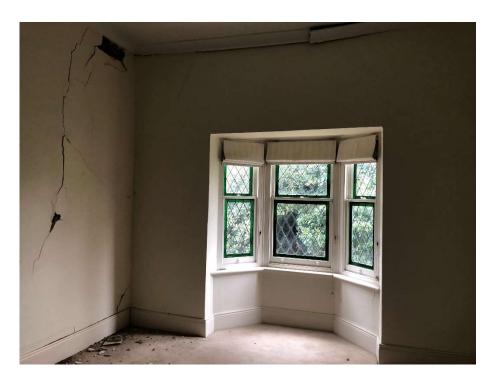
7. Internal view, front room. Cracking in internal wall and cornice.

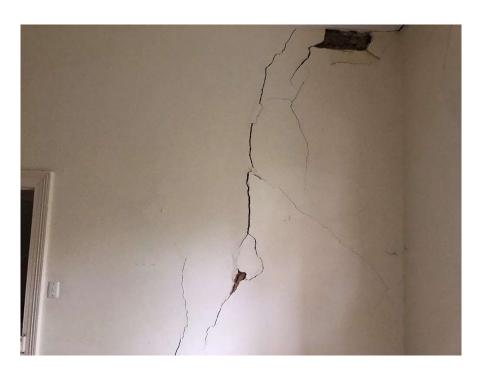
8. Damage category 4 cracking in internal wall.

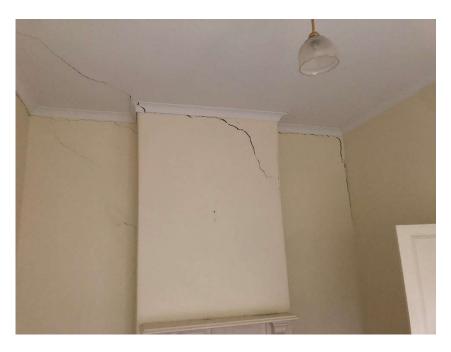
9. Internal view. Major cracking and deformation

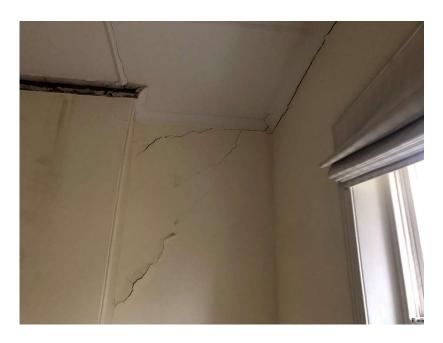
11. Internal view Major cracking and deformation

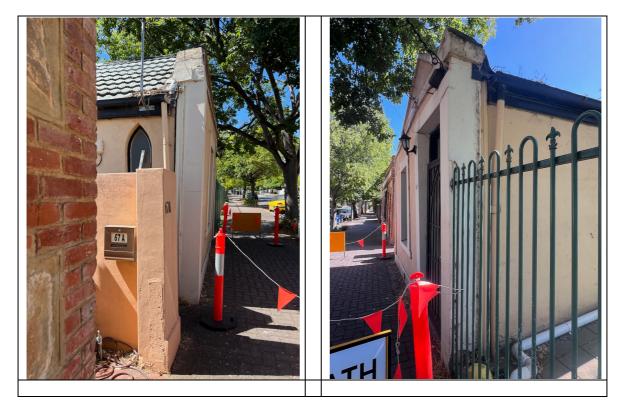
It would appear that since 2005 the front façade has rotated outwards. The lean is significant, but not irredeemably beyond repair.

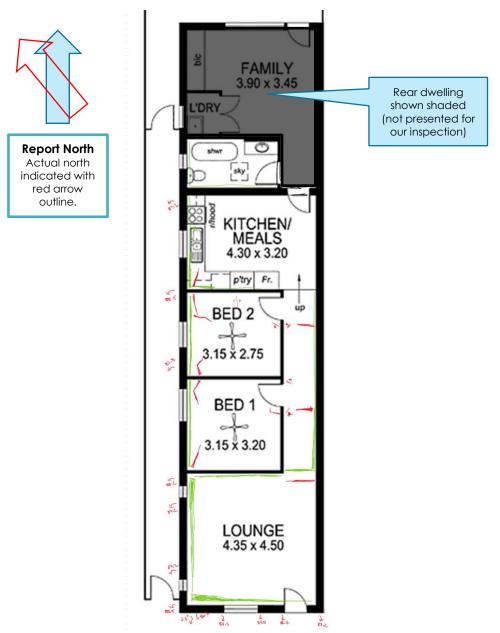
The most severe cracking, and that which we understand causes the applicant concern, was observed to the front lounge and along the western elevation (including the wall/ceiling junctions and the intersections between the western wall and internal return walls).

The southern (front) and western elevations' verticality was measured at various locations using a digital spirit level. The southern elevation was measured to be between 2.7° and 3.3° out of vertical alignment relatively consistently across its width. The western elevation was measured to be between 0.8° and 2.8° out of vertical alignment, with the severity of misalignment increasing from the rear to the front.

Figure 2 – **Red** is damage to walls, **green** is damage to ceilings & cornices, numbers and arrows externally indicate measured rotations

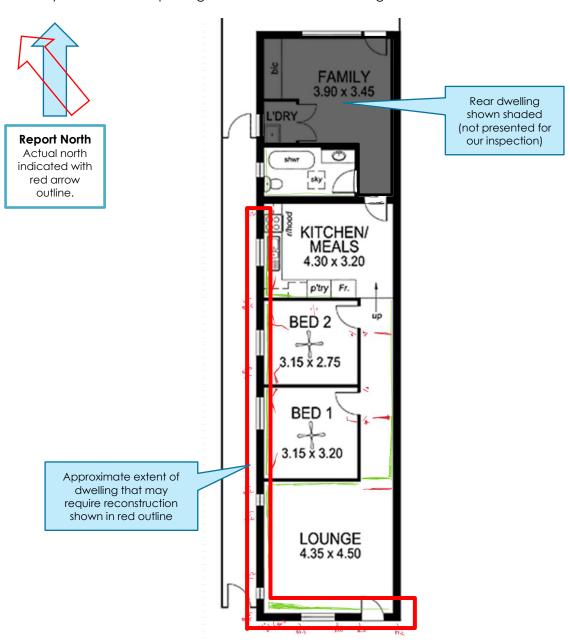
There is distortion to decorative and operable elements within the other areas of the dwelling (such slopes in the floor diaphragm, misalignment of architraves, shaving of doors, and gap filling of cornices). These issues can be resolved relatively simply by an experienced tradesperson by replacing distorted elements or adjusting the floor frame. However, distortion will likely return with the passage of time unless the building's foundation is stabilised.

Figure 3 – Approximate extent of structure that may require reconstruction
