# **Council Assessment Panel Agenda & Reports**

17 January 2024

Revision Number	Revision Date Revision Description			plot date : 20/12/2023	status: PRELIMINARY	AnthonyCiroccoDesign
			۸2	scale : As indicated	client name: Katelyn, Jessica & Matthew	ACN 078 297 060
			HZ	job no : 221025	project title:	+61 (8) 8336 0500
			Sheet Size	drawn by : JC checked by : JL	PROPOSED RESIDENCE	info@acdesign.net.au
				Sheeked by . SE	project address:  10 GRAY ST, NORWOOD	www.acdesign.net.au
			-	Contractor to verify all dimensions on site. Do not		Level 1, 502 Lower Nth Est. Rd. Campbelltown 5074
				of the design shown herein is retained by this office.	page no.: P100 drawing title: GENERAL LOCATION	2010117 002 201101 THIT 231. INC. CONTINUOUS THE
	Page 1 of 1	00	Revision No.	Written authority is required for any reproduction.	P100 GENERAL LOCATION	Sydney melbourne perth brisbane adelaide

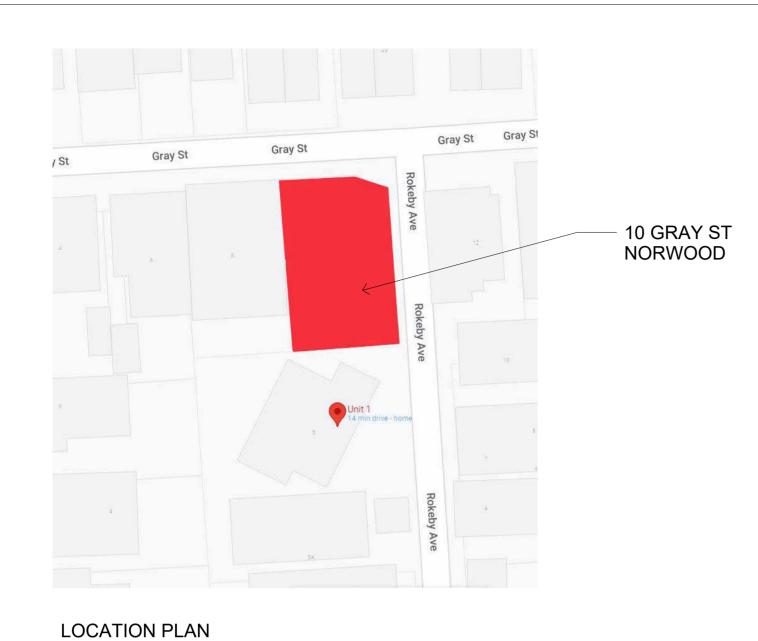
**HOUSE A**

AREAS		Sq.m	
TOTAL LANI	D	246	SITE COVERAGE 128/246 = 52.4%
GF LIVING FIRST FL LIV OUTDOOR I		128.0 56.0 19.0	PRIVATE OPEN SPACE = 46.2 Sq.m
TOTAL =		203.0	LANDSCAPE SPACE = 51.6 Sq.m

# **HOUSE B**

AREAS	S	Sq.m	
TOTAL LAND	)	232	SITE COVERAGE 126/232 = 54.3%
GF LIVING FIRST FL LIV OUTDOOR L	/ING	126.0 56.0 19.0	PRIVATE OPEN SPACE = 85.0 Sq.m
TOTAL	= 2	201.0	LANDSCAPE SPACE = 35.7 Sq.m

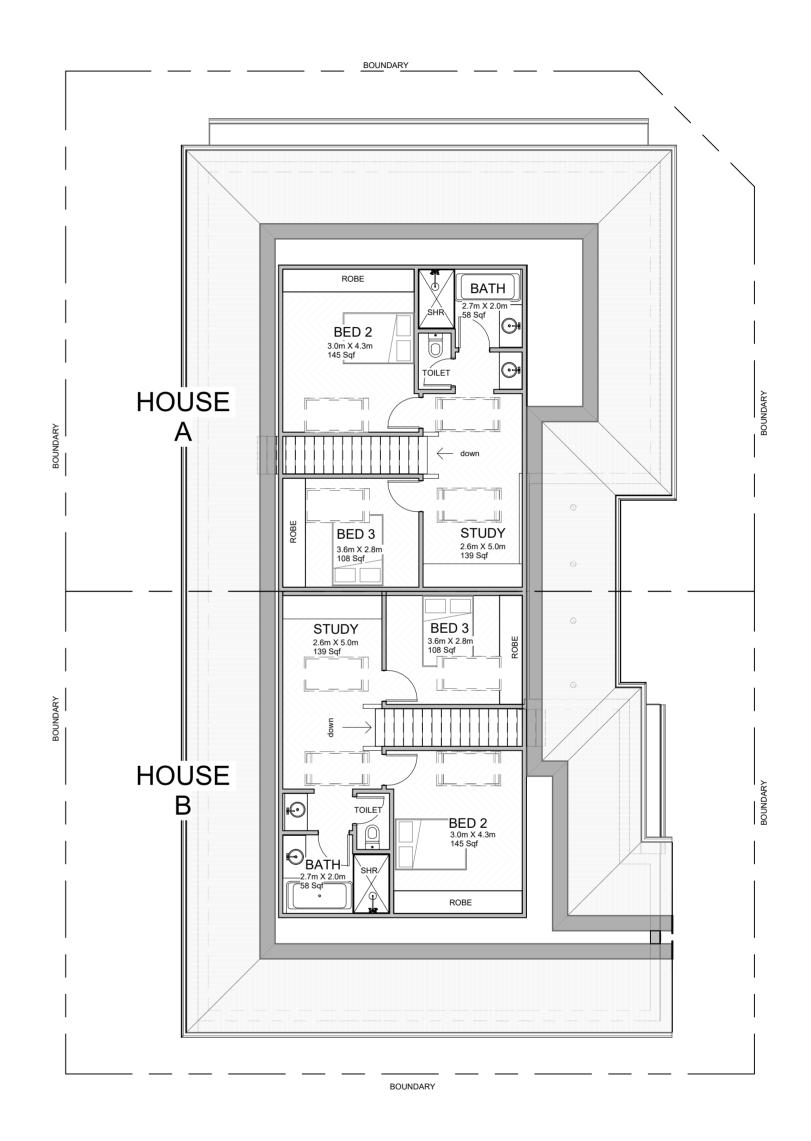
# 2 FIRST FLOOR 1:100

Revision Number Revision Date	Revision Description		plot date : 20/12/2023	status: PRELIN	MINARY	AnthonyCiroccoDesign
		A2	scale: 1:100	client name: Katelyn, Jes	sica & Matthew	7 (11111011 y C11 0 C C 0 D C 31 9 1 1 1 1 1 1 1 1 y C 11 0 C C 0 D C 31 9 1 1 1 1 1 1 1 1 1 1 1 1 1 1 1 1 1
		AZ	job no : 221025	project title:		+61 (8) 8336 0500

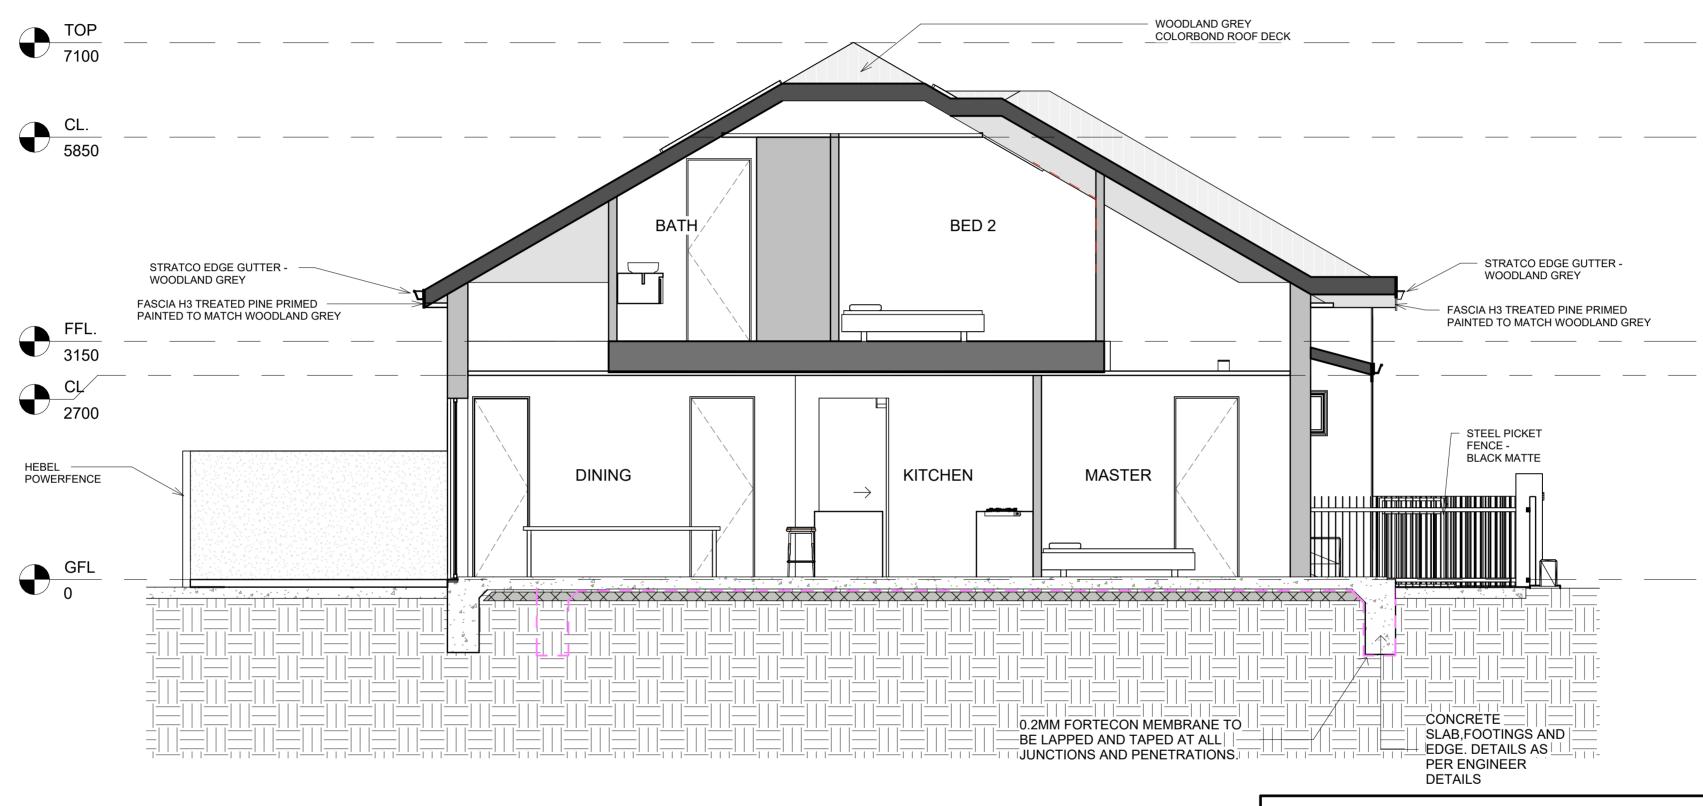
**SECTION B** 1:50

NEW BOUNDARY FENCE ( HEBEL POWERFENCE PAINTED WHITE WASH 1 BY HAMES ), STEEL PICKET FENCE ( FRONT FENCE ), BLACK MATTE STEEL GATE FENCE:

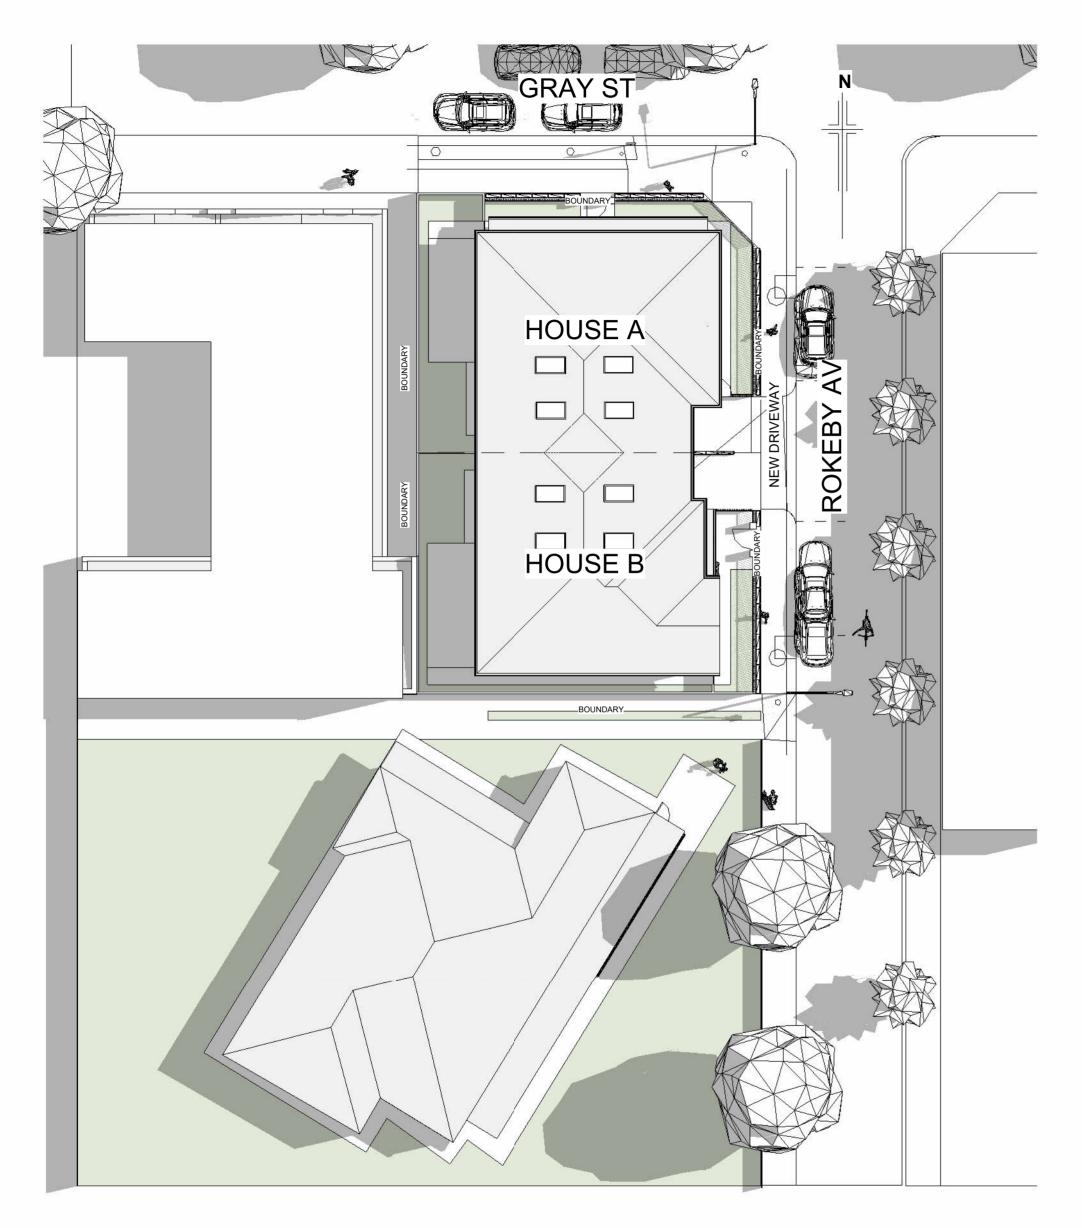
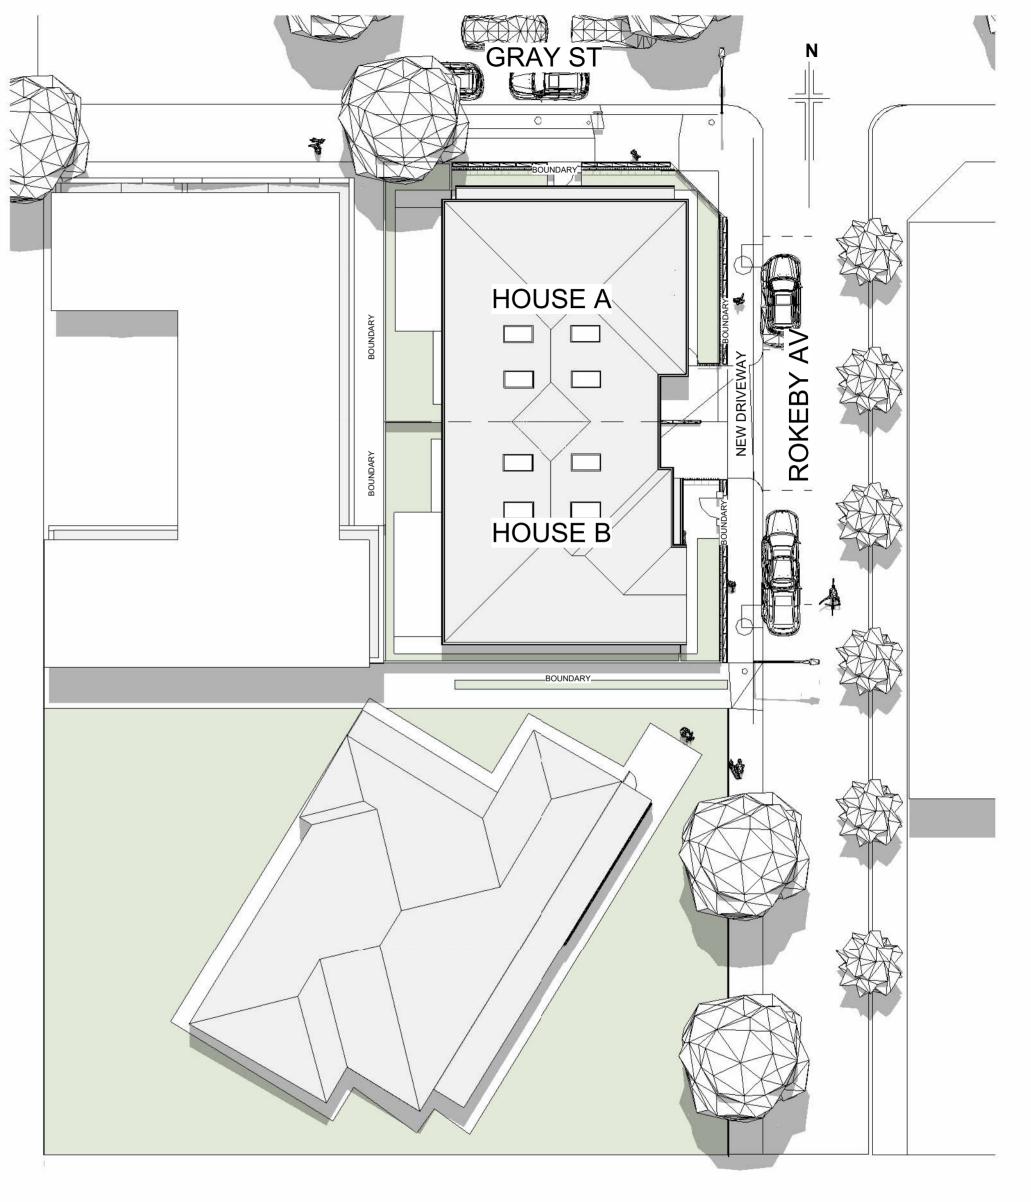
SITE PLAN SUN 9AM - SUMMER
1:200

2 SITE PLAN SUN 12PM - SUMMER 1:200

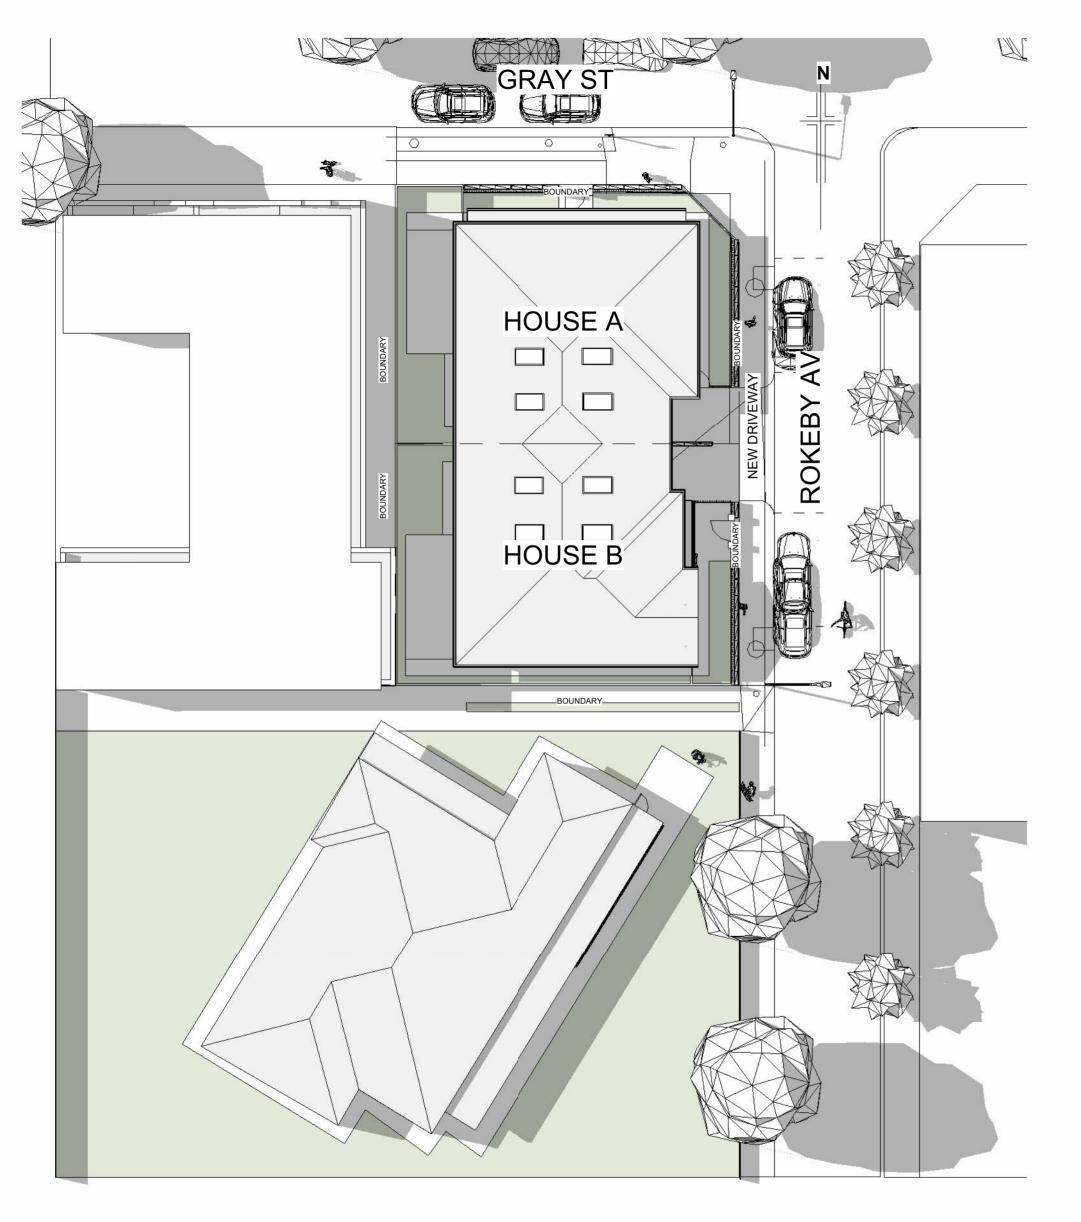
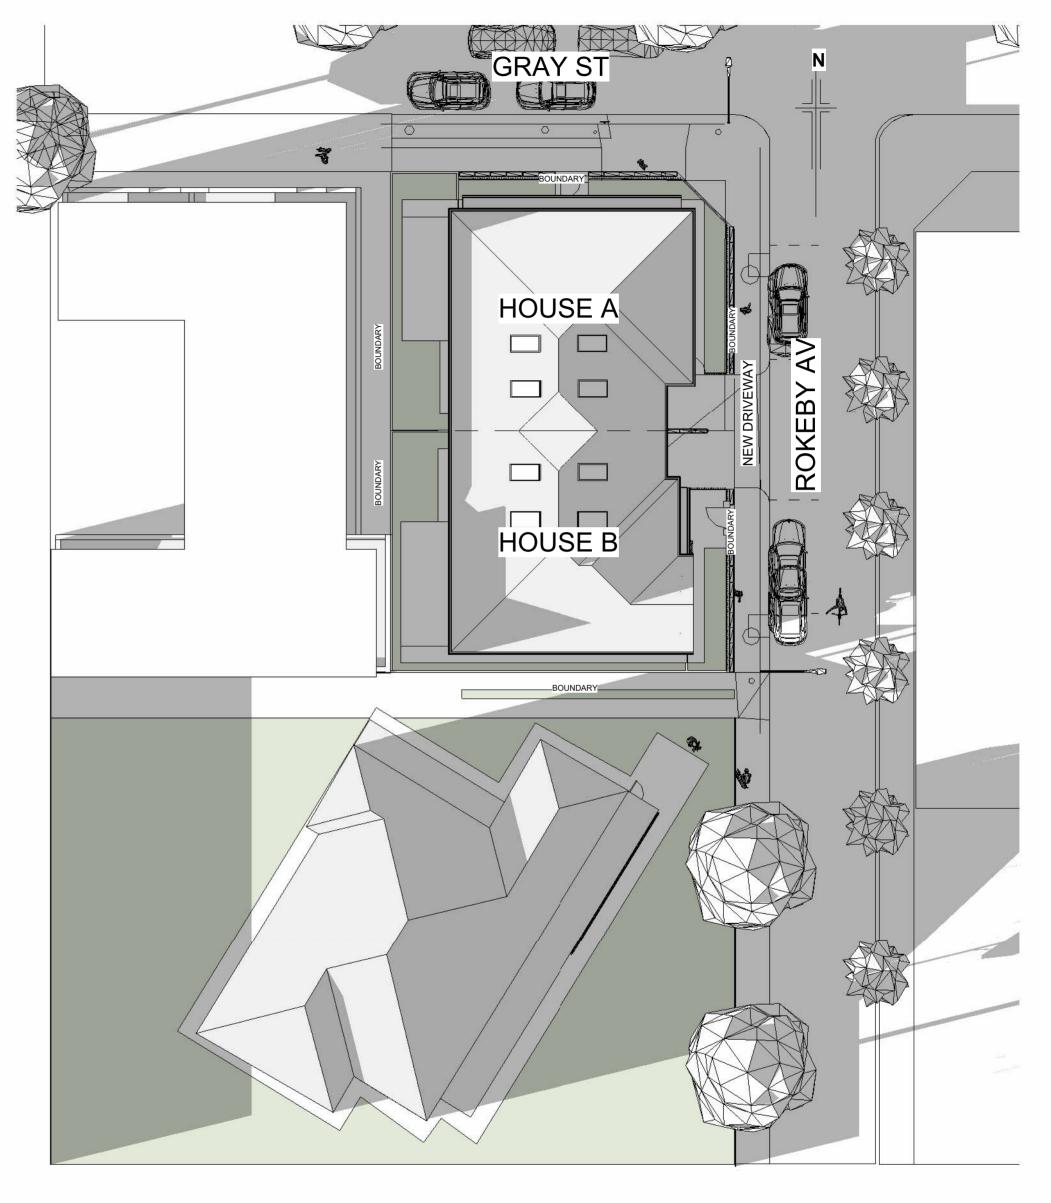
# 1 SITE PLAN SUN 3PM - SUMMER 1: 200

2 SITE PLAN SUN 6PM - SUMMER
1:200

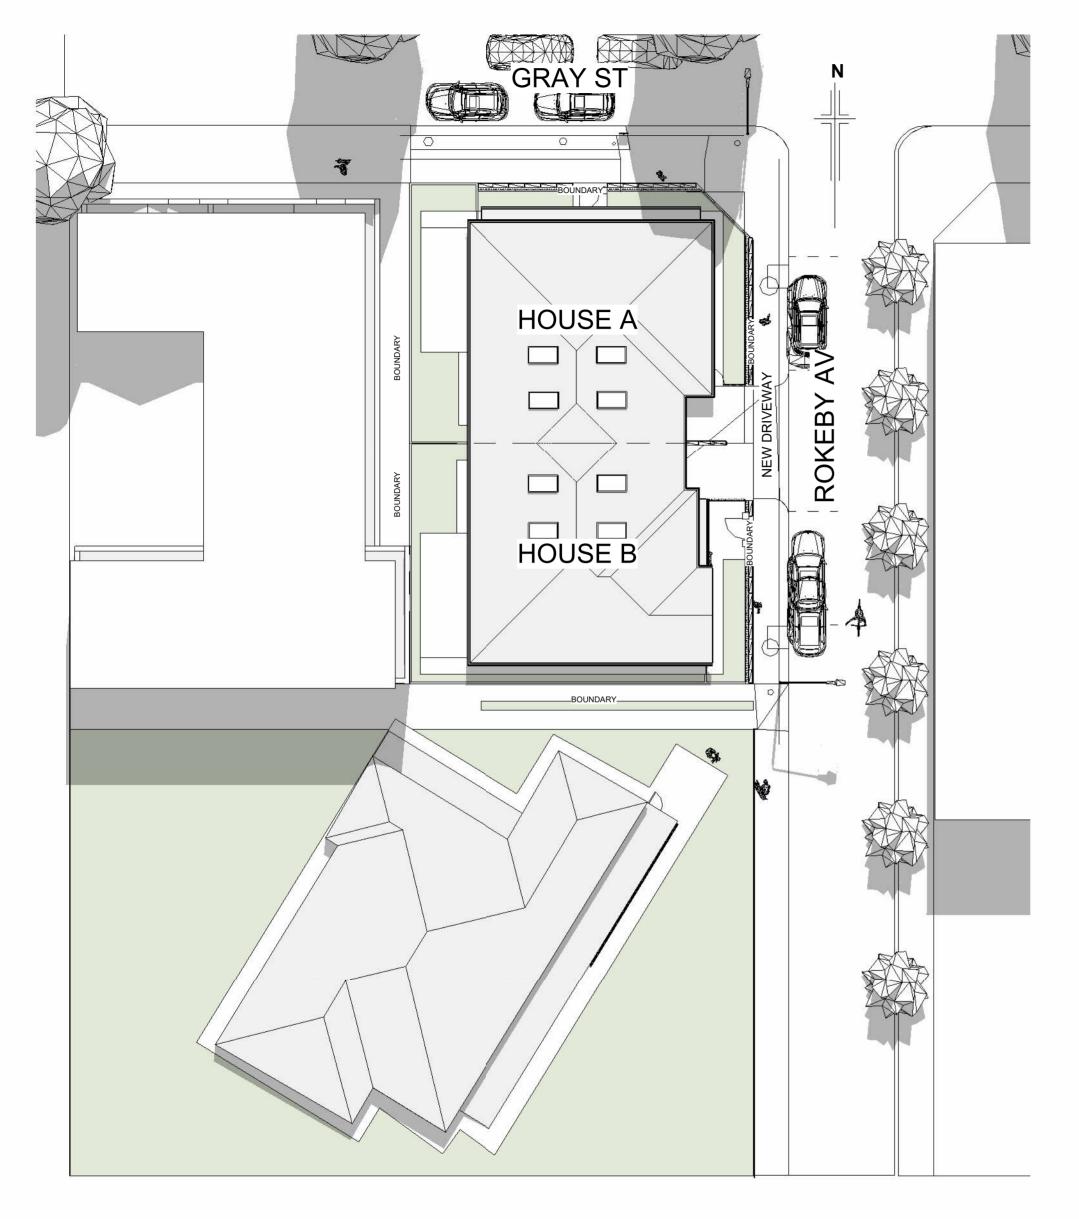
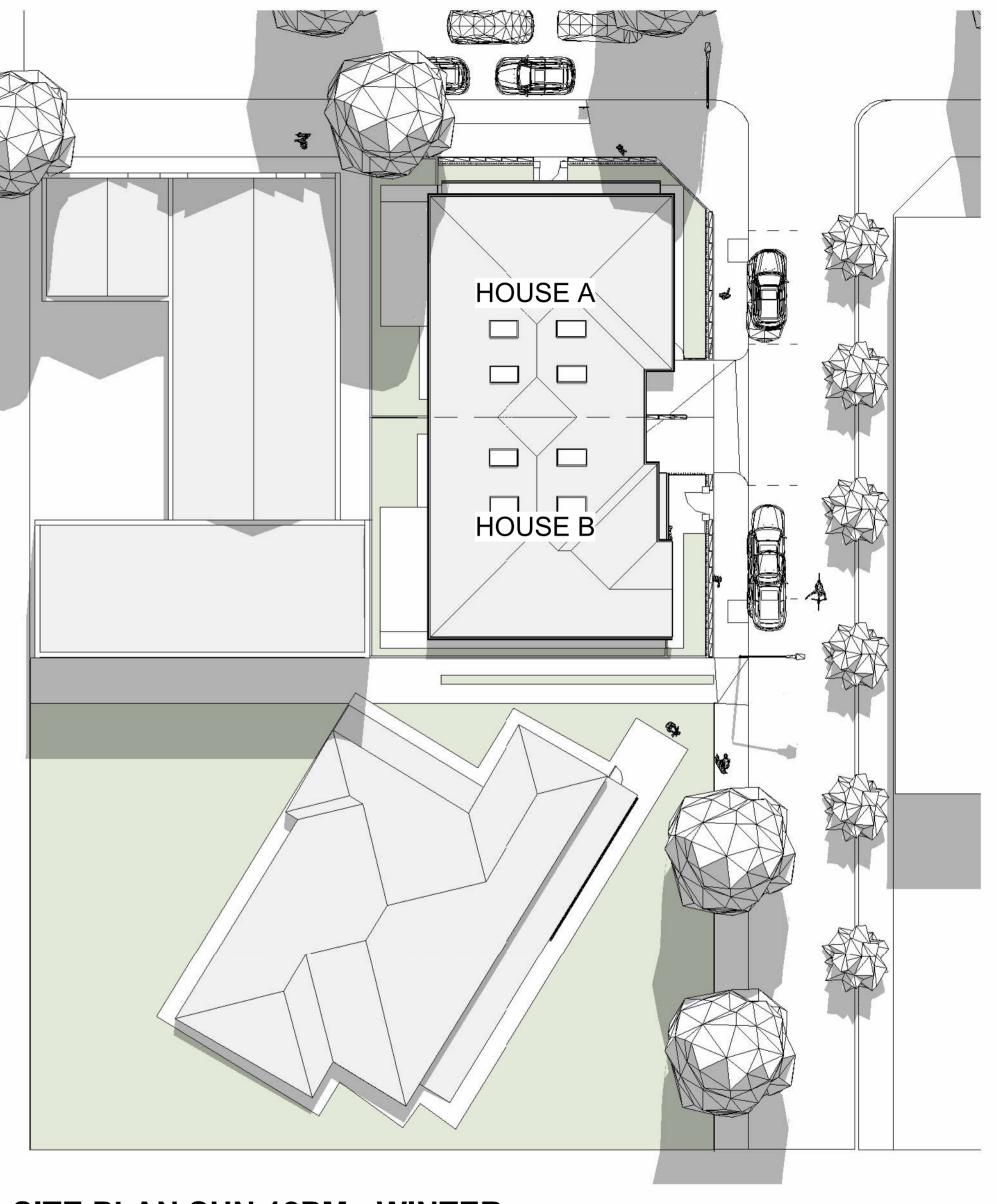
1 SITE PLAN SUN 9AM - WINTER
1: 200

2 SITE PLAN SUN 12PM - WINTER 1:200

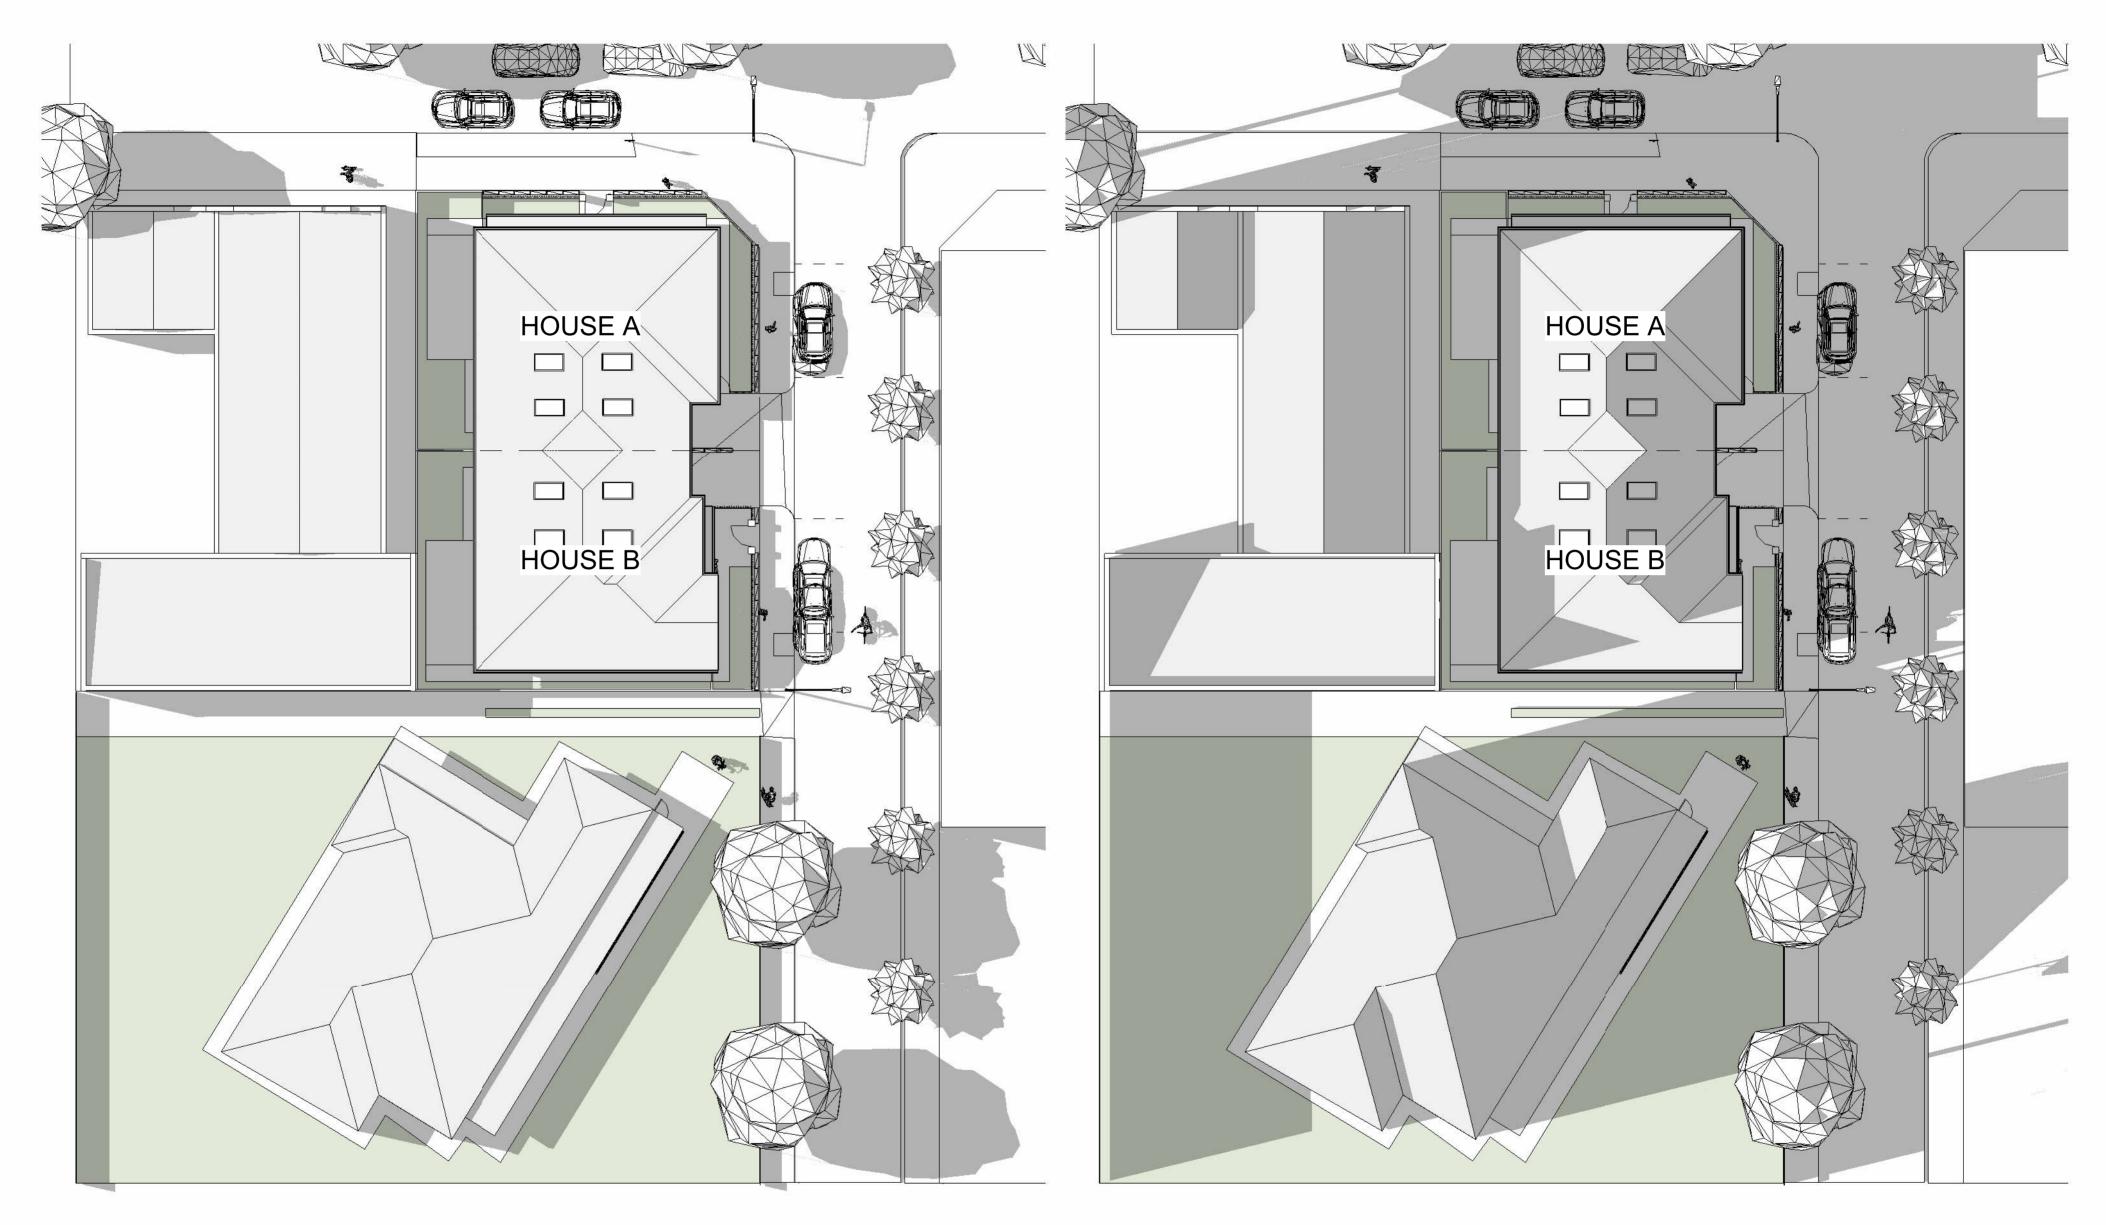
1 SITE PLAN SUN 3PM - WINTER
1:200

2 SITE PLAN SUN 6PM - WINTER
1:200

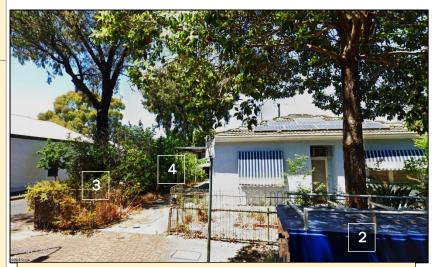
View to east. Dwelling orientates north with car port off side to east and driveway/site access near street corner. Tree 2 in Gray Street foreground and Trees 3 and 4 in Rokeby Ave.

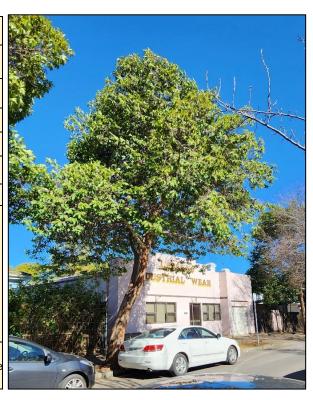
TREE 1	Lophostemon confertus Brushbox		
LOCATION	Approx aligns with southern boundary projection into Gray St verge. Edge of trunk meets kerb.		
TRUNK MEASURE	1280 @1.4, 1450 @1.0, 1720 @0.3 mtrs H		
SIZE	Height 5 mtrs, Canopy 4 4 4 4 mtrs NSEW		
PROTECTION	SRZ 2.5 TPZ 4.9 mtrs rad		
LEGAL STATUS	Unregulated as per SA PDI Regs 2017 -3F 2(b)		
AGE	230-25 yrs Early Mature		
CONDITION	Health-Very Good, Structure-Good-Fair, Stability-Good Single upright trunk biased north 10° divides x 2 @ 2.5 mtrs high angled ribbed inclusion codominant half hemisphere canopies Stem 1 250 mm Ø 30° north, Stem 2 400 mm Ø 30° south.  Hardy pollution and disruption tolerant species no longer favoured in urban areas due to nut drop nuisance.  Approx 30-40 yrs remaining life expectancy.		
QUALITY	Moderately High – Minor stem defect, no disease, no limb failures, well balanced, well maintained, high shade amenity

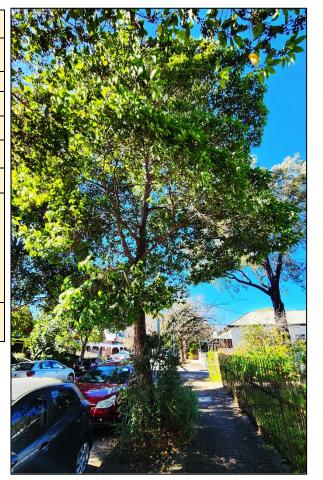
TREE 2	Lophostemon confertus Brushbox	
LOCATION	Trunk on kerb edge 8.5 mtrs off southern boundary projection.	
TRUNK MEASURE	1150 @1.4, 1250 @1.0, 1650 @0.3 mtrs H	
SIZE	Height 5 mtrs, Canopy 4 4 4 4 mtrs NSEW	
PROTECTION	SRZ 2.5 TPZ 4.7 mtrs rad	
LEGAL STATUS	Unregulated as per SA PDI Regs 2017 -3F 2(b)	
AGE	20-25 yrs Early Mature	
CONDITION	Health- Good, Structure-Good-Fair, Stability-Good Upright single trunk, distinct taper, lateral 1 north @ 3 mtrs H apical codominant., Hardy pollution and disruption tolerant species no longer favoured in urban areas due to nut drop nuisance. Approx 30-40 yrs remaining life expectancy.	
QUALITY	High - No defects, no disease, no limb failures, well balanced, well maintained, high shade amenity.

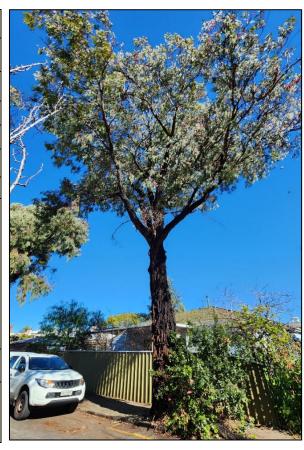
TREE 3	Eucalyptus sideroxylon Ironbark	
LOCATION	4.5 mtr south of northern front boundary projection in Rokeby Ave footpath Edge of trunk meets kerb.	
TRUNK MEASURE	2520 @1.4, 2640 @1.0, 2670 @0.3 mtrs H	
SIZE	Height 15 mtrs, Canopy 10 8 6 6 mtrs NSEW	
PROTECTION	SRZ 3.1 TPZ 10.1 mtrs rad	
LEGAL STATUS	Regulated as per SA PDI Regs 2017 -3F 2(b)	
AGE	40-45 yrs Over-Mature	
CONDITION	Health-Fair, Structure-Good-Fair, Stability-Fair Single upright tapered trunk with lower limb removals to 3 mtrs H then high angled lateral limbs L1 400 mm Ø 60° north and north-west, L2 south 6 mtrs H 400 mm Ø 40° with main stem/limb cluster x 3 @ 8 mtrsH. Foliar density moderate, canopy coverage good. Disruption and compaction tolerant species with low limb flexibility resulting in limb fatigue in turbulent weather. Up to 10 yrs remaining useful lifespan.	
FORM	Tall tapered stem forming upper peripheral apical canopy surrounding upper central canopy

QUALITY	Moderate-high proportion of small limbs and low foliar density indicates mildly stressed growing conditions possibly from heat bank. No obvious disease, well balanced, well maintained. Very large for confined street

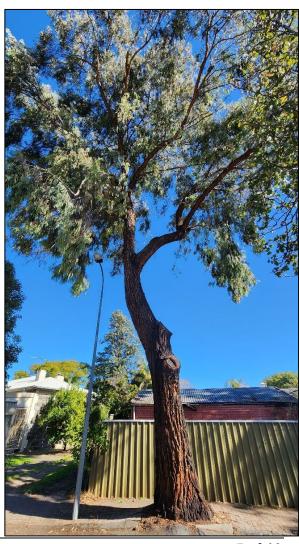
TREE 4	Eucalyptus sideroxylon Ironbark	
LOCATION	2.2 mtrs north of southern rear boundary projection in Rokeby Ave footpath. Edge of trunk meets kerb.	
TRUNK MEASURE	2580 @1.4, 2640 @1.0, 3040 @0.3 mtrs H	
SIZE	Height 15 mtrs, Canopy 6 8 6 4 mtrs NSEW	
PROTECTION	SRZ 3.1 TPZ 9.5 mtrs rad	
LEGAL STATUS	Regulated as per SA PDI Regs 2017 -3F 2(b)	
AGE	40-45 yrs Fully Mature	
CONDITION	Health-Very Good, Structure-Good, Stability-Good Single upright tapered trunk with lower limb removals to 3 mtrs H diverts south corrects to vertical from L1 north 600 mm Ø 45°6 mtrsH subdominant apical, limb cluster x 4 @ 9 mtrs with regrowth. Foliar density very good and canopy coverage very even. Disruption and compaction tolerant species with low limb flexibility resulting in limb fatigue in turbulent weather. Approx 20-25 yrs remaining life expectancy.	
QUALITY	High – Size for age and condition indicates good response to larger growing area, no disease, no limb failures, well balanced, well maintained, high shade amenity

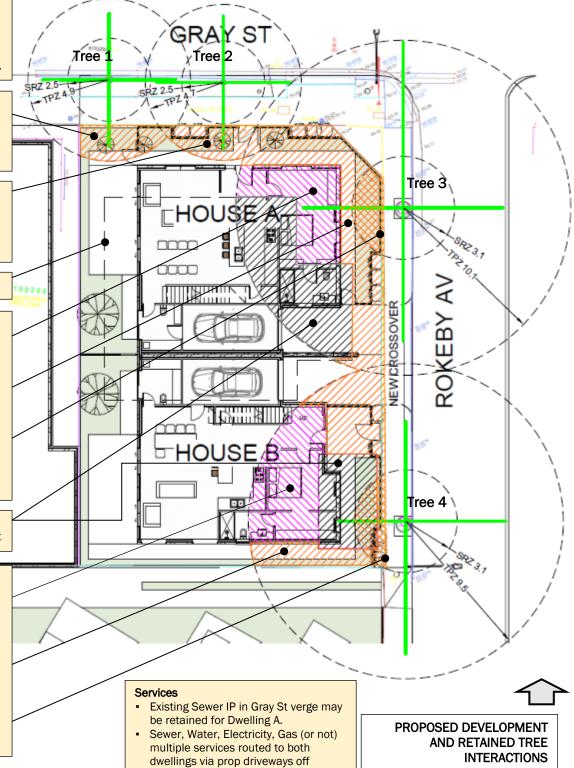
10 Gray Street Norwood Base source Anthony Cirocco Designs

multiple services routed to both dwellings via prop driveways off Rokeby between Trees 3 and 4 drilled from main to reduce trench impacts.

DEVELOPMENT	Deep Encroachments of 7.1% of Tree 3 and 10.2% of Tree 4's TPZ's considered within species and each specimen's capacity to sustain.  Shallow Encroachment posed by peripheral paving and gardens elsewhere to Trees 1-4 considered low impact sustainable.  Services to be routed into each proposed allotment between Trees 3 and 4 where root disturbance would be lowest or drilled in to achieve negligible impacts.  Pruning intervention to address risk or construction access not required.  No trees exhibit history or apparent likelihood of limb failure.  Maintenance pruning able to undertaken if required post development  Overall encroachment by builtform contended as Minor as per Section 3.3.2 of AS 4970 Protection of Trees on Development Sites.	
PROTECTION	<ul> <li>Temporary fencing to property boundary able to isolate street trees from construction activity conducted exclusively within subject property.</li> <li>Front and side garden areas may be fenced off internally from machinery access post demolition and wet based mixing and waste disposal activities.</li> <li>Pier holes for boundary fencing to be hand dug and relocated if roots &gt;50mm discovered.</li> <li>Fencing or boundary walling based on pier and suspended beams, no trenching or strip footings required or permitted.</li> <li>All site access via existing driveway and proposed driveway, nowhere else required.</li> <li>Tree Assessment Services nominated as Project Arborist.</li> </ul>

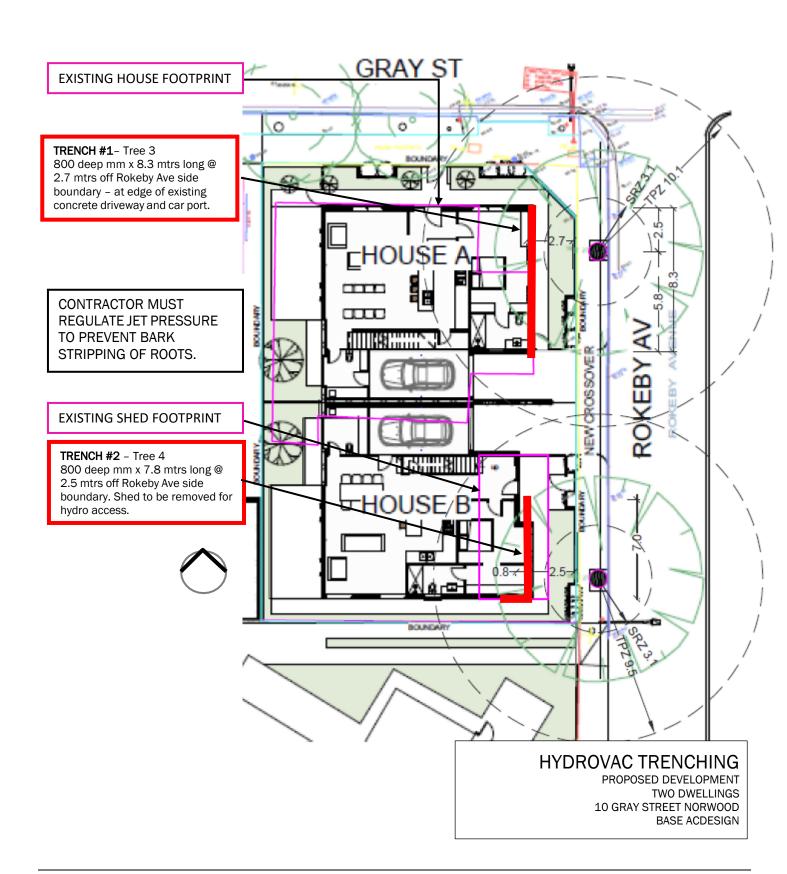
Results of discovery undertaken by hydrovacuum contractor to specified lengths and 600 mm depth.

Note that engineering footing design has not been undertaken and that depth of strip footing nominated on architectural elevations and sections was indicative only and not based on any soil test based engineered profile.

Essentially, limited findings indicate that neither the health, structural condition or stability of Trees 3 or 4 would be affected by the minor encroachment posed by proposed development.

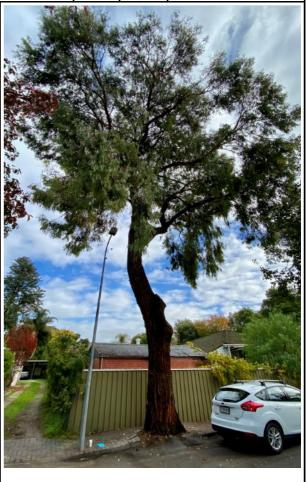
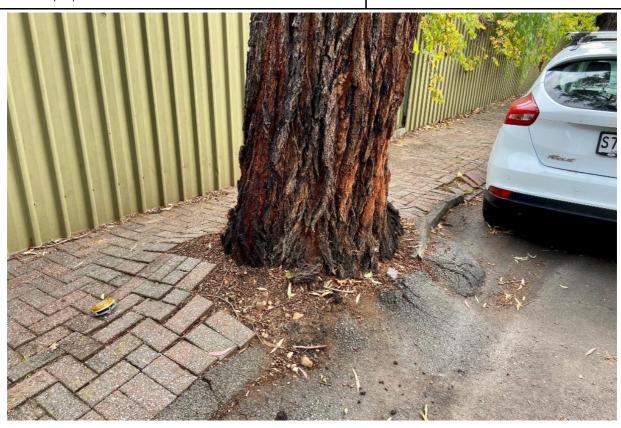
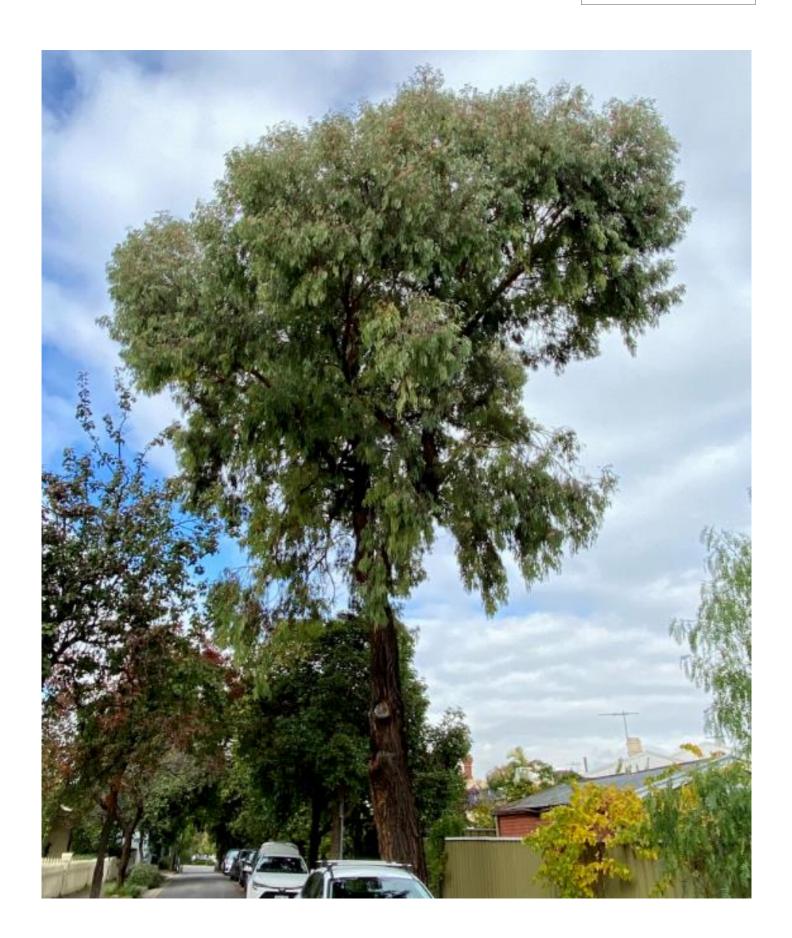
The tree is situated/planted into a narrow footpath with the tree now within 1m of the adjacent property boundary and causing displacement of pavement and road surface.

Overall this Regulated tree has good health and good structure and there is no action required from an arboricultural perspective. SRZ = 3.09m TPZ = 9.48m

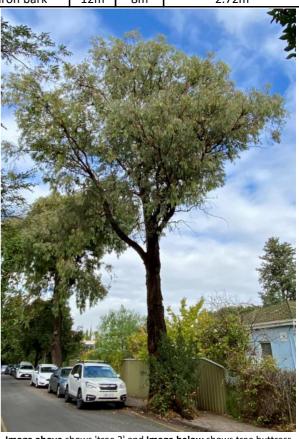
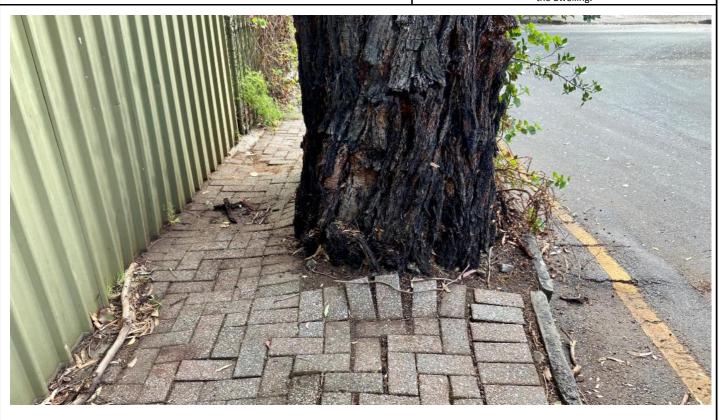
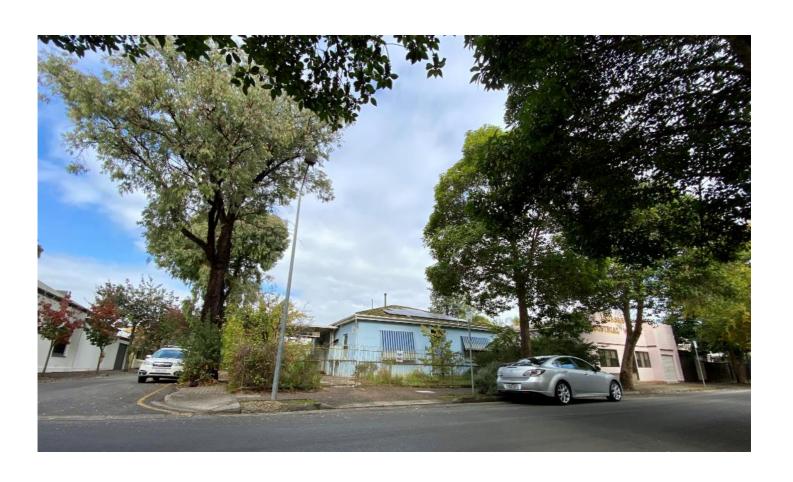
Date of Inspection & Staff: Thursday 18 May 2023, City Arborist							
Custon	ner / CRM / Concerns:	DA 23005863 seeks to demolish exisiting dwelling and construct two new dwellings					
Ac	Idress / Location:	10 Gray Street Norwood					
Tree No.	Genus	nus Species Common Name I		Height	Spread	Trunk Circumference	
2	Eucalyptus	sideroxylon	red mugga iron bark	12m	8m	2.72m

•
Age Class	Mature
Health	Fair
Structure	Sound
Shape & Form	Good
	-
Quantified Tree Risk Assessment	Broadly Acceptable
Legislative Controls	Regulated Tree
Recommendation	Retain
No. & Replacement Species	N/A

throughout the trees crown indicating the tree having been through a period of gradual decline, at this stage overall health is fair and will be subject to changes to root growing

environment. The tree is free of any structural defect that could be observed from ground level. The tree is currently <1m from the property boundary. SRZ = 3.09m TPZ = 10.08m

Image above shows 'tree 2' and Image below shows tree buttress and displacement of infrastructure. Image 3 shows current growing enviornment of the four trees that surround this potential development site, consisting of undisturbed garden bed, dwelling and minor infrastructure. The trees are likely to be a similar age to the dwelling.

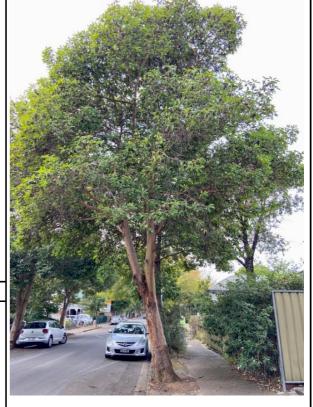
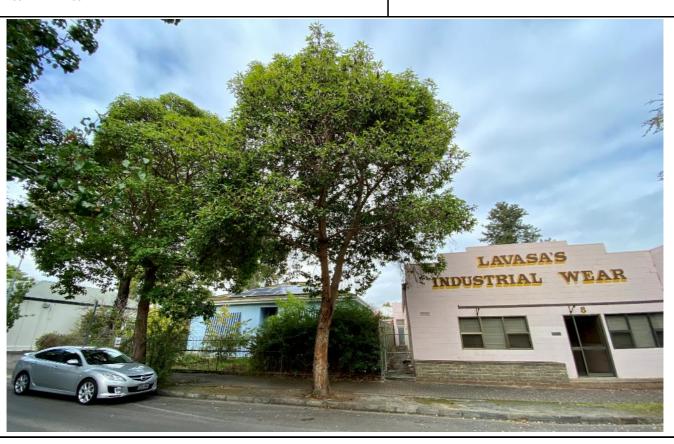
Date of Inspection & Staff: Thursday 18 May 2023, City Arborist					orist		
Customer / CRM / Concerns: DA 23005863 seeks to demolish exisiting dwelling and construct two new dv					two new dwellings		
Ac	Idress / Location:	10 Gray Street Norwood					
Tree No. Genus Species Common Name		Height	Spread	Trunk Circumference			
4	Lophostemon	confertus	Queensland box	10m	8m	1.3m

Age Class	Mature
Health	Good
Structure	Good
Shape & Form	Good
<b>Quantified Tree Risk Assessment</b>	Broadly Acceptable
Legislative Controls	None
Recommendation	Retain
Recommendation	Retain
Recommendation  No. & Replacement Species	Retain N/A

The tree is situated at 2.55m from the property boundary to the south and is well suited to its location.

SRZ = 2.53m TPZ = 4.68m

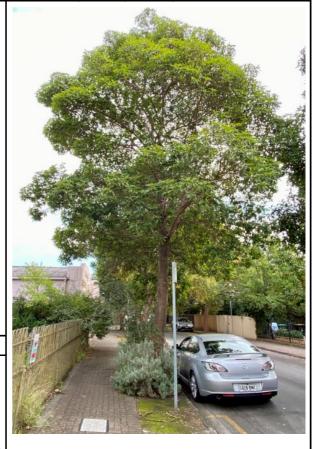
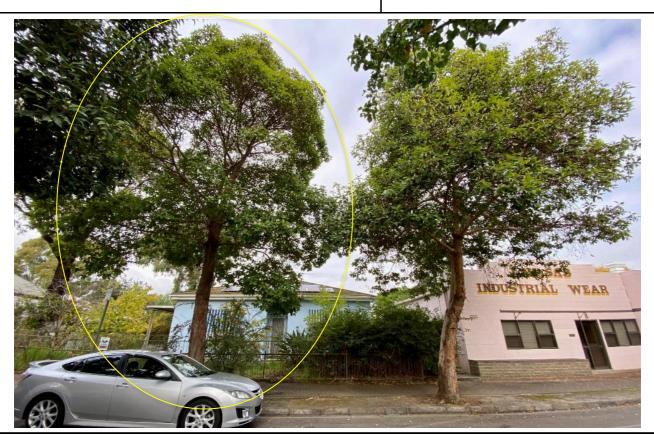
Date of Inspection & Staff: Thursday 18 May 2023, City Arborist						
Customer / CRM / Concerns: DA 23005863 seeks to demolish exisiting dwelling and construct two new dwe					two new dwellings	
Ac	Idress / Location:	10 Gray Street Norwood				
Tree No.	ree No. Genus Species Common Name		Height	Spread	Trunk Circumference	
3	Lophostemon	confertus	Queensland box	10m	8m	1.3m

Age Class	Mature
Health	Good
Structure	Good
Shape & Form	Good
<b>Quantified Tree Risk Assessment</b>	Broadly Acceptable
Legislative Controls	None
Recommendation	Retain
No. & Replacement Species	N/A

The tree is situated at 2.55m from the property boundary to the south and is well suited to its location. Tree 3 is circled in yellow below.

SRZ = 2.47m TPZ = 4.56m

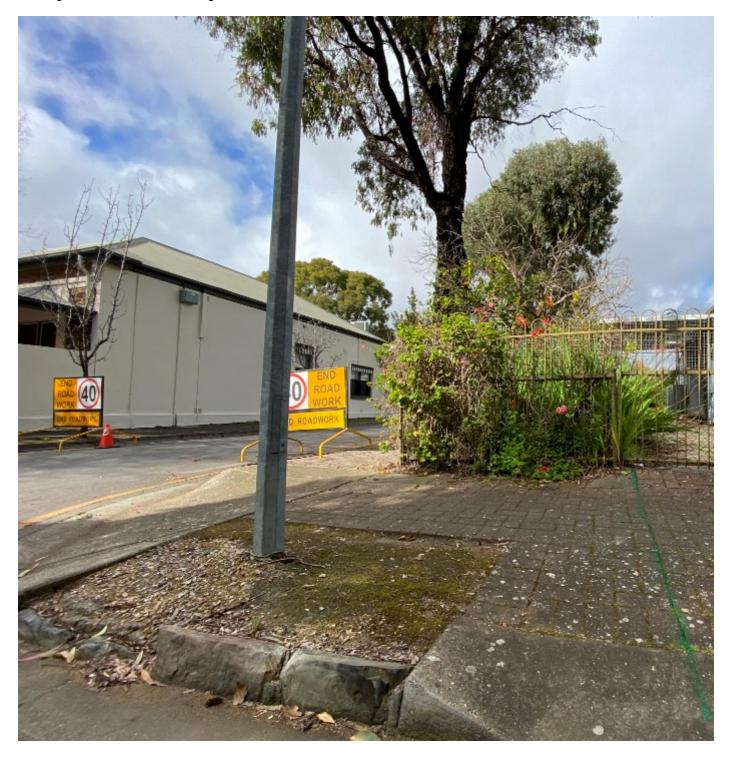
Further to my email below and for my own understanding, I took the below image during the assessment, the green line in the image shows the approximate location of the eastern front walls of both dwellings and the line at which an investigative trench would be dug to the south.
