# **Council Assessment Panel Agenda & Reports**

17 January 2024

Revision Number	Revision Date Revision Description			plot date : 20/12/2023	status: PRELIMINARY	AnthonyCiroccoDesign
			۸2	scale : As indicated	client name: Katelyn, Jessica & Matthew	ACN 078 297 060
			HZ	job no : 221025	project title:	+61 (8) 8336 0500
			Sheet Size	drawn by : JC checked by : JL	PROPOSED RESIDENCE	info@acdesign.net.au
				Sheeked by . SE	project address:  10 GRAY ST, NORWOOD	www.acdesign.net.au
			-	Contractor to verify all dimensions on site. Do not		Level 1, 502 Lower Nth Est. Rd. Campbelltown 5074
				of the design shown herein is retained by this office.	page no.: P100 drawing title: GENERAL LOCATION	2010117 002 201101 THIT 231. INC. CONTINUOUS THE
	Page 1 of 1	00	Revision No.	Written authority is required for any reproduction.	P100 GENERAL LOCATION	Sydney melbourne perth brisbane adelaide

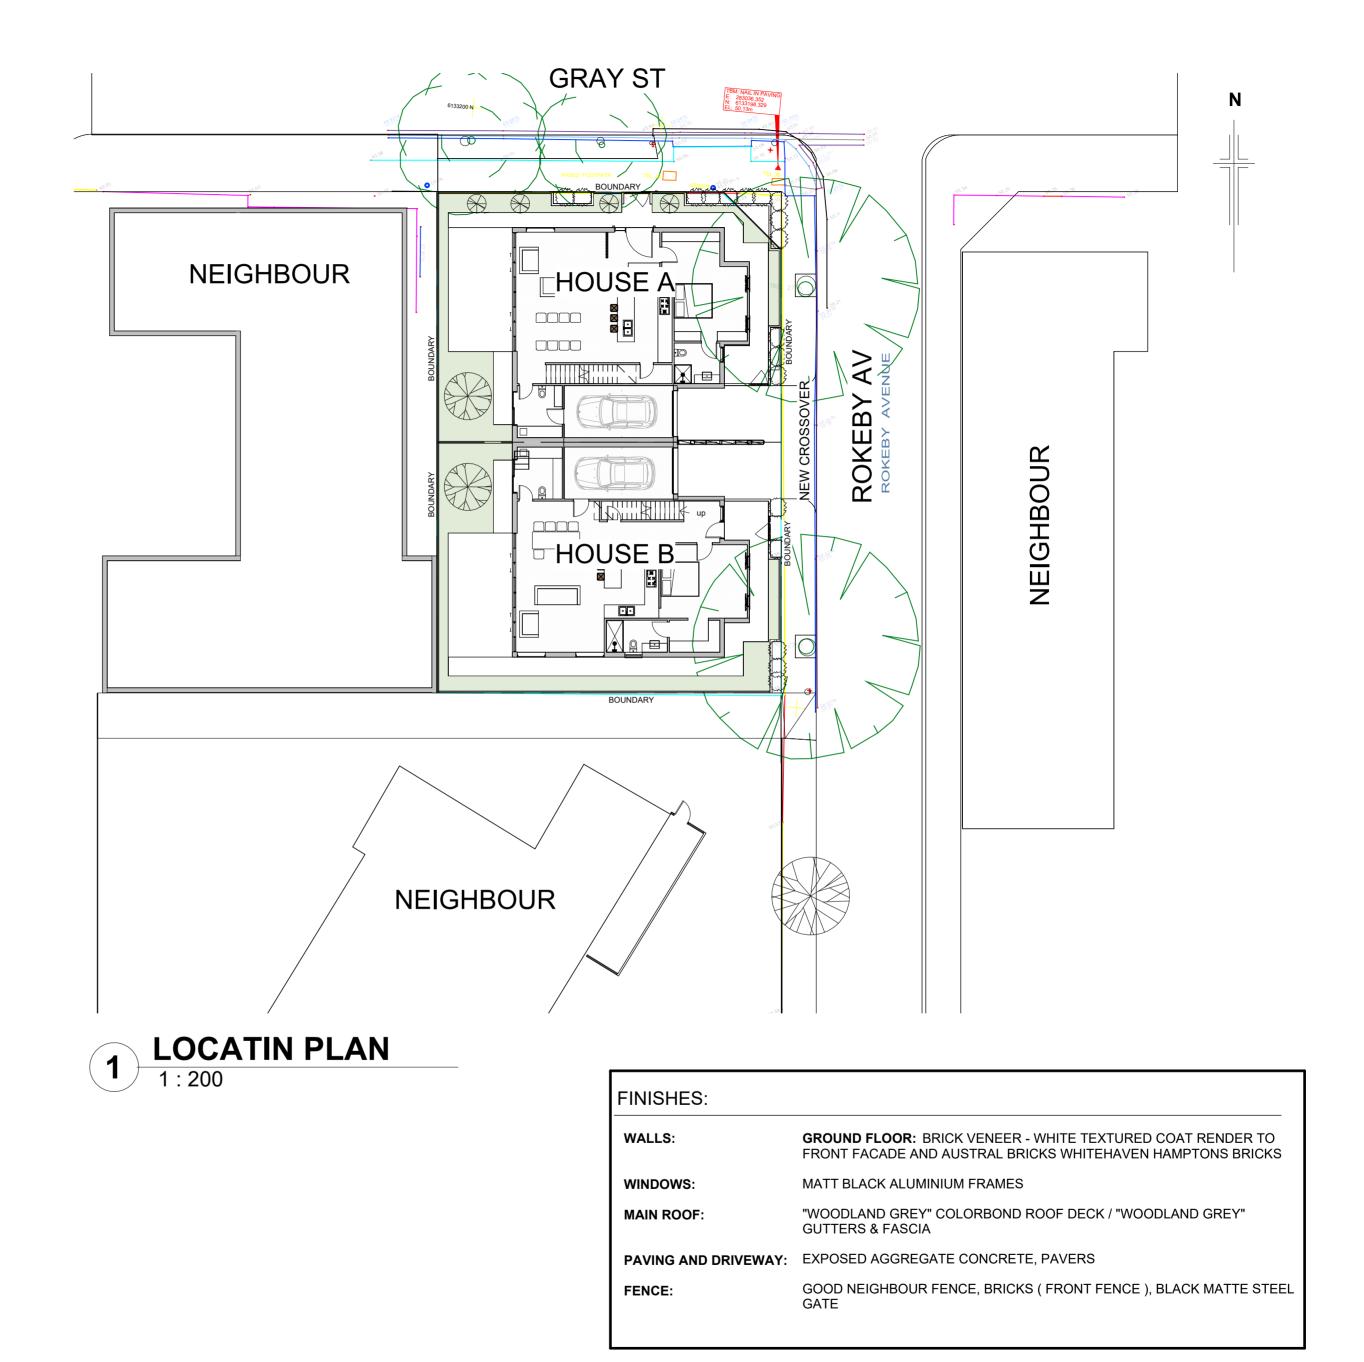
AREAS	Sq.m	
TOTAL LAND	236	SITE COVERAGE 112/236 47.8%
GF LIVING FIRST FL LIVING OUTDOOR LIVING	112.9 50.0 21.4	PRIVATE OPEN SPACE = 85.0 Sq.m
TOTAL =	183.9	LANDSCAPE SPACE = 40.0 Sq.m

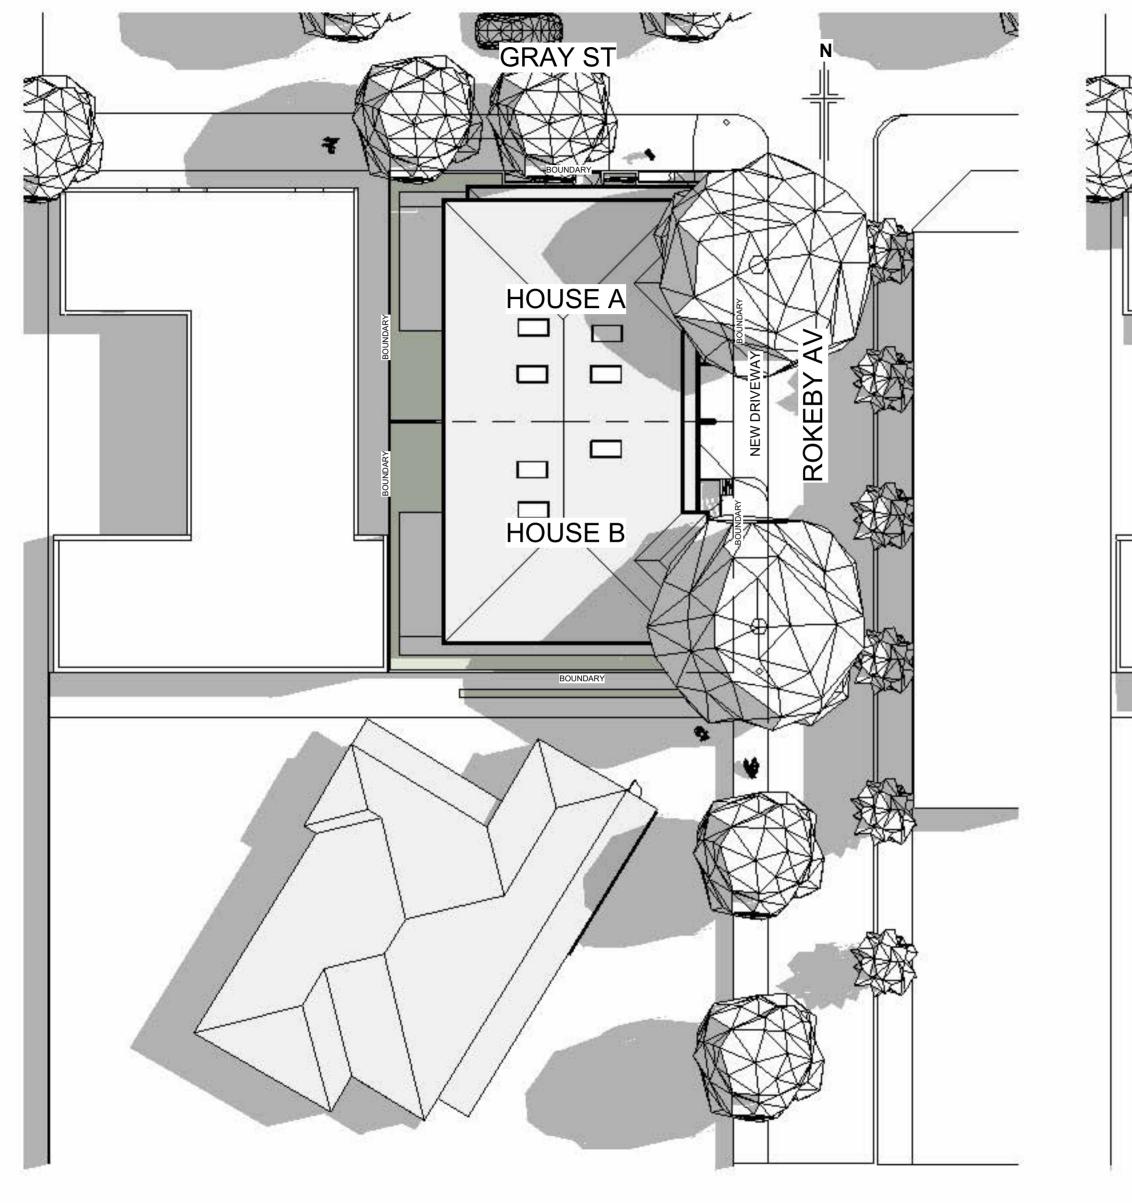
1 SITE PLAN SUN 9AM 1:200 2 SITE PLAN SUN 12PM 1:200

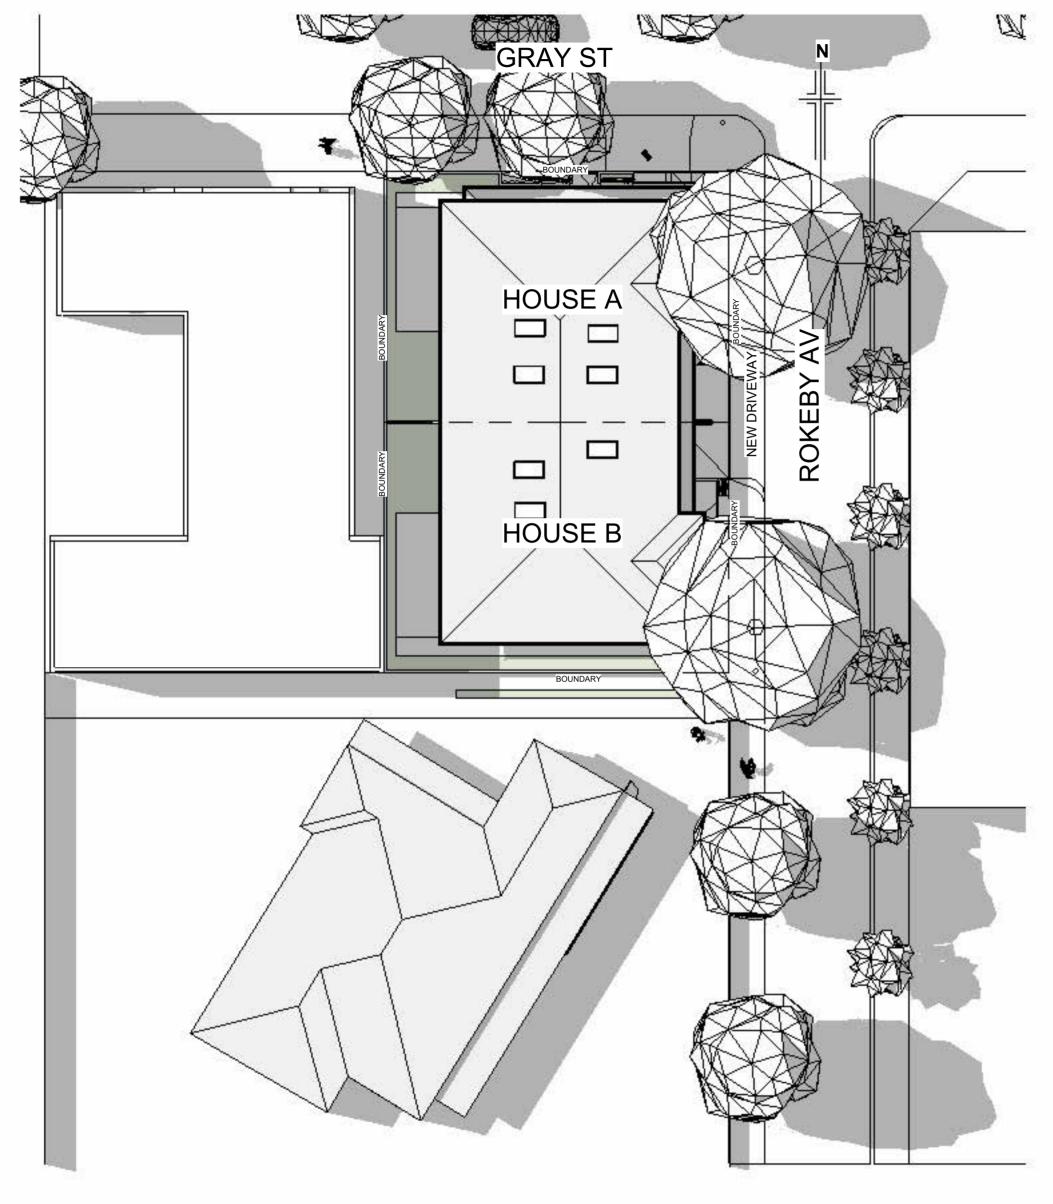
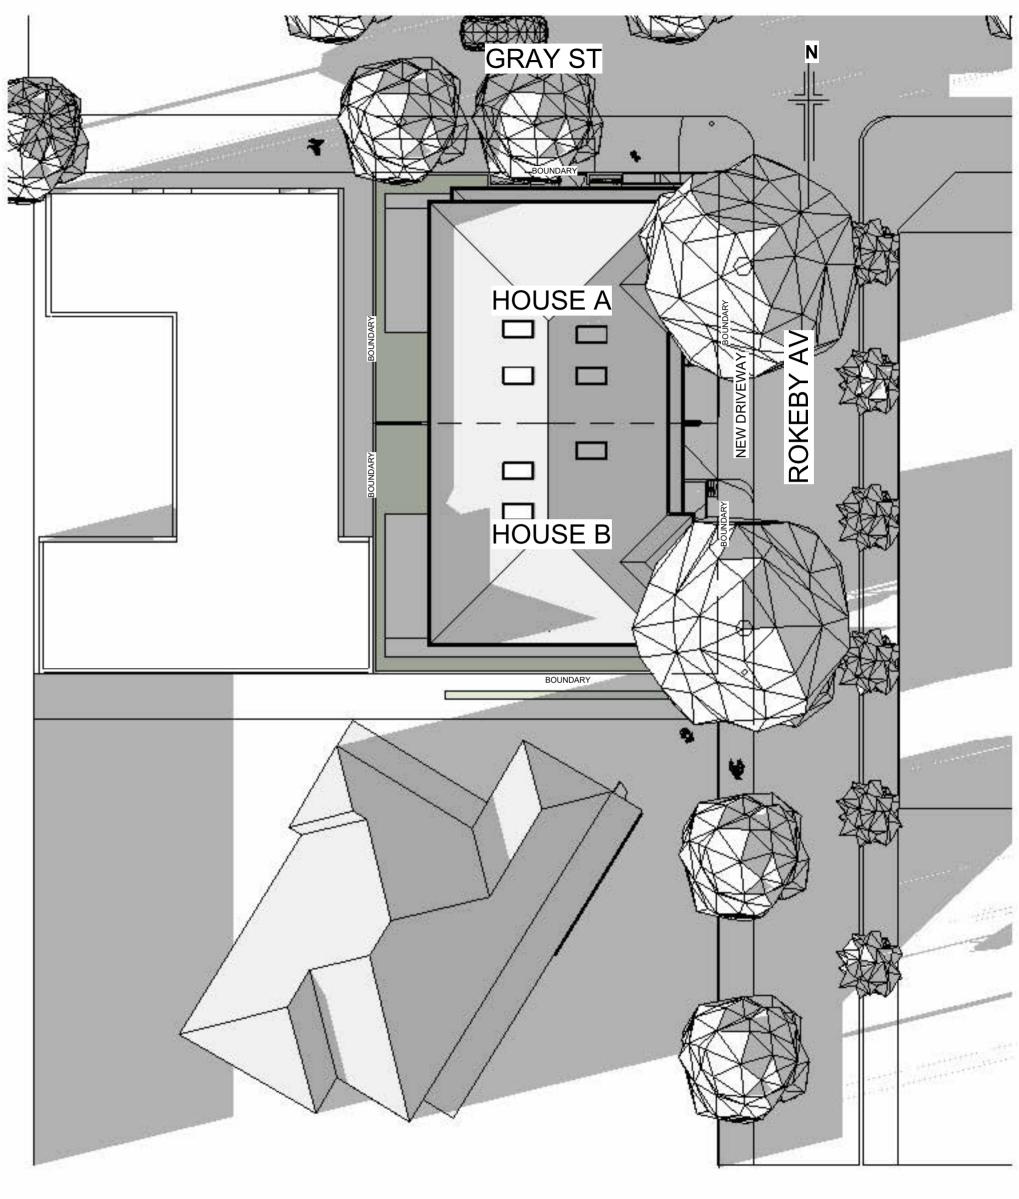
1 SITE PLAN SUN 3PM 1:200 2 SITE PLAN SUN 6PM 1:200

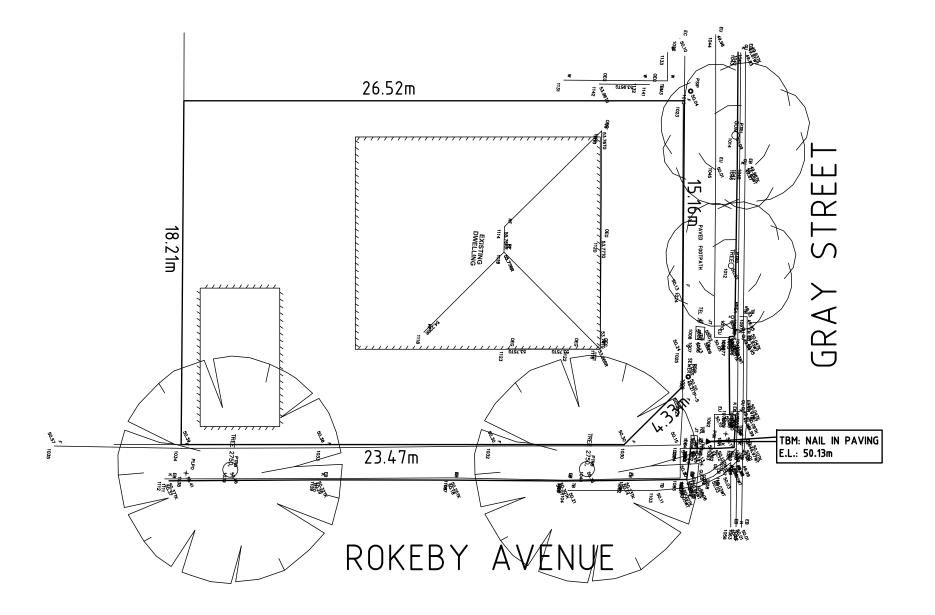
WHERE EXISTING STRUCTURES ARE TO BE REMOVED, PRE-WETTING IS MANDATORY.

A 04.04.23 FOR APPROVAL ΚP PROJECT PROPOSED DEVELOPMENT AT: 10 GRAY STREET NORWOOD FOR: AC DESIGN DRAWING TITLE LEVEL PLAN ENGINEER DATE SCALE DRAWN 1:200 04.04.2023 PROJECT No. DRAWING No. SHEET SIZE BY OTHERS 23-072 **C1 A3 AUSTRUCT** 6 CRITTENDEN ROAD, FINDON, SA, 5023. PH: (08) 8448 2900 Consulting Engineers

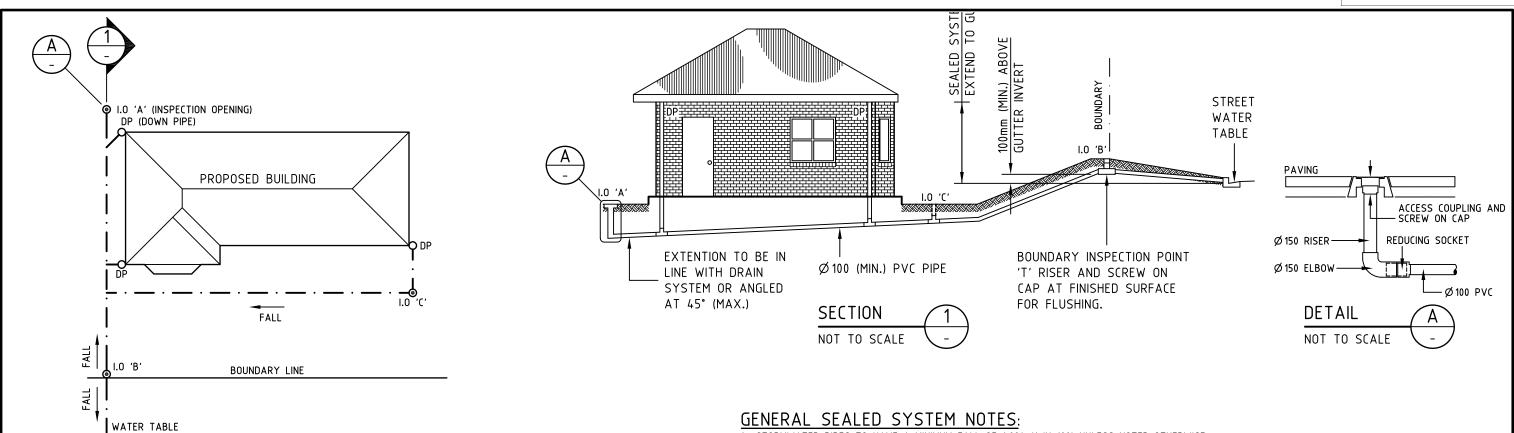
# TYPICAL DOMESTIC SEALED (PRESSURISED) DRAINAGE SYSTEM LAYOUT

#### 3. NO SURFACE INLETS (SUMPS OR GRATED INLET PITS) PERMITTED INTO SEALED SYSTEM. 4. PROVIDE LEAF GUARDS AT DOWN PIPE INLETS.

2. DO NOT USE SEAMED SHEET METAL DOWN PIPES OR FITTINGS WITH A PRESSUREISED SYSTEM.

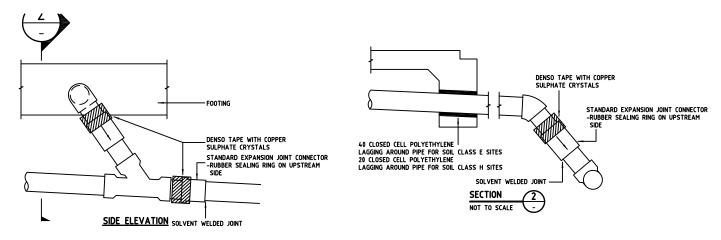
## STORMWATER & SEWER FLEXIBLE SERVICE CONNECTION DETAILS FOR CLASS 'H' & 'E' SITES NOT TO SCALE

DUE TO THE MOISTURE REACTIVE NATURE OF SOILS ON CLASS 'H' & 'E' SITES, IT IS REQUIRED THAT THE SERVICE PIPES INCLUDE STANDARD EXPANSION TYPE JOINT COUPLINGS. PROVIDE A FLEXIBLE CONNECTION TO PIPE IN ACCORDANCE WITH THE FOLLOWING;

- 1. CONNECTIONS ARE REQUIRED AT EACH LOCATION WHERE PIPES (50mm OR LARGER) PENETRATE OR PASS BENEATH THE EXTERNAL FOOTING BEAMS.
- 2. TWO EXPANSION JOINT CONNECTORS ARE REQUIRED, AS DETAILED ABOVE, AT EACH CONNECTION..
- 3. THE DENSO TAPE MUST BE SPRINKLED WITH COPPER SULPHATE CRYSTALS PRIOR TO WRAPPING AND MUST EXTEND 50mm BEYOND THE JOINT ON EITHER SIDE.
- 4. DETAILS ARE APPLICABLE TO TO SEWER AND STORMWATER
- REFER TO THE CONSTRUCTION/GEOTECHNICAL REPORT FOR SOIL CLASSIFICATION.

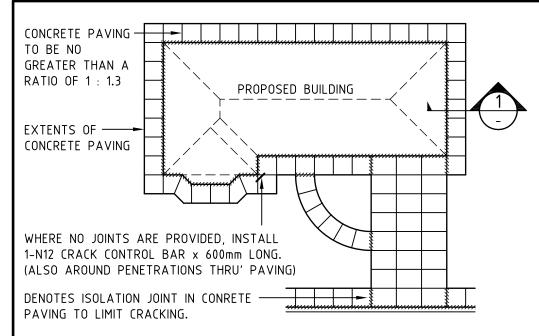
## TYPICAL CONCRETE PAVING LAYOUT AROUND BUILDING

- UNLESS NOTED OTHERWISE, PAVED AREAS SHALL HAVE A MINIMUM WIDTH OF 900mm. A PREFERABLE WIDTH OF 1200mm SHOULD BE ADOPTED FOR CLASS 'E-D' SITES.
- 2. WHERE CONCRETE PAVEMENTS ARE ADOPTED, REFER TO THE TABLE BELOW:

- B. PAVEMENTS SHALL NOT BREACH THE DAMP PROOF COURSE OR BUILT-IN DAMP PROOF MEMBRANE UNLESS OTHER ADEQUATE DAMP-PROOFING MEASURES HAVE BEEN TAKEN.
- REACTIVE SOILS MAY CAUSE PAVING TO SEPERATE HORIZONTALLY FROM THE BUILDING PERIMETER.
   IT IS IMPORTANT THAT ANY GAPS BETWEEN THE BUILDING AND PAVING BE IMMEDIATLEY SEALED WITH A FLEXIBLE MASTIC SEALANT.

- 10. PROVIDE EGDE DRAINS WHERE NECESSARY TO DIVERT RUNOOF CLEAR OF THE BUILDING.
- 11. PROVIDE TERMITE PROTECTION TO AS 3660.1.

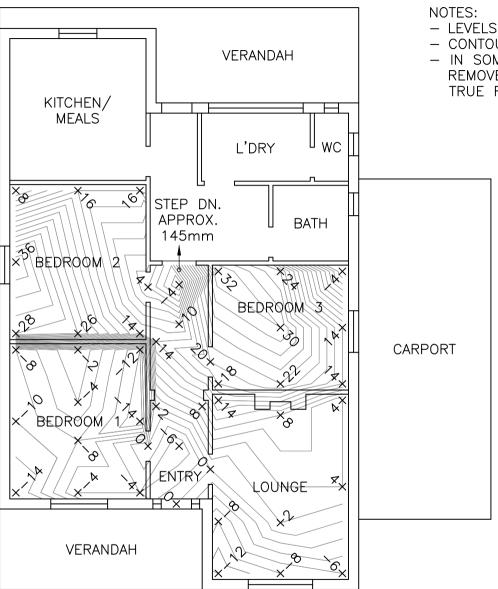
- LEVELS ARE SHOWN IN MILLIMETRES.
- CONTOURS ARE SHOWN AT 2mm INTERVALS.
- IN SOME AREAS THE CARPET WAS WORN OR HAD BEEN REMOVED, AND THE RECORDED LEVELS MAY NOT BE A TRUE REPRESENTATION OF THE TIMBER FLOOR BELOW.

- Floor Level Survey - Drawing No. 23186-1

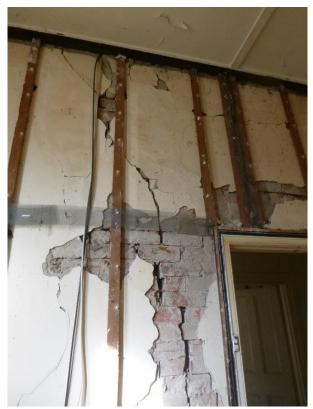
Major cracking - Lounge

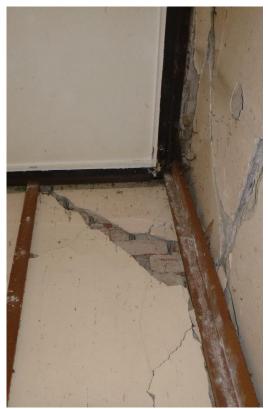
Major cracking - Lounge

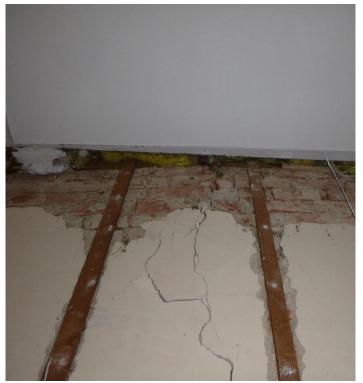
Severe bow in internal wall - Bedroom 1

During their second inspection of the dwelling, Imparta observed the bowing/leaning of the northern and eastern walls of the southern bedroom. Additionally, and most notably, their engineer also observed that the removal of the plasterboard exposed significant cracking to the two front (eastern) rooms of the dwelling and the middle southern room (labelled as Living Room by Imparta and Bed 2 by others), that could be classified as within or beyond Damage Category 4 (AS 2870-2011), i.e. >15mm width. Imparta opined that this damage 'warrants, at least, local reconstruction of the affected walls down to sound brickwork'. The extent of reconstruction required, however, would be subject to further investigation by a masonry contractor.

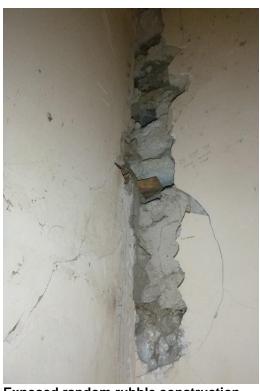
Exposed random rubble construction – Bedroom 1

Magryn observed significant (>15mm) cracking to several of the walls that were not previously observed by TMK or Imparta, with some up to 45mm in width. Further, some walls were noted to be of 'random rubble construction, with minimal to no mortar'. Otherwise, Magryn's observations were similar to those of TMK and Imparta previously.

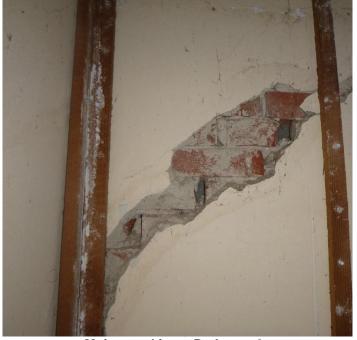
Major cracking - Bedroom 2

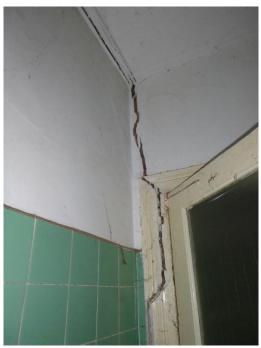
Major cracking - Bathroom

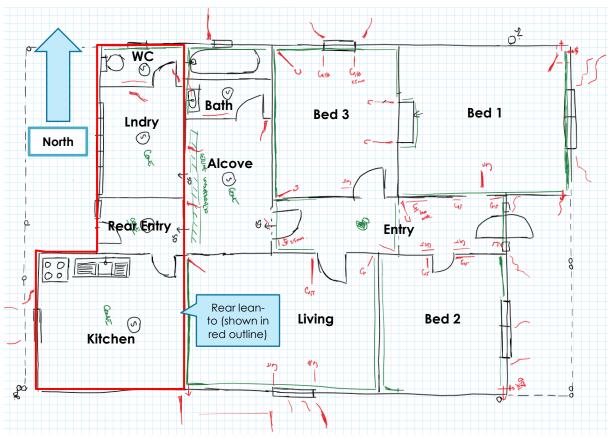
Figure 2 – **Red** is damage to walls, **green** is damage to ceilings & cornices, **blue** is damage to floors, **yellow** highlighting indicate the most severe settlement that may require structural correction

Due to the number of instances of damage identified, we have not included each in our report. We have included the most significant items for your consideration. We have included a copy of our site notes, which shows the instances of internal damage marked up on a floor plan of the building, as Figure 2 below. Should a more comprehensive catalogue of cracking be required, we would be pleased to provide it upon receipt of your further instructions.

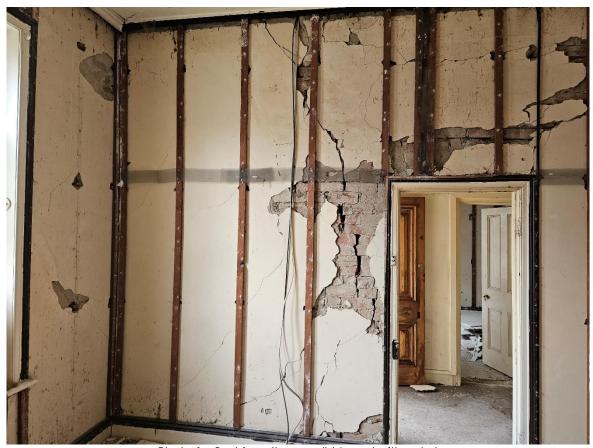
Photo 1 – Bed 1 southern wall (shared with entry)

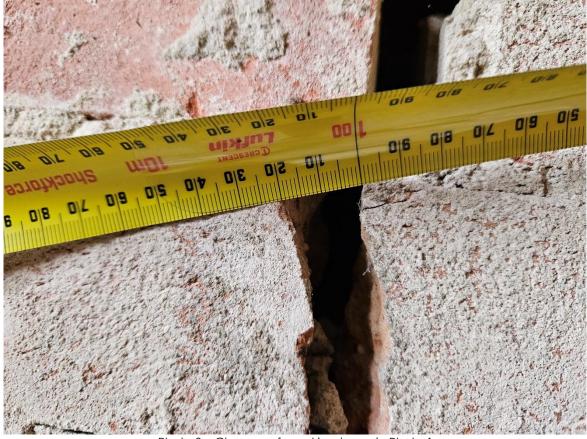
Photo 2 – Close up of crackingshown in Photo 1

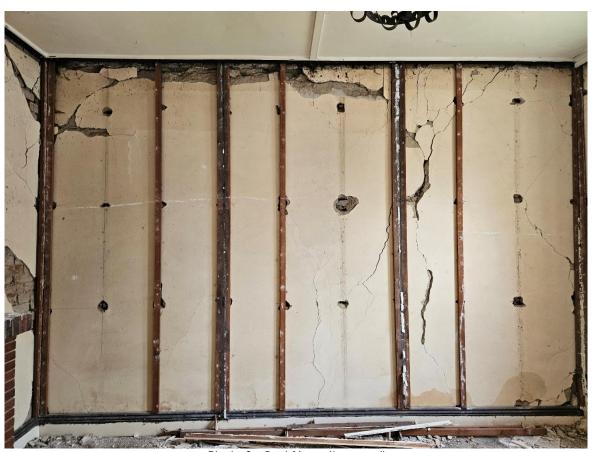
Photo 3 – Bed 1's northern wall

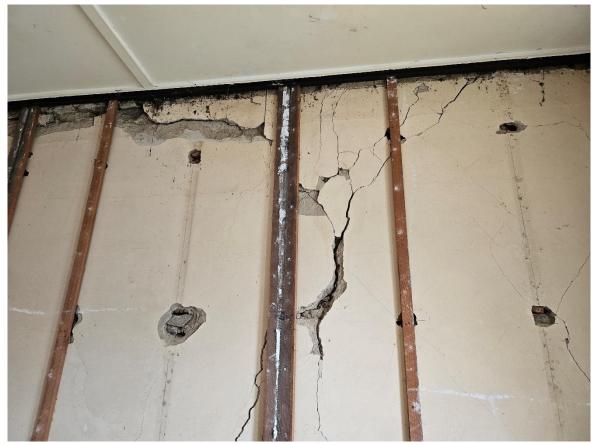
Photo 4 – Bed 1's northern wall

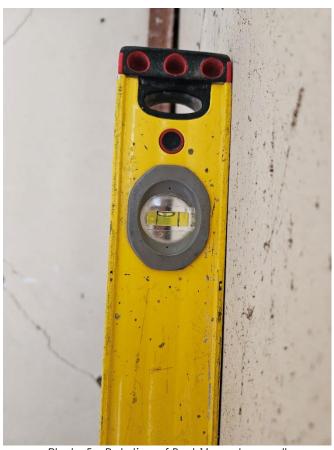
Photo 5 – Rotation of Bed 1's eastern wall

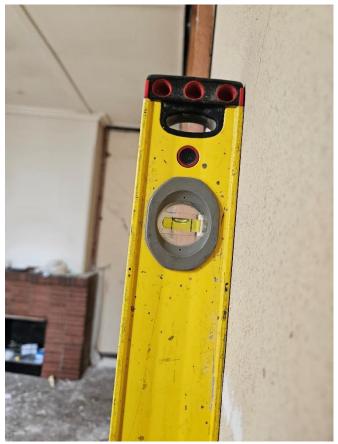
Photo 6 – Rotation of Bed 1's northern wall

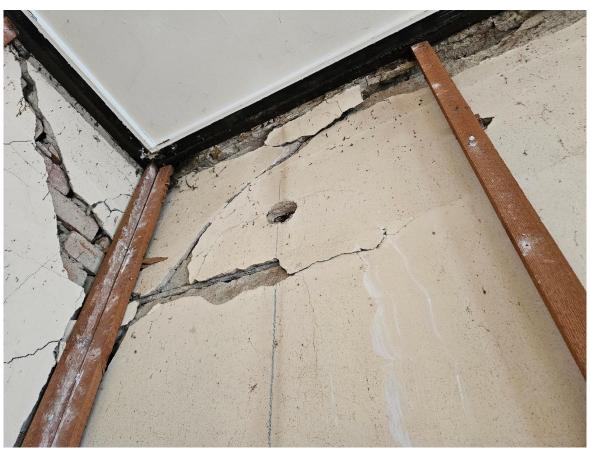
Photo 7 – Tie-rod chased into norhtern wall of Bed 1, distortion to walls and deterioration of plaster

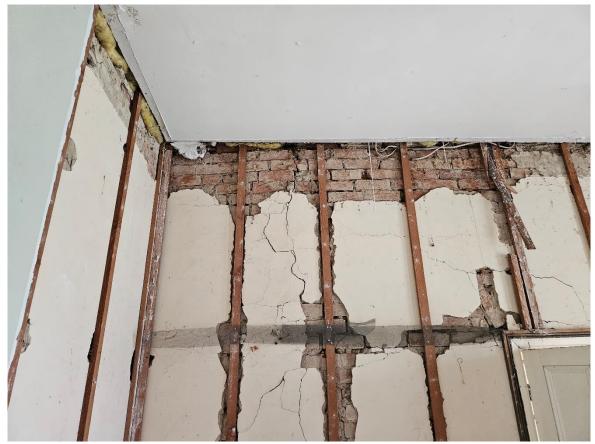
Photo 8 – Bed 2's northern wall, brickwork to top half of wall requires reconstruction

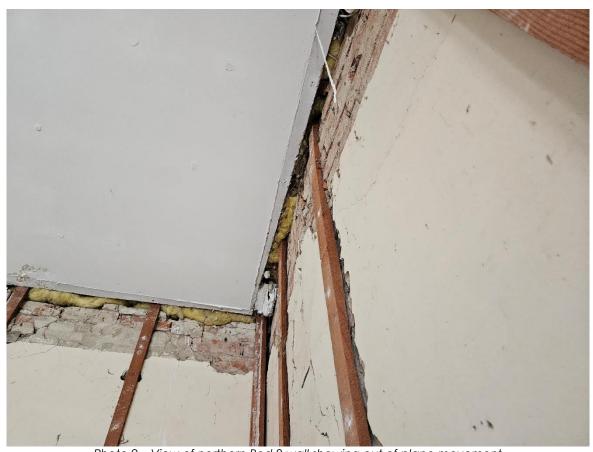
Photo 9 – View of northern Bed 2 wall showing out of plane movement

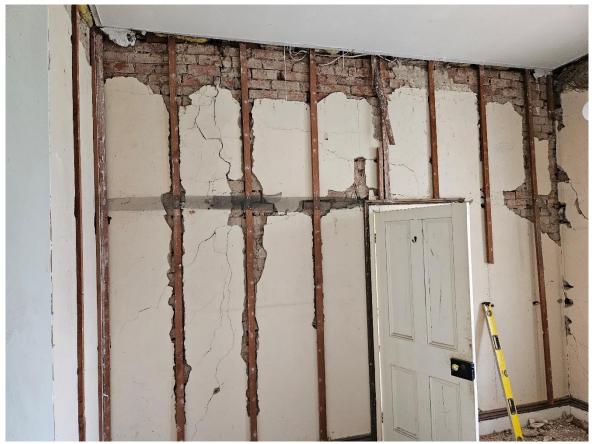
Photo 10 – Overall view of Bed 2's northern wall showing conditino of plaster

Photo 10

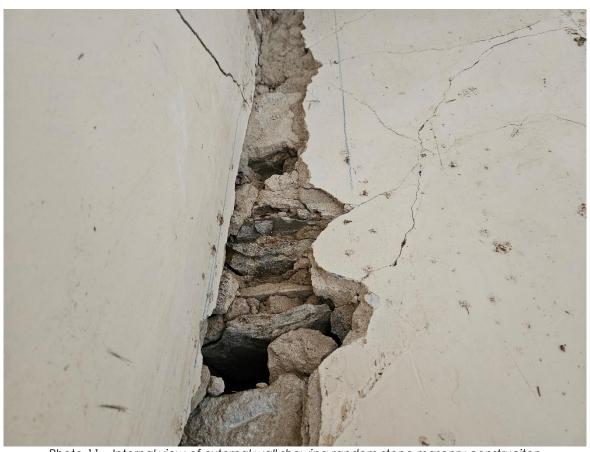
Photo 11 – Internal view of external wall showing random stone masonry construciton

Photo 11

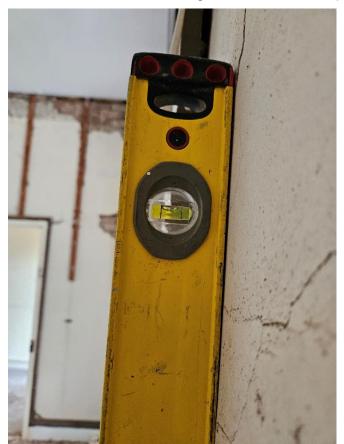
Photo 12 – Rotation of Bed 2's eastern wall consistent with long-term settlment towards east

Photo 12

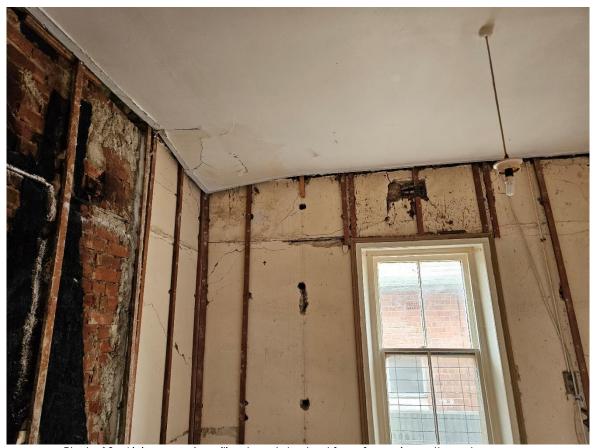
Photo 13 – Living room's ceiling has detached from frame in south-eastern corner

Photo 13

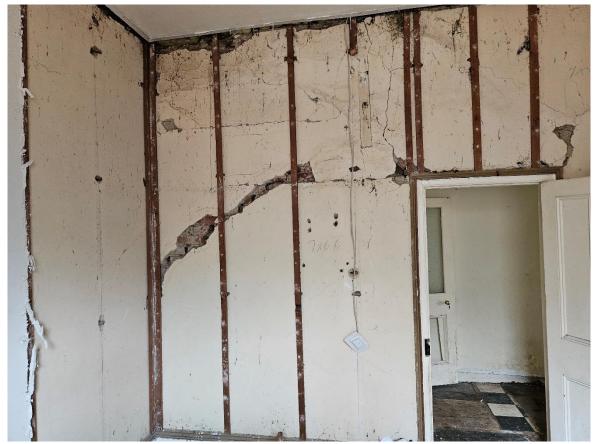
Photo 14 – Overall veiw of living room's northern wall

Photo 14

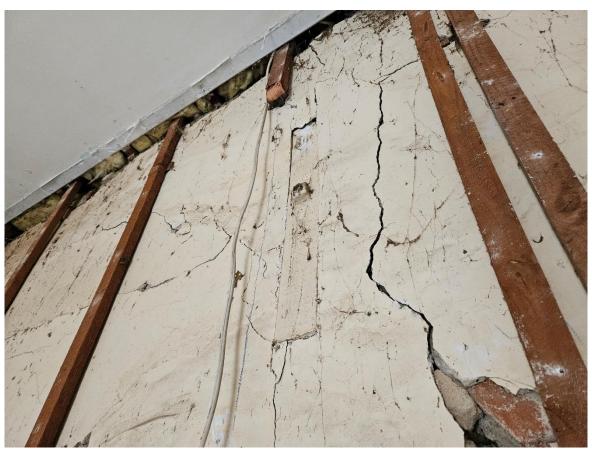
Photo 15 – Tie rod end plate in Living room's northern wall, rotation of brickwork around end plate

Photo 15

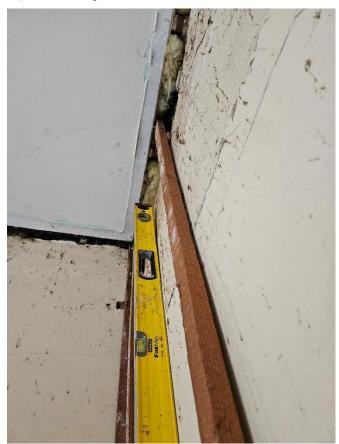
Photo 16 – Gap between straight edge and living room's northern wall shows distortion to top brick courses

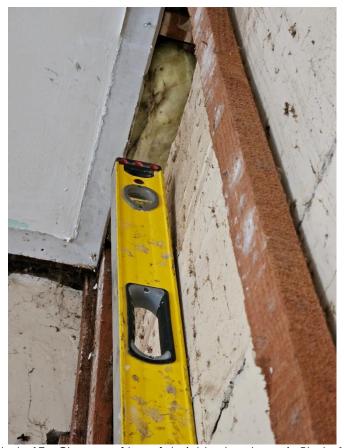
Photo 17 - Close up of top of straight edge shown in Photo 16

Photo 17

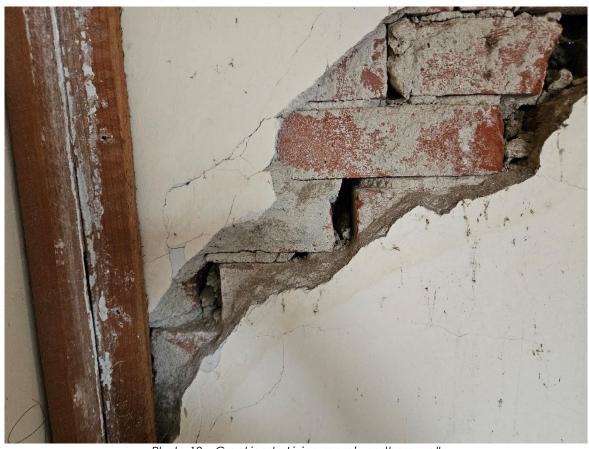
Photo 18 – Cracking to Living room's northern wall

Photo 18

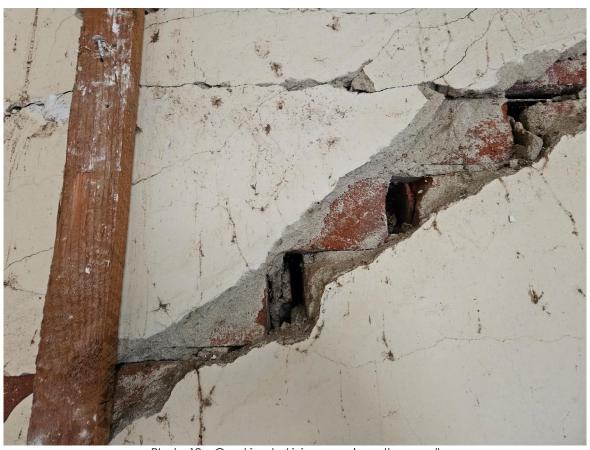
Photo 19 – Cracking to Living room's northern wall

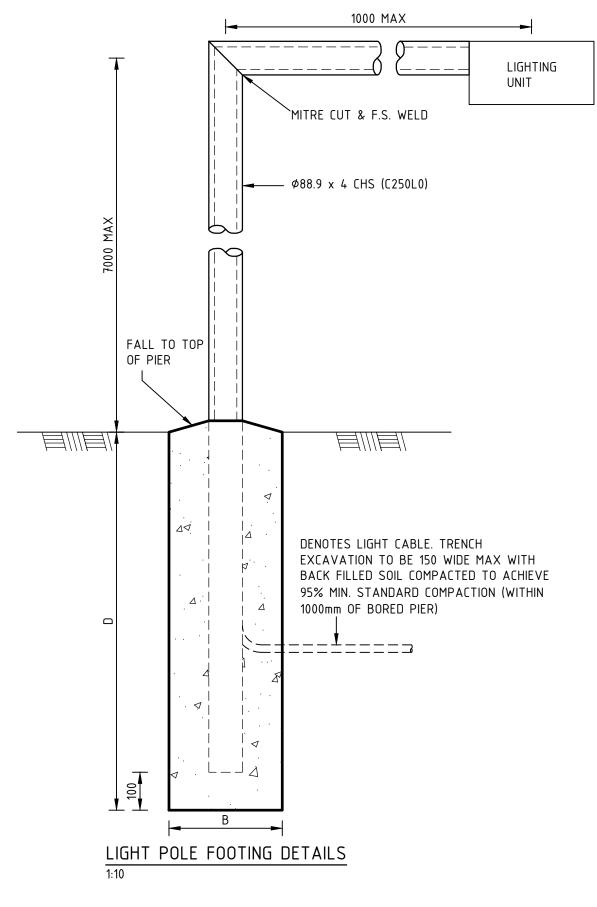
- MAXIMUM LIGHT POLE HEIGHT 7 m.
- 2. MAXIMUM LIGHTING UNIT EPA 0.25 m<sup>2</sup> (EFFECTIVE PROJECTED ARFA)
- 3. BORED PIERS TO BE FULLY FOUNDED IN FIRM NATURAL GROUND OR CERTIFIED COMPACTED FILL, CONCRETE GRADE TO BE MIN. 25 MPa (REFER TO ATTACHMENT SDN)
- 4. THIS DESIGN ALLOWS FOR A MAXIMUM WIND SPEED OF 39 m/s (BASED ON AN IMPORTANCE LEVEL 1 STRUCTURE, TERRAIN CATEGORY 2, WIND REGION A).
- SOIL DESCRIPTION:

'POOR' - SOFT CLAY OF MEDIUM PLASTICITY, CLAYEY SILT, SAND OR LOOSE SANDY SILTS WITH COHESION 0-3 kPa. 'GOOD' - FIRM CLAY OF MEDIUM TO HIGH PLASTICITY, SILTY CLAY, SANDY CLAY WITH COHESION GREATER THAN OR EQUAL TO 4 kPa.

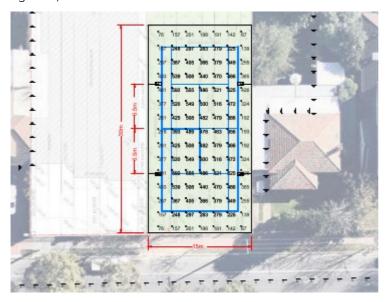
The structures are located within the site and behind the building line of the dwellings on the subject land and 68 Ninth Ave, this assists with mitigating visual impact (see figure 1).

Figure 1 - Proposed siting of the structures behind the building line of adjoining dwellings.
