Council Assessment Panel Agenda & Reports

19 May 2025

DEVELOPMENT NO.:	25003913
APPLICANT:	John Miller and Haley Miller
ADDRESS:	69 HIGH ST KENSINGTON SA 5068
NATURE OF DEVELOPMENT:	Demolition of a dwelling (Local Heritage Place)
ZONING INFORMATION:	<p>Zones:</p> <ul style="list-style-type: none"> • Established Neighbourhood <p>Overlays:</p> <ul style="list-style-type: none"> • Airport Building Heights (Regulated) • Historic Area • Heritage Adjacency • Hazards (Flooding - General) • Local Heritage Place • Prescribed Wells Area • Regulated and Significant Tree • Stormwater Management • Urban Tree Canopy <p>Technical Numeric Variations (TNVs):</p> <ul style="list-style-type: none"> • Minimum Site Area (Minimum site area is 400 sqm) • Maximum Building Height (Levels) (Maximum building height is 2 levels)
LODGEMENT DATE:	17 Feb 2025
RELEVANT AUTHORITY:	Assessment panel/Assessment manager at City of Norwood, Payneham and St. Peters
PLANNING & DESIGN CODE VERSION:	P&D Code (in effect) Version 2025.3 13/2/2025

RE: CRACKING IN EXISTING DWELLING - 69 High St, Kensington SA 5068

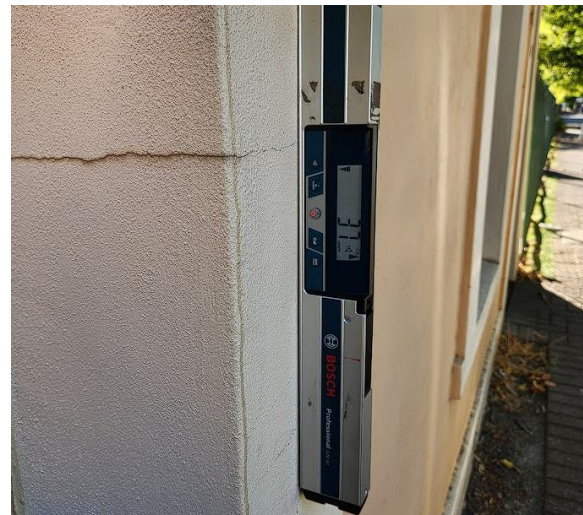
Rotation of southern wall on western end.

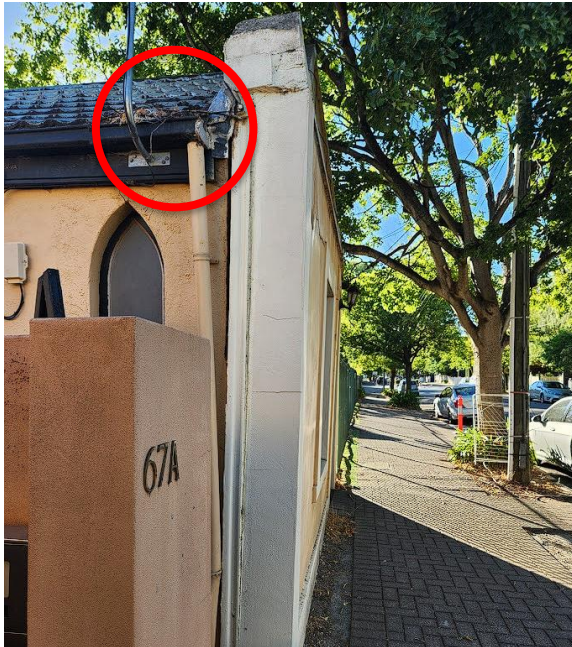
Significant leaning of front wall. Gutter filled with debris.

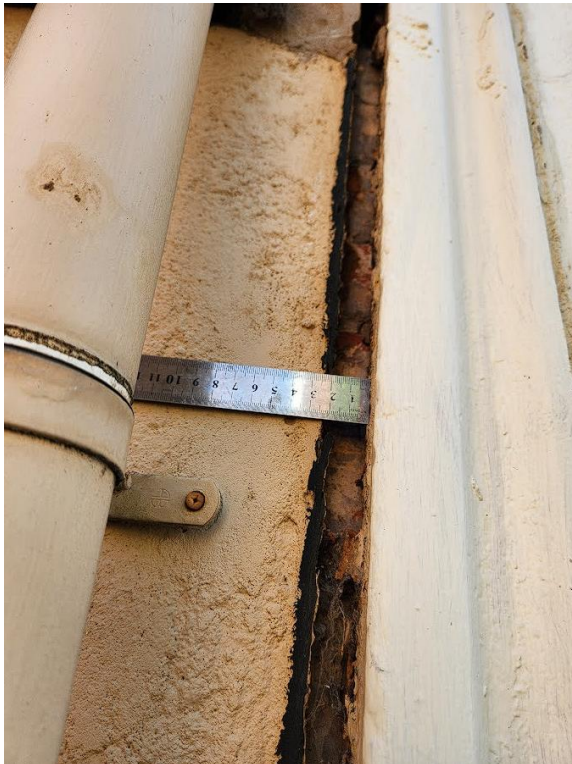
Measurement of separation between render and southern wall.

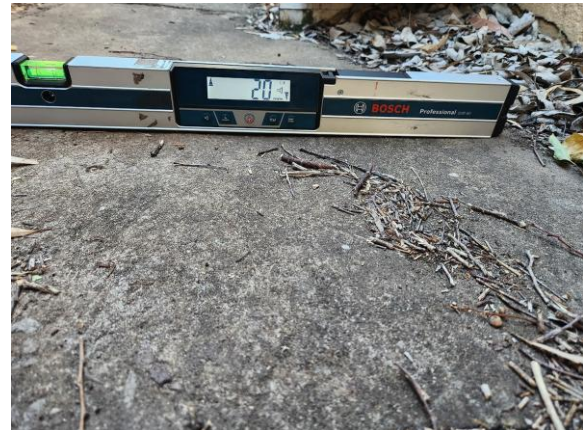
Fall of western perimeter paving away from building.

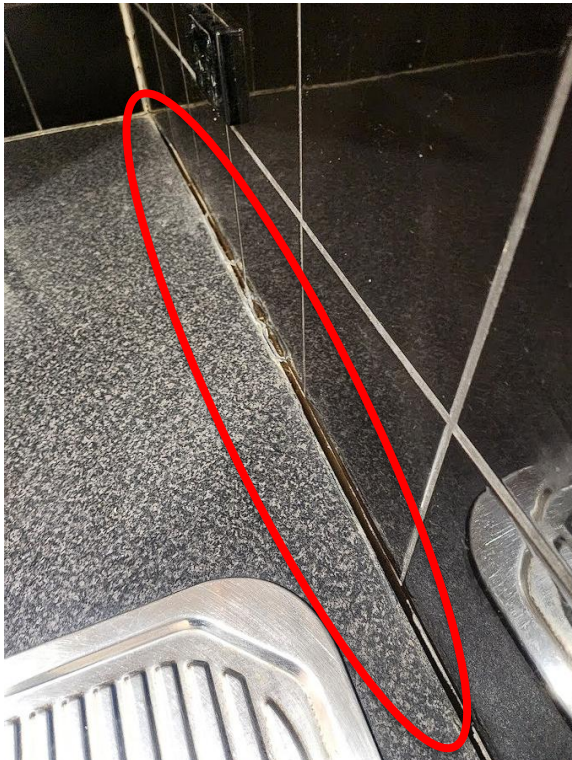
- Western wall was leaning 25mm/m to the west to the south of the kitchen window.
- 8mm separation between kitchen benchtop and wall near kitchen window, indicating movement of the western wall to the west. Separation was noted to be 17mm near southwestern corner of room.
- Separation of cornice from wall near kitchen window.
- 10mm vertical cracking in southwestern corner. Bed 2 was visible through the cracking.
- 1mm horizontal cracking to ceiling at entry to kitchen from corridor.
- Plaster debonded from wall in northeastern corner of room.
- Separation of cornice from wall in northeastern corner of room.

Separation of kitchen benchtop from western wall, indicating rotation of wall.

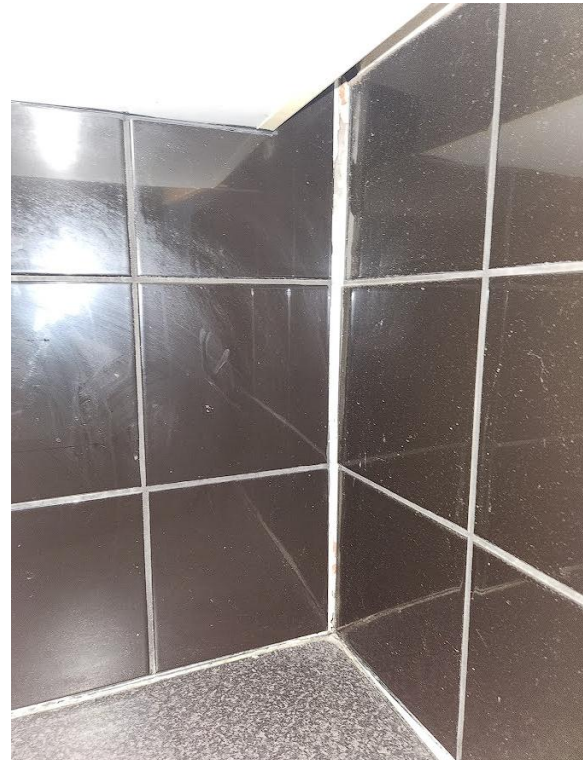
Separation in southwestern corner of room, indicating rotation of wall.

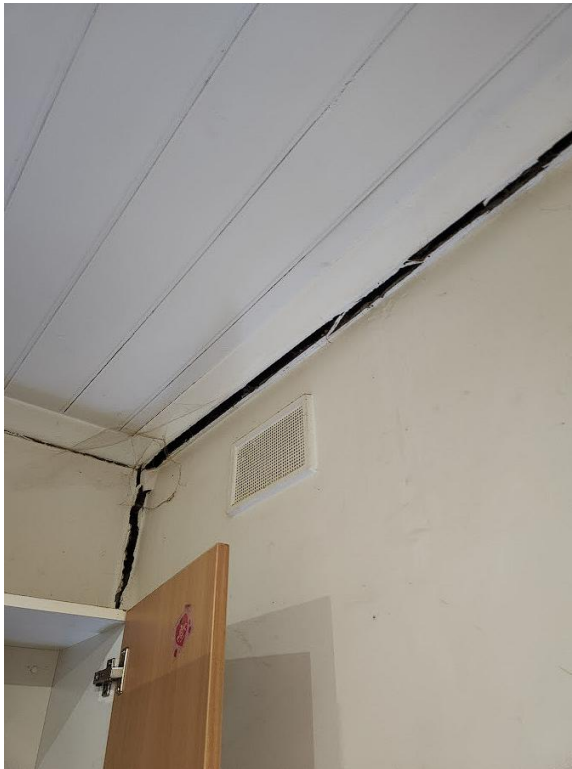
Separation of cornice from western wall, indicating rotation of wall.

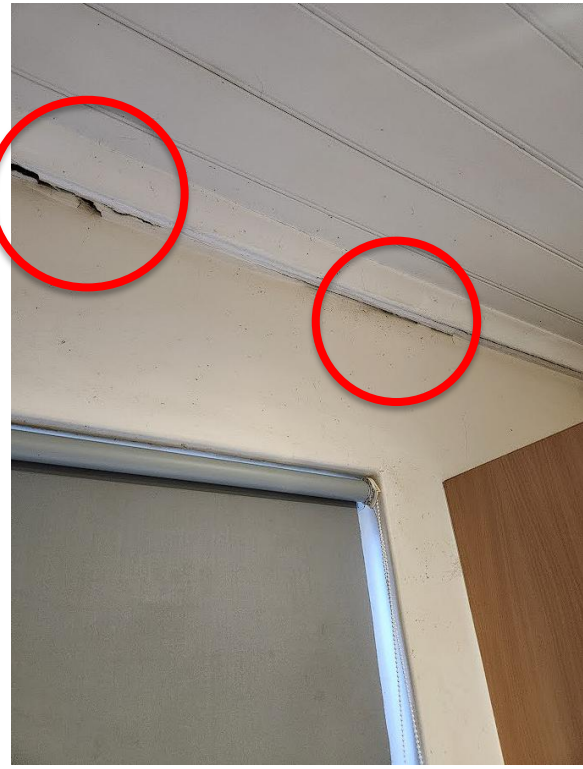
Separation of cornice from western wall was less on northern end.

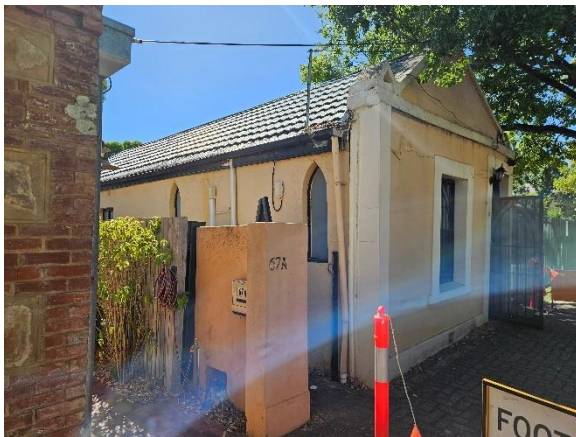
Photo 1 – General view of northern elevation showing lean towards Council footpath and cracking towards top of gable

2. It may be necessary to reconstruct the southern (front) and western elevations and local parts of the return walls to remediate the more severe movement that has occurred to these areas (refer to Figure 3 above and the associated discussion regarding realigning the existing walls).

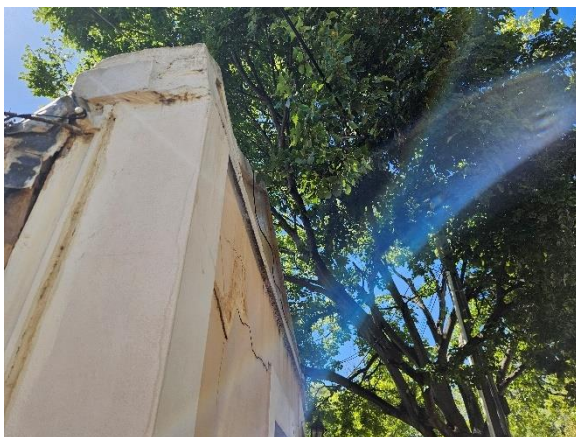
Photo 3 – Side view of top of gable attempting to capture horizontal bow in wall

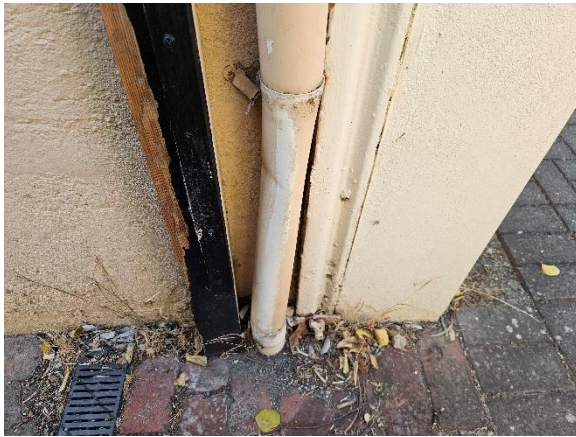
Photo 5 – Railway section positioned against front elevation and assumedly tied through dwelling is indicative of past attempts to stabilise dwelling's front

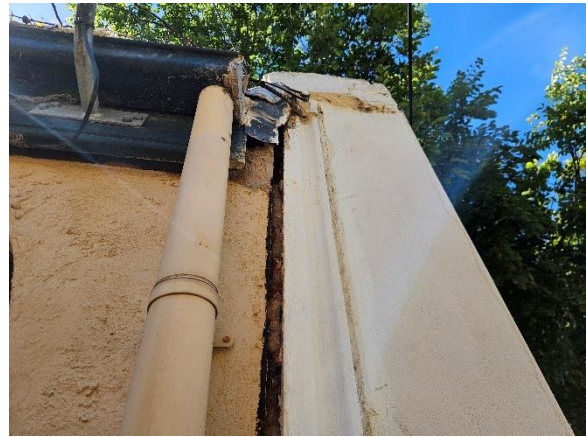
Photo 6 – Tapered separation between railway section and front elevation indicative of worsening in external wall rotation over time

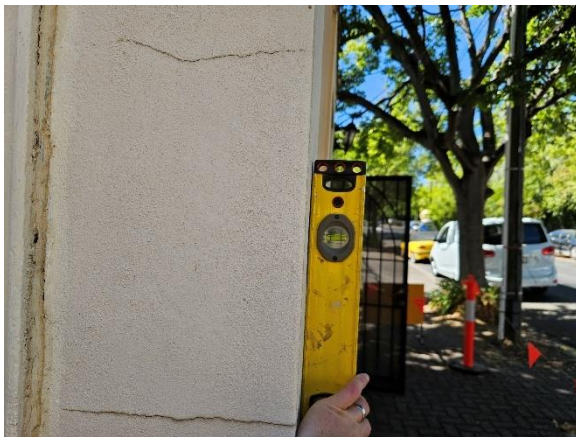
Photo 7 – Spirit level placed against front elevation showing lean towards footpath

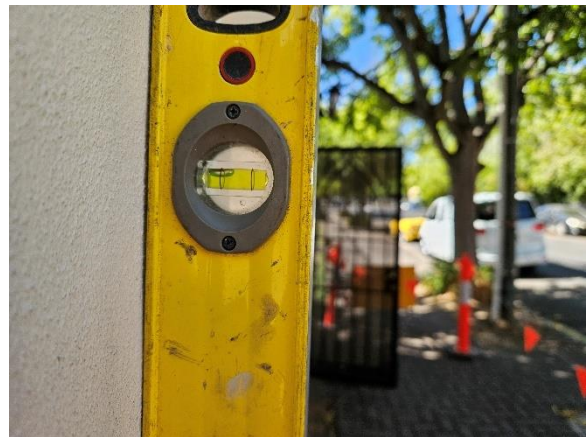
Photo 8 – Close up of spirit level gauge in position shown in Photo 7

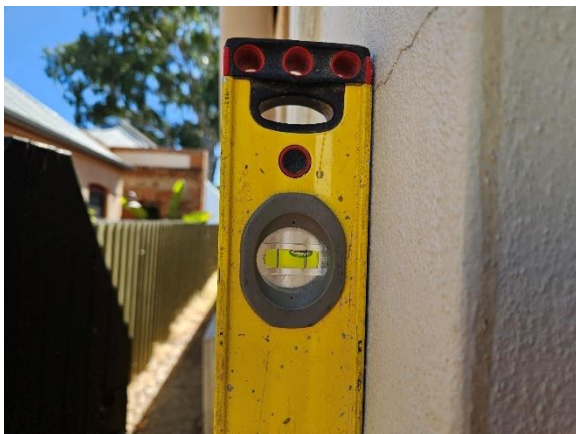
Photo 9 – Spirit level placed against southern end of western elevation showing outward lean towards the adjacent property

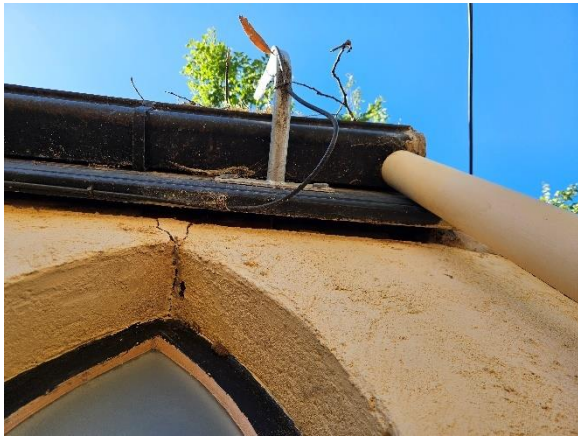
Photo 11 – Separation between western elevation and fascia

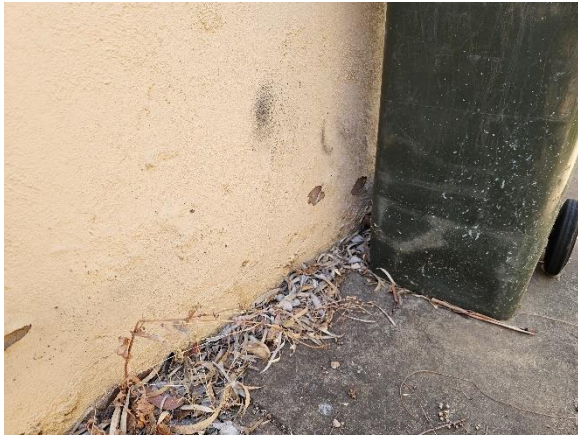
Photo 13 – Bubbling / blistering of lower paint finish along western elevation indicative of rising damp

Damp affected masonry elements would need replacing or repointing (as applicable). However, more severely affected masonry may require local rebuilding. The extent of damp affected masonry that requires the most attention is within the extent suggested be allowed for reconstruction in Figure 3 above.

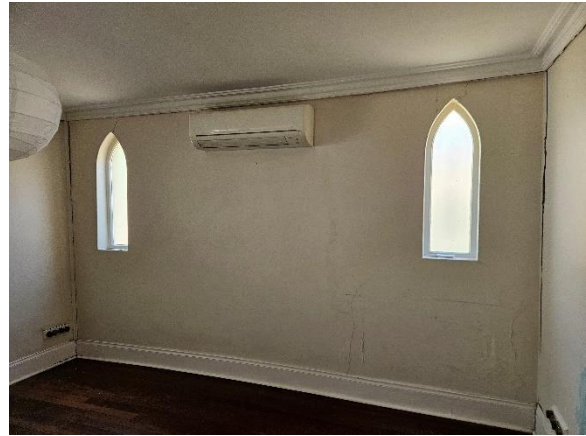
Photo 14 – General view of front lounge room's western elevation

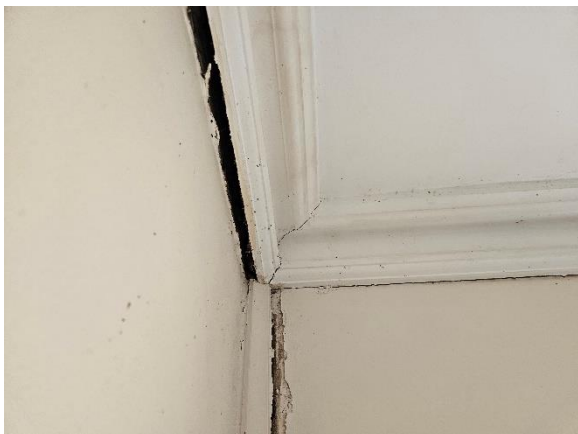
Photo 15 – Gap between front elevation and cornice as well as previous filling, note also separation between corner beading and wall – beading evidence of past attempts to conceal gapping at this wall junction

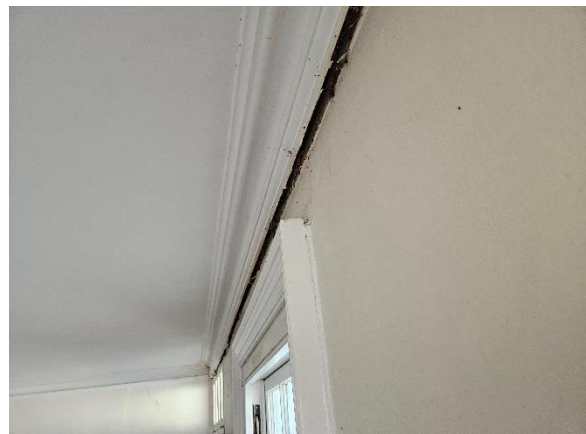
Photo 16 – View of cornice separation along front elevation

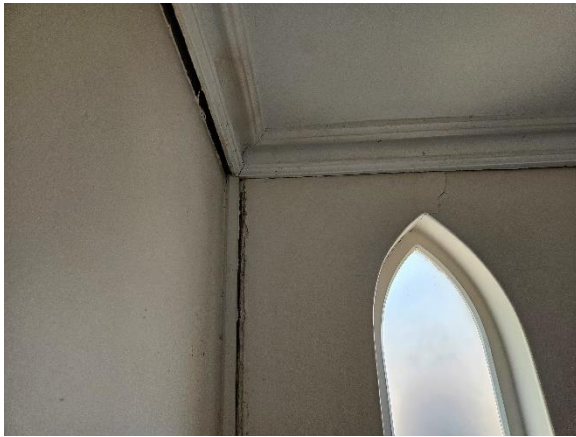
Photo 17 – Broader view of gapping between front elevation and cornice, and at western / front elevation intersection (as shown in closer image in Photo 15)

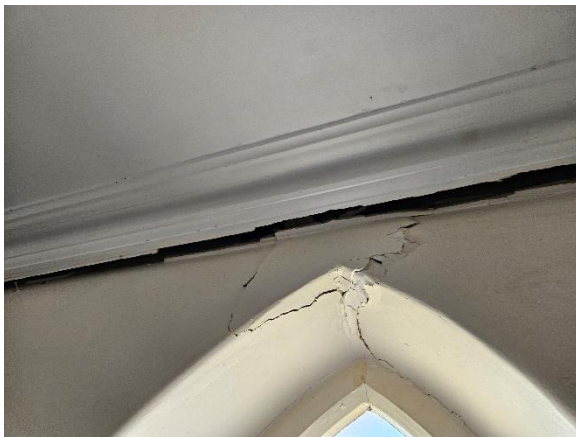
Photo 19 – Cornice separation along western wall, previous crack repairs and recent cracking above window

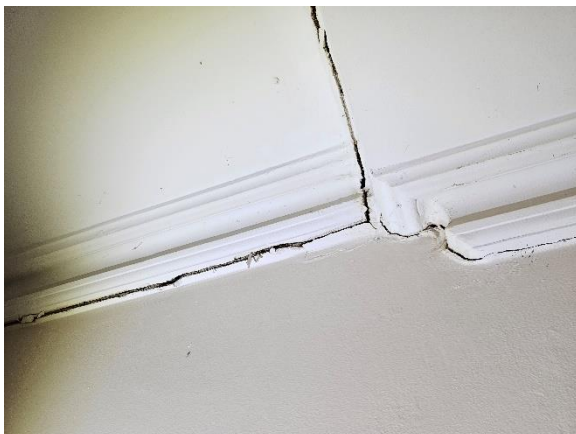
Photo 21 – Example of typical severity of cracking away from area of concern, hallway's eastern wall and cornice / ceiling shown

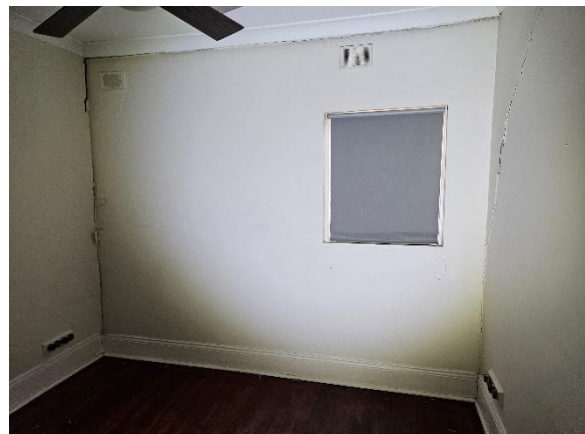
Photo 22 – General view of bed 1's western elevation

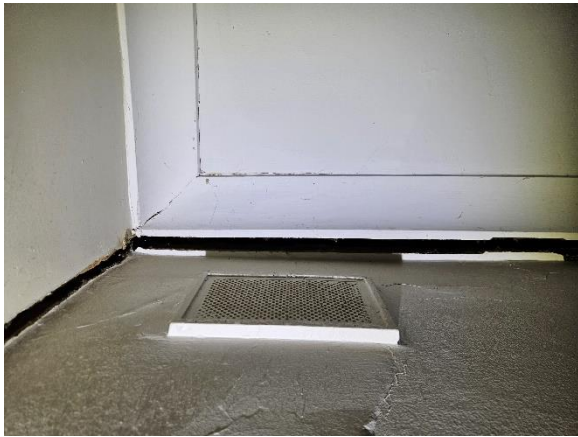
Photo 23 – Separation at bed 1's western wall / cornice junction and intersecting wall

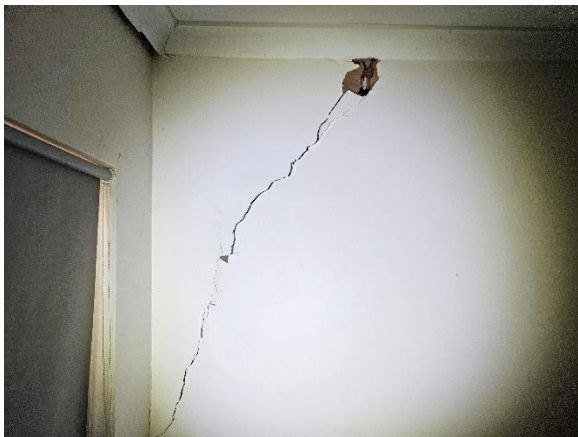
Photo 25 – Cracking to bed 1's northern wall, dislodged of plaster at top of wall makes cracking appear more severe, note also separation of western wall/cornice visible

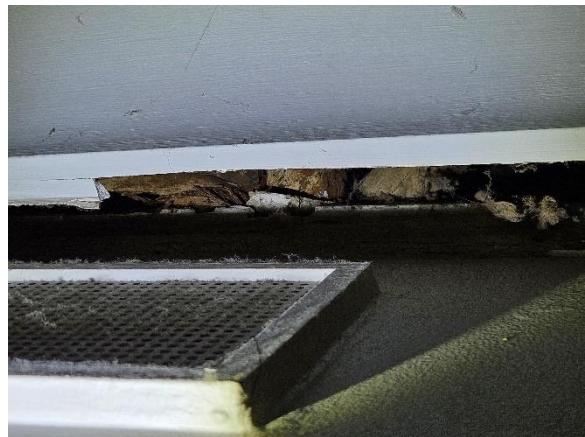
Photo 26 – Separation and missing filler showing possible evidence of timber deterioration

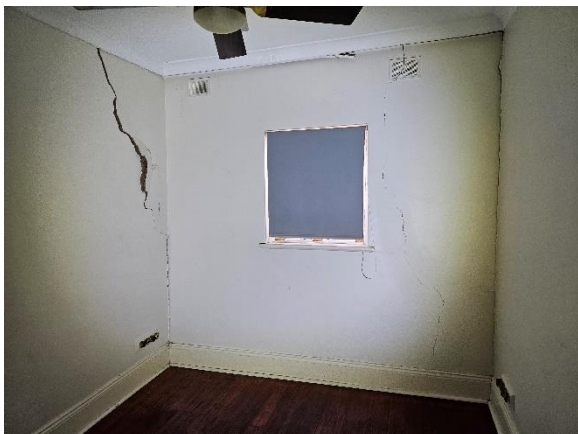
Photo 27 – General view of bed 2's western elevation and intersecting walls

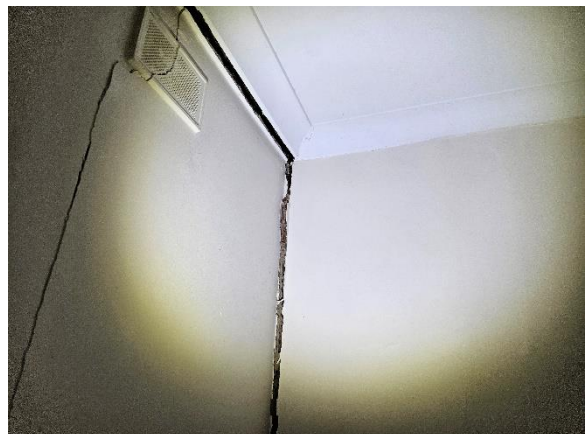
Photo 28 – Separation of bed 1's western wall / cornice, and cracking between western elevation and intersecting wall

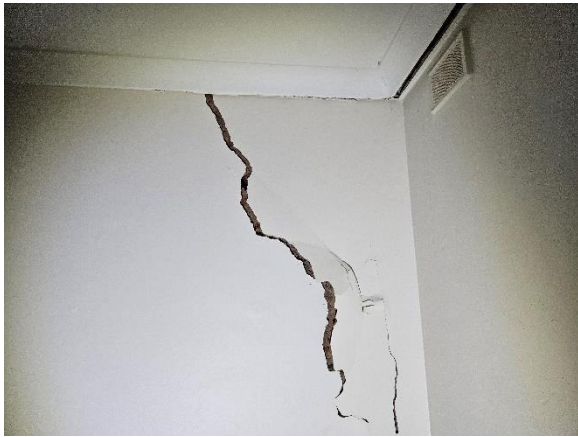
Photo 29 – Cracking to bed 2's southern wall near intersection with western wall, note also separation of western wall / cornice junction

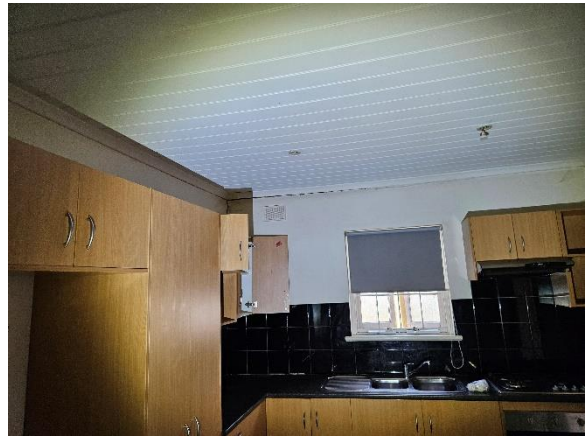
Photo 30 – General view of the kitchen area

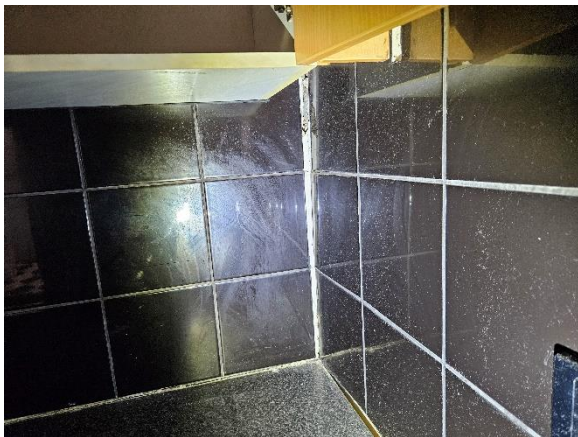
Photo 31 – Tapered vertical cracking in south-western corner of kitchen

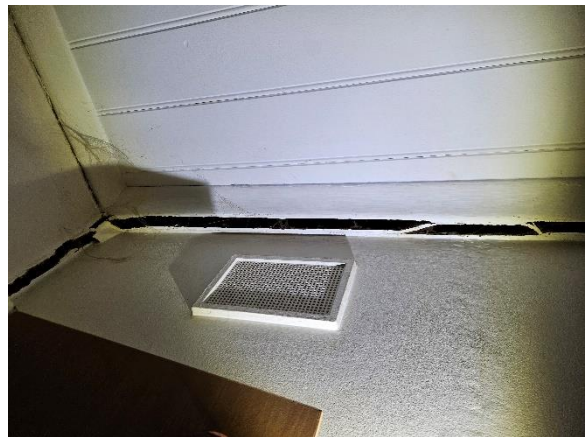
Photo 32 – Top of cracking shown in Photo 31, as well as separation of the western wall / cornice junction (including previous filling material)

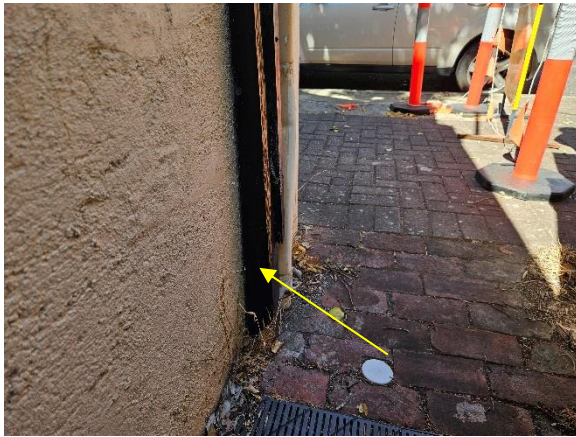
Photo 35 – Tapered wall plate forming part of side gate indicative of past movements to wall (plate thicker at bottom)

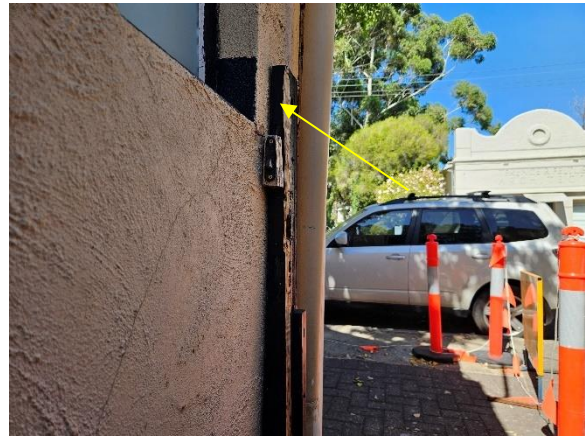
Photo 36 – Tapered wall plate forming part of side gate indicative of past movements to wall (plate thinner at top)
