Council Assessment Panel Agenda & Reports

20 October 2025

1.1. This is an expert report prepared at the request of Mr Nic Wong of Nic Design Studio relating to the condition of the existing house at 7 Stephen Terrace, St Peters, South Australia.

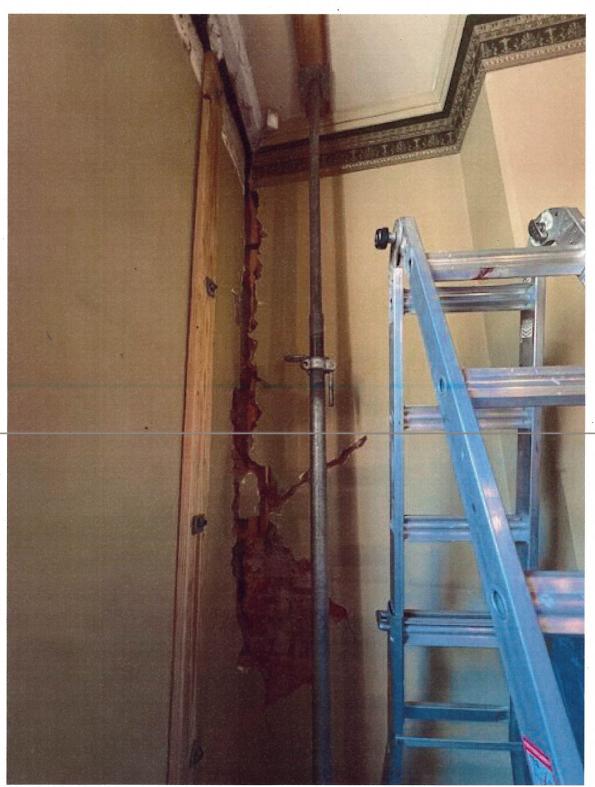
Crack raked out in second room in preparation for side wall being pushed back to plumb.

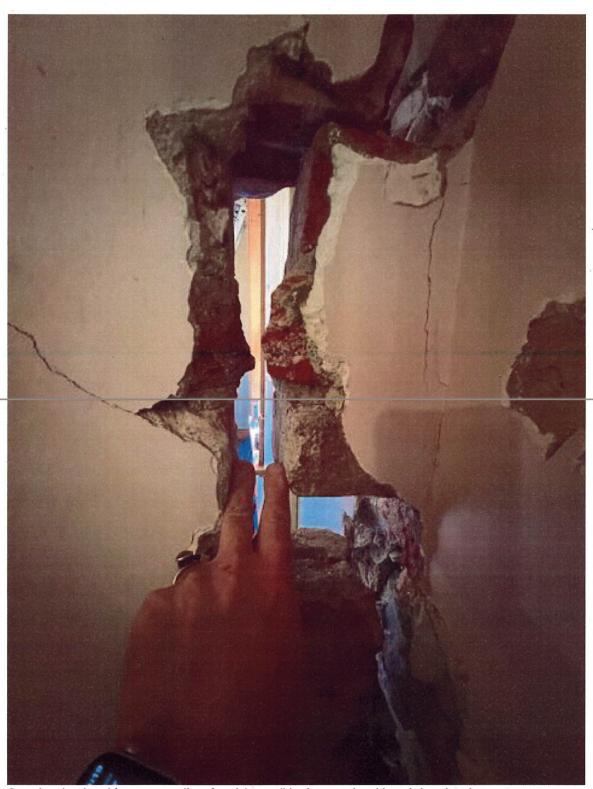
Crack raked out in preparation for side wall being pushed back to plumb.

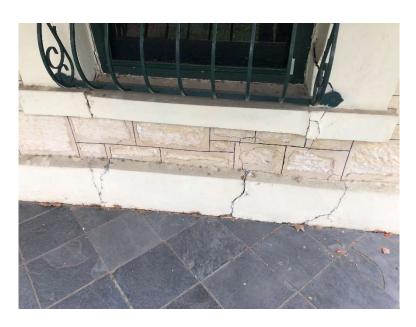
2. Major cracking below front window with sill cracked and sloping

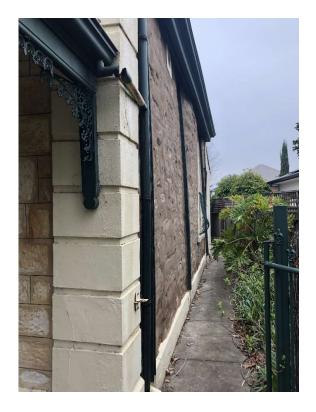
3. South east wall. Steel posts. Severe bowing deformation of masonry wall

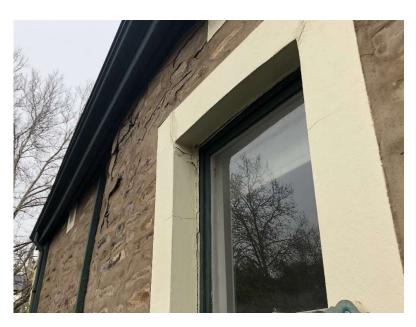
4. South east wall. Severe bowing and cracking deformation of masonry wall

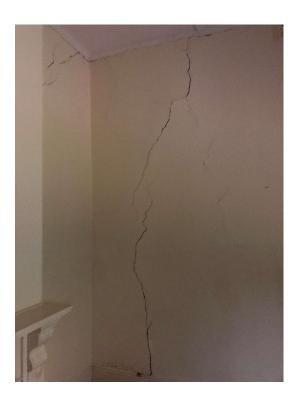
10. Internal view Major cracking and deformation

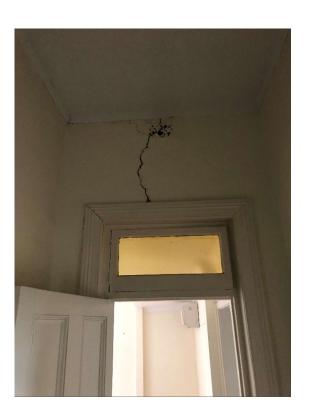
12. Internal view Major cracking and deformation

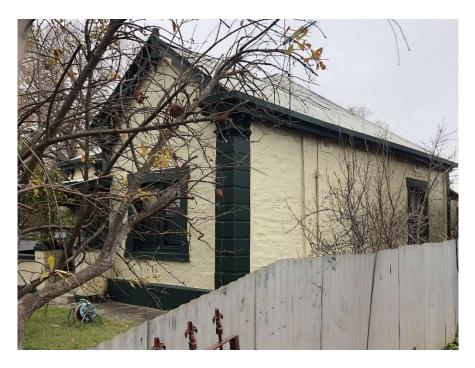
There is villa nearby on the same side of Stephen Terrace of very similar construction, with stone masonry walls and steel restraining posts. It was observed that this structure appears to be in much better condition than the one in question, with no apparent bowing or cracking in the walls visible from a distance. This suggests that the site conditions at 7 Stephen Tce are more reactive. Photos 13, 14.

13. Adjacent villa of similar construction with steel restraining posts. Good condition

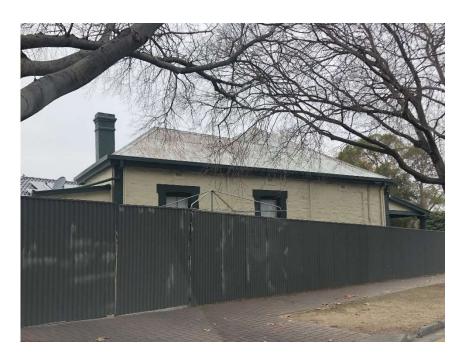
14. Adjacent villa of similar construction with steel restraining posts. Good condition

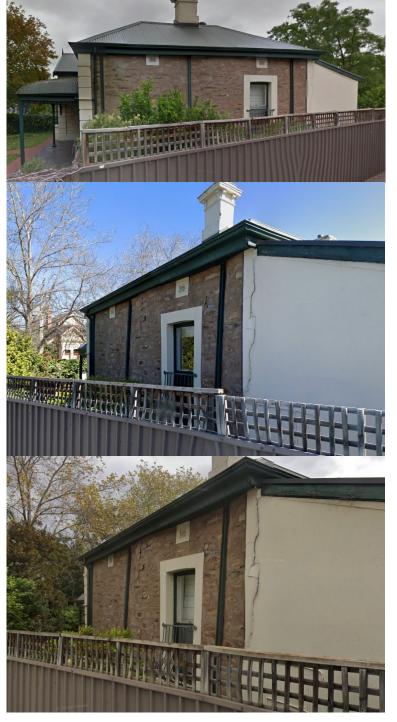
As to whether these rods were over tightened back in the late 1800s is impossible to say. That is an assumption from Mr Wilkinson, as certainly the old photos of the building do not show the walls with the current level of movement or evidence of this over tightening. Google Street View images dating back to 2013 show the eastern wall relatively intact with minimal movement. The western wall back at a similar time had some bowing, but nothing like what is present now. So, it appears the tie rods and supports did a reasonable job until sometime between 2013 and 2020. See the imagery on the following page.

2013 Google Street View image of the eastern wall

2020 Google Street View image of the eastern wall

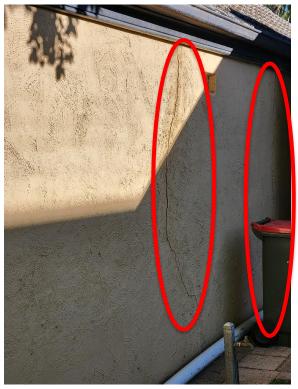
6-7mm diagonal cracking and 3-4mm vertical cracking on eastern boundary wall (from childcare side).

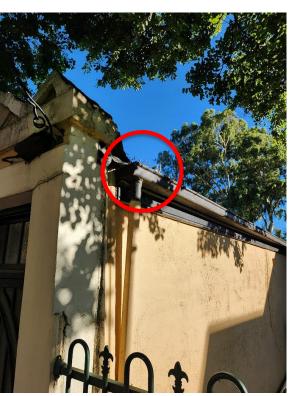
Debris in gutter.

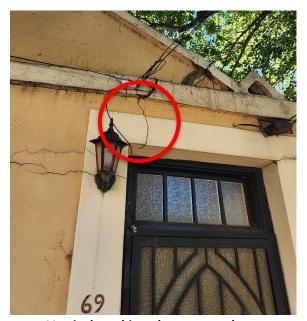
Vertical cracking above entry door.

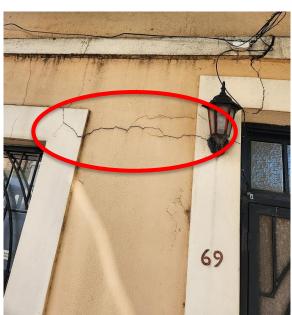
Horizontal cracking west of entry door.

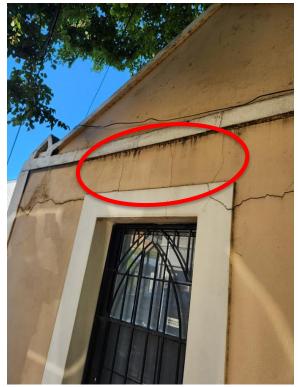
Horizontal and vertical cracking above southern living room window.

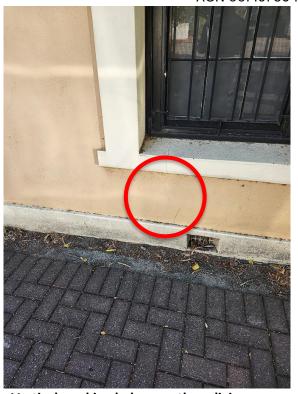
Vertical cracking below southern living room window.

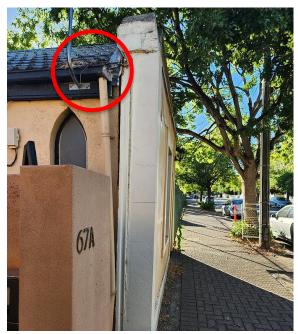
Significant leaning of front wall. Gutter filled with debris.

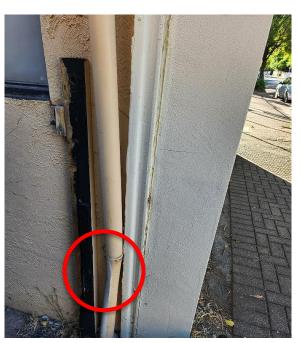
Damaged downpipe and clogged trench drain near side entry door.

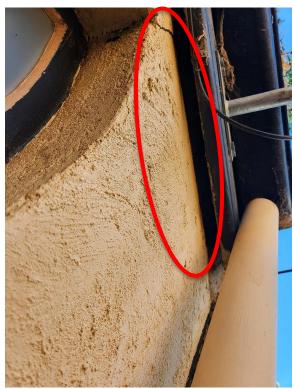
Separation of fascia from wall near southwestern corner of building.

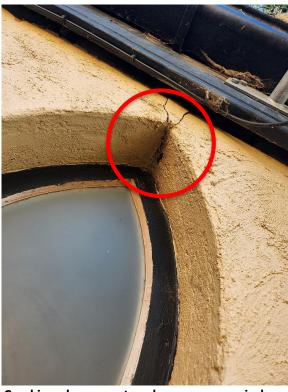
Cracking above western lounge room window.

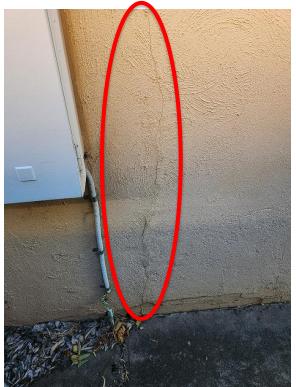
Hairline vertical cracking near meter box.

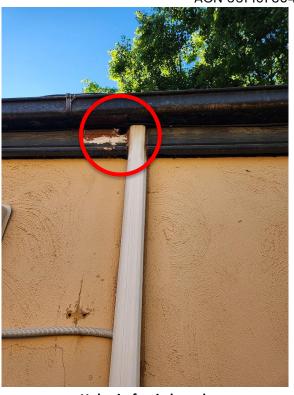
Holes in fascia board.

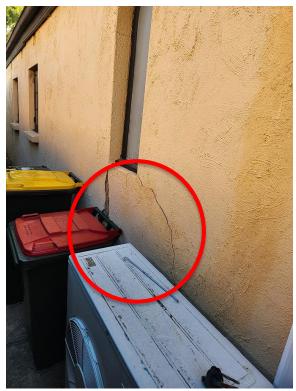
Diagonal cracking and debonded render near air conditioning unit.

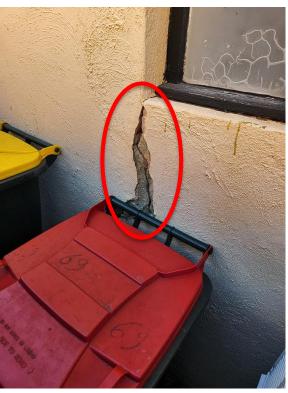
Vertical cracking below northern lounge room window on western wall.

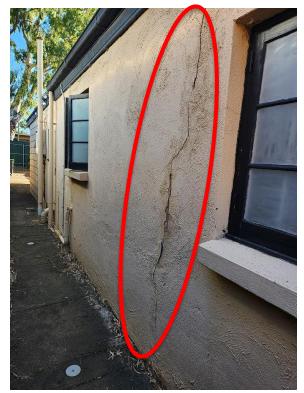
Vertical cracking to the north of bed 2 window.

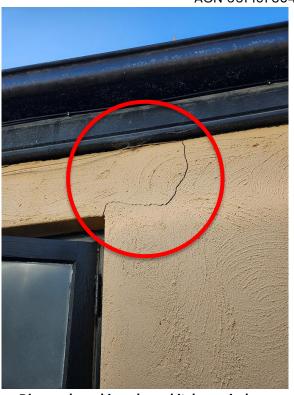
Diagonal cracking above kitchen window.

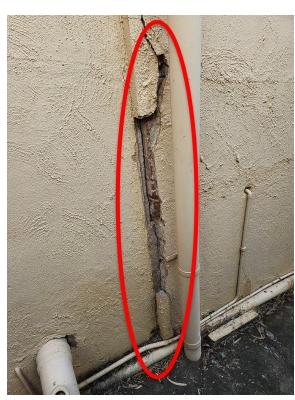
Vertical cracking to external wall near bathroom.

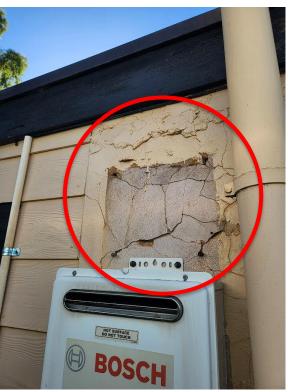
Cracking to render above water heater.

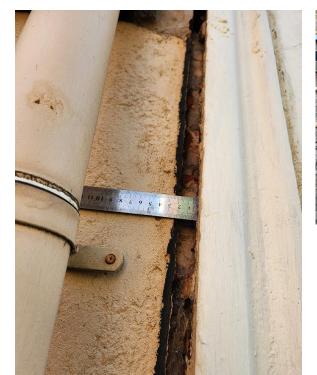
Measurement of separation between render and southern wall.

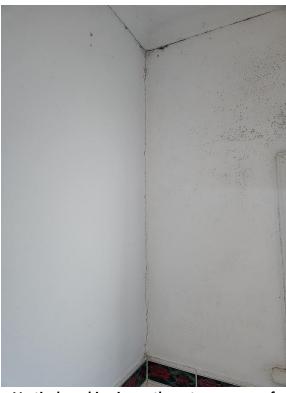
Vertical cracking in southwestern corner of room.

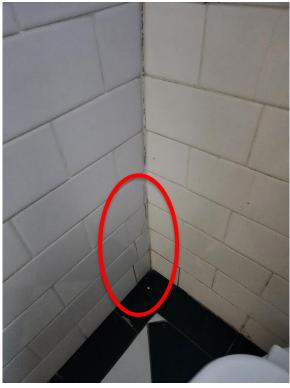
Broken tiles in southwestern corner of room.

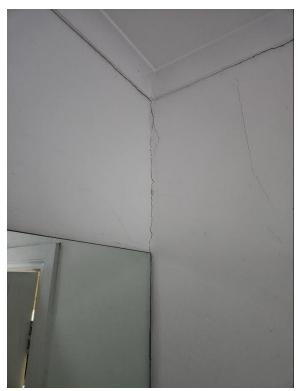
Vertical cracking in northeastern corner of room.

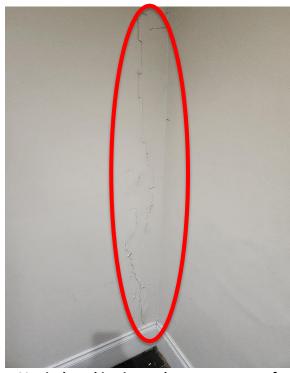
Vertical cracking in northeastern corner of room.

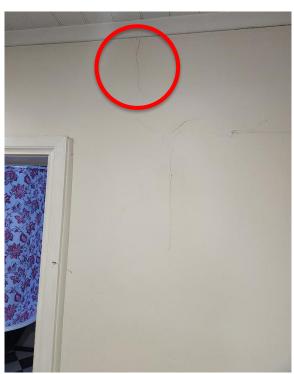
Vertical cracking to northern wall of room.

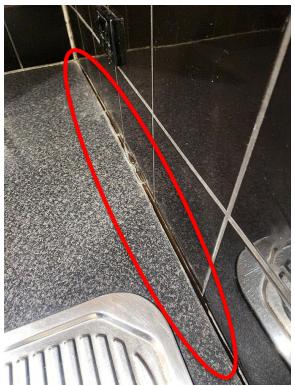
Separation of kitchen benchtop from western wall, indicating rotation of wall.

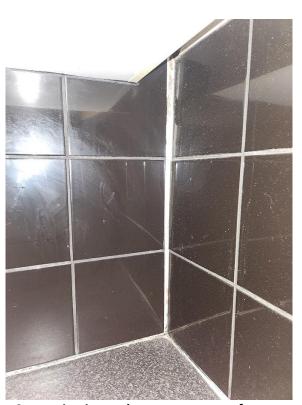
Separation in southwestern corner of room, indicating rotation of wall.

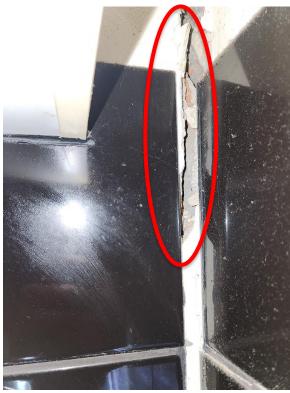
Vertical cracking in southwestern corner of room.

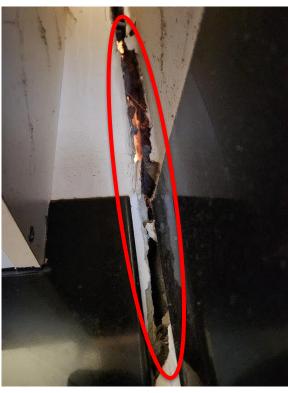
Vertical separation in southwestern corner of room.

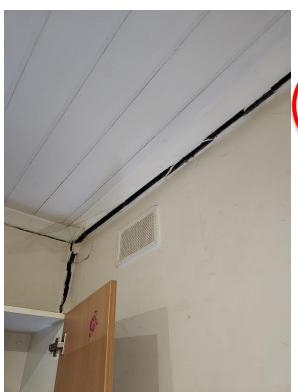
Separation of cornice from western wall, indicating rotation of wall.

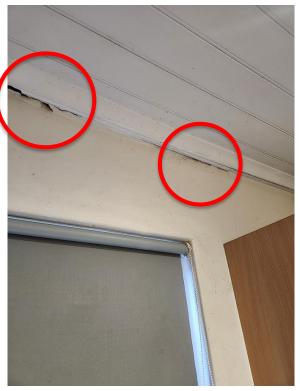
Separation of cornice from western wall was less on northern end.

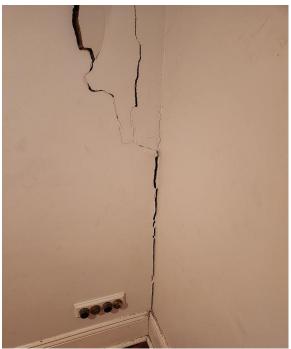
Vertical and diagonal cracking in southwestern corner of room.

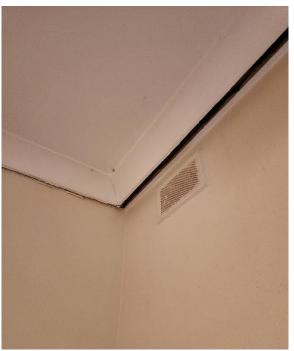
Separation of cornice from western wall on southern end.

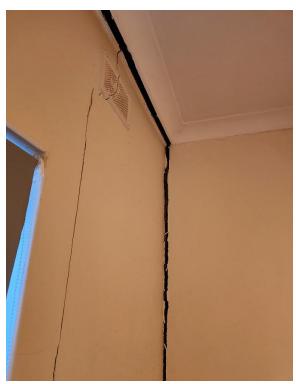
Vertical cracking in northwestern corner of room, indicating rotation of western external wall.

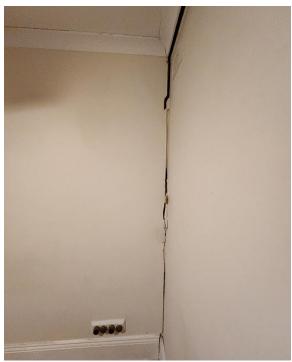
<u>Bed 1</u>

Vertical cracking in southwestern corner of room and separation of cornice from wall.

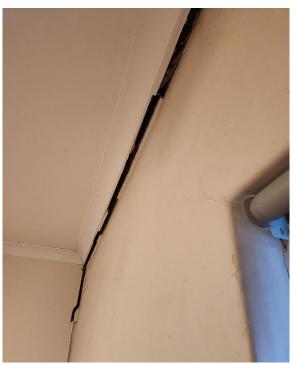
Separation of cornice from wall.

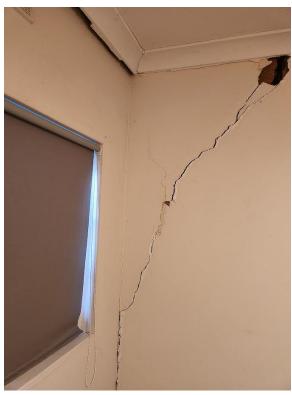
Diagonal cracking to northwestern corner of room.

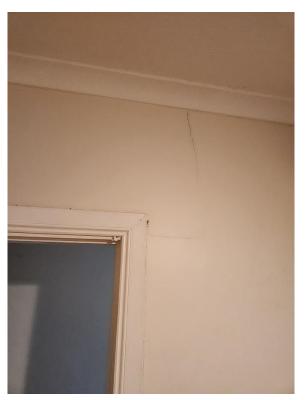
Vertical cracking above door.

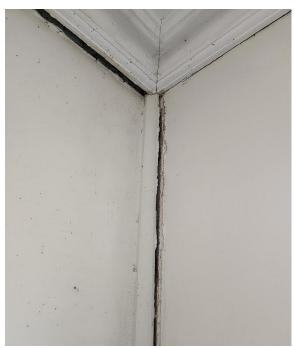
Lounge Room

Vertical cracking and separation of cornice in southwestern corner of room.

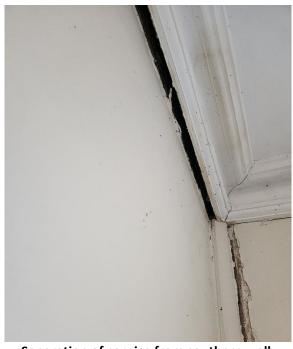
Separation of cornice from southern wall.

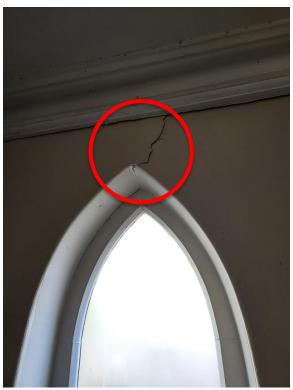
Diagonal cracking above southern window on western wall.

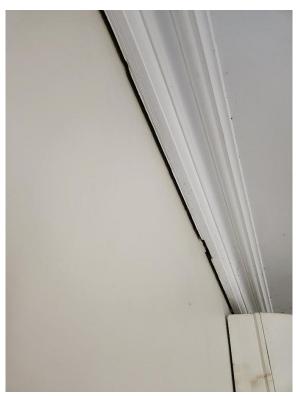
Separation of cornice from western wall.

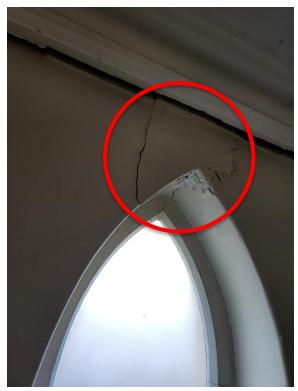
Vertical cracking and debonded render above northern window on western wall.

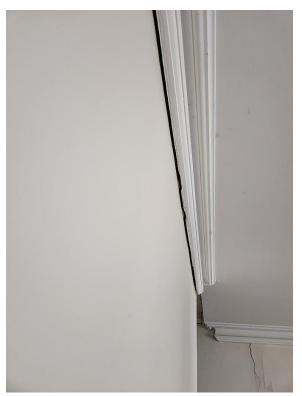
Separation of cornice from northern wall.

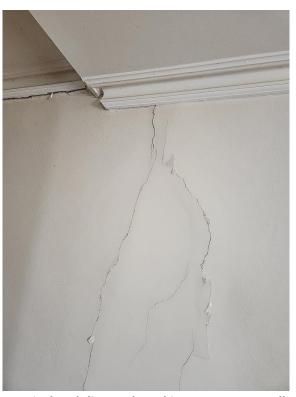
Vertical and diagonal cracking on eastern wall of lounge room.

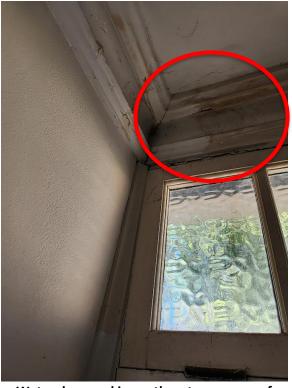
Water damaged in southeastern corner of room, above entry door.

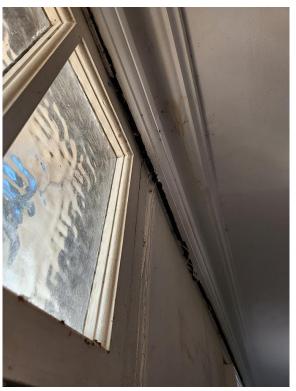
Separation of cornice from southern wall.

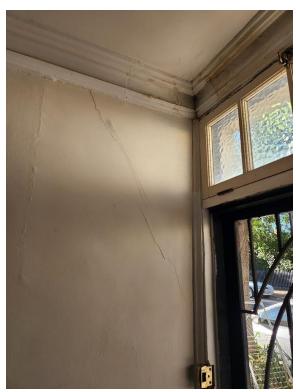
Diagonal cracking on eastern wall, near entry door.

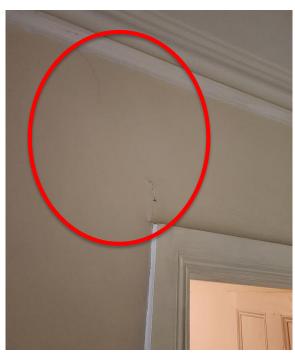
Diagonal cracking above bed 2 door.

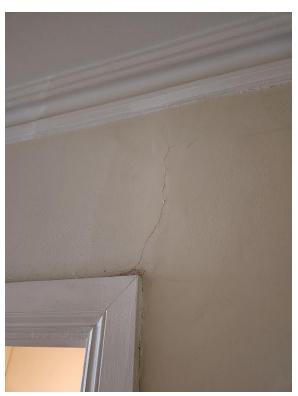
Diagonal cracking above bed 1 door.

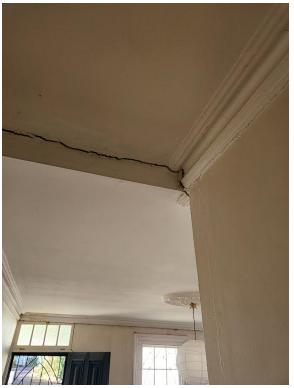
Horizontal cracking to ceiling between lounge room and corridor.

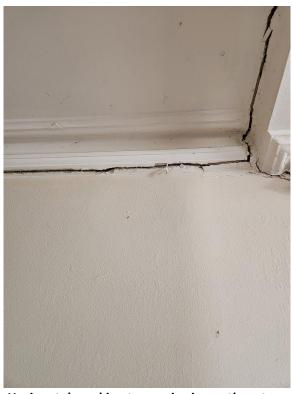
Horizontal cracking to cornice in southeastern corner of corridor.

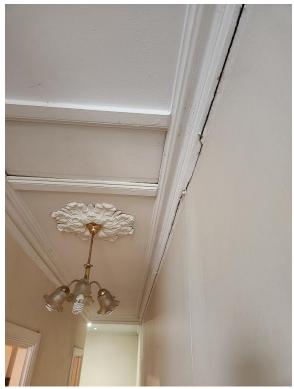
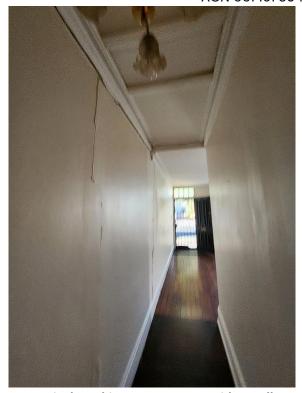
Vertical cracking to eastern corridor wall.
